Safety Investigation Report

Ref. AAIU-2016-AII-04
Issue date: 3 January 2018
Status: Final – Revision 1

Classification:	Accident
Level of investigation:	Standard
Date and time:	11 June 2016 at 16:50 UTC
Aircraft:	ATEC Zephyr 2000 ultralight aeroplane
Owner:	Private
Location:	Along the highway E42, near the exit “Malmedy”.
Type of flight:	General aviation – Local flight
Phase:	Cruise
Occurrence type:	System/component failure or malfunction non-powerplant (SCF-NP)
Persons on board:	One pilot and one passenger
Injuries:	None

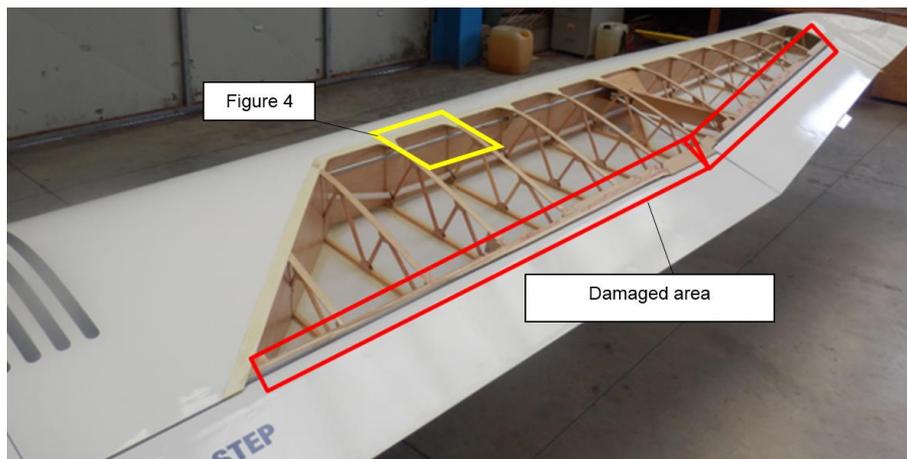
Damage to the wooden structure, due to the fabric being ripped off, was only visible on the rear spar.

Figure 2: areas where the adherence of glue to wood caused wood fibre particles stripping

Wood damage was only localized at the plywood rear spar upper cap (the upper part of the trailing edge) where some remains of fabric fibres were visible. At these places, the wood fibres likely remained attached to the missing fabric. No remnants of fabric fibres was found at any other surface of the wing structure where the fabric was bonded.

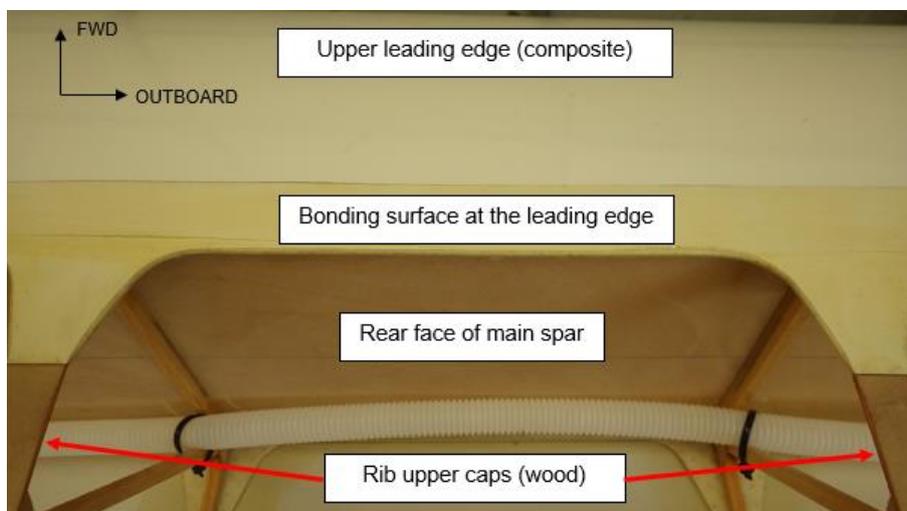
The composite skin of the leading edge is painted white and shows a beige colour where the fabric was bonded. This indicates that some glue remained on the composite support.

No damage was found at the leading edge composite structure and at the upper caps of the ribs (no wood fibre pull-out traces).

Figure 3: Top-down view where the fabric was bonded at the leading edge (beige zone)

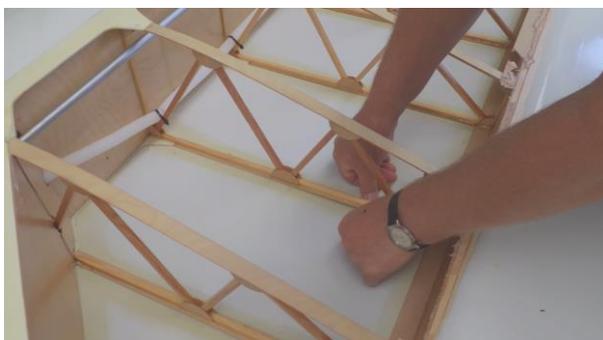
Figure 4: Adherence test of the lower fabric.

A moderate force was sufficient to detach the fabric from its support. The pressure was applied progressively to cause a sudden failure of the bonding, accompanied by a cracking sound resulting in 30 cm detachment of the fabric from the rib.

As soon as a portion of the fabric was detached, an extremely limited pressure at the edge of the separation was sufficient to cause additional significant detachment of the fabric.

As with the upper wing, inspection of the rib cap and also the fabric at the area of separation did not show any wood damage and any fabric damage (no fibre separation).

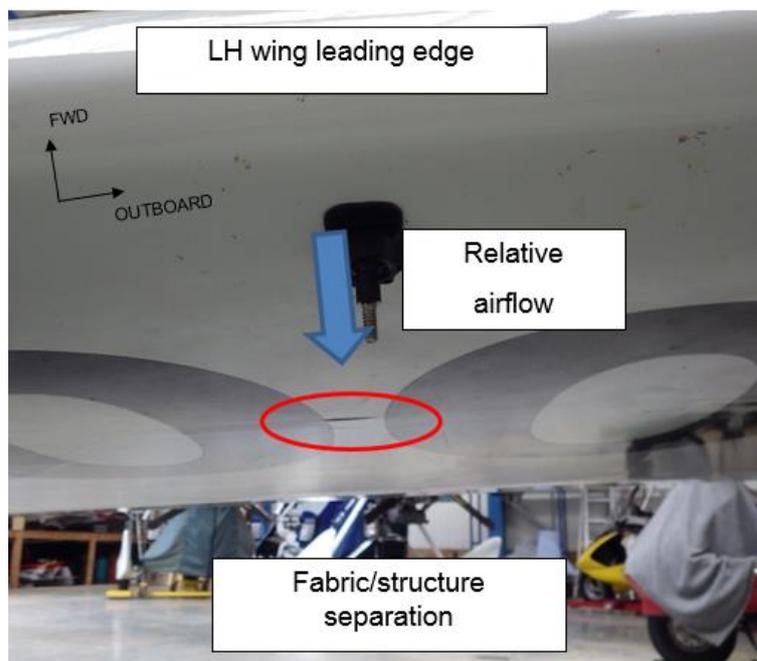
The pilot was not aware of this anomaly. He stated he never noticed it during the pre-flight inspections.

This de-bonding was exposed to the relative wind having the potential to enlarge the opening to blow the airflow inside the wing structure, resulting in a possible entire de-bonding of the fabric, in particular in case of poor adhesion of the fabric.

Figure 5: Limited lower fabric separation

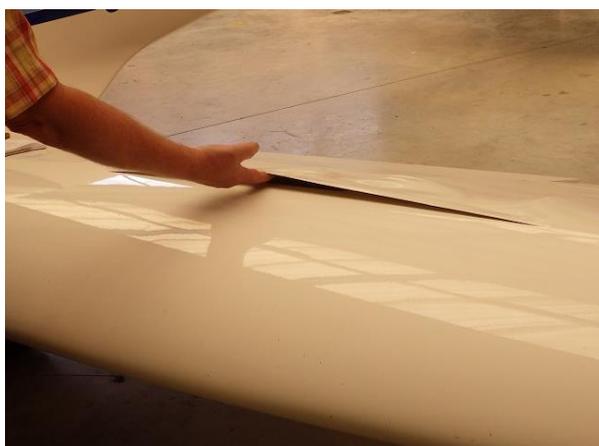
Figure 6: Easy uplifting of the fabric.

After gaining access to the upper fabric through a cut in the lower fabric, a moderate upwards manual pressure was applied on the fabric close to the leading edge. It caused the bonding to suddenly fail for more than 50 cm at the leading edge, while emitting a cracking sound.

Thereafter, as seen on Figure 6, a very limited force was sufficient to cause additional significant separation of the fabric.

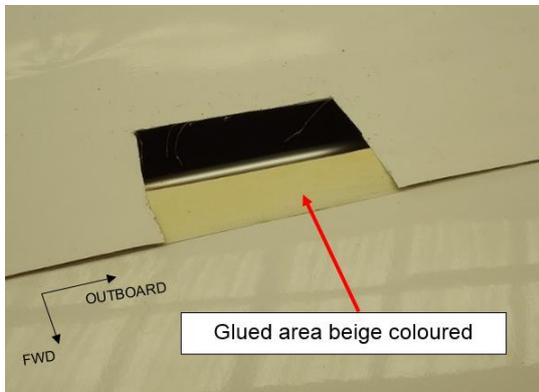
A piece of the fabric located at the leading edge bonding was extracted for a close examination of the inner surface of the glued area (see Figure 7). On the inner side of the fabric sample, a beige coloured zone, slightly going over a pencil stroke, indicated that the fabric had been pre-glued before positioning it onto the structure of the wing.

Figure 7: cut piece of upper fabric

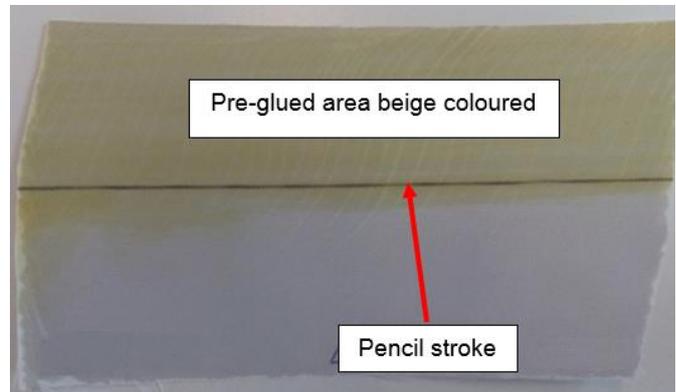
Close examination of the fabric's texture and the corresponding composite surface of the leading edge didn't show any sign of glue material pull out.

Figure 8: inner side of the cut piece of fabric

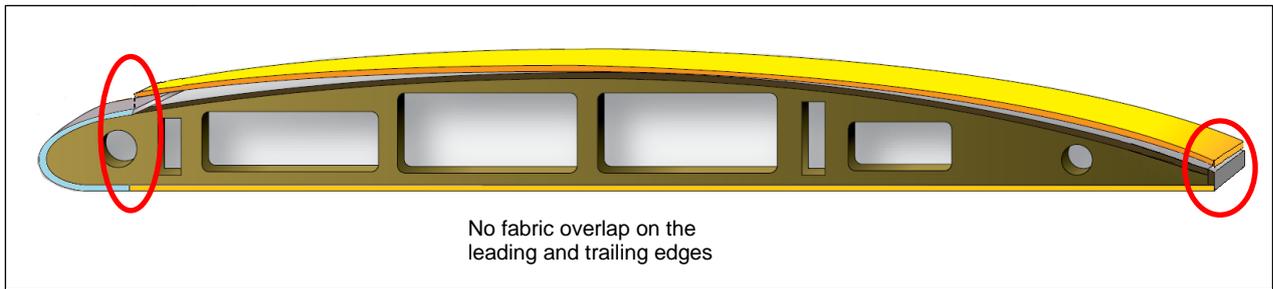
The ATEC design for the fabric covering (see sketch on Figure 9) is characterized by 3 fundamental differences with respect to the usual covering method:

- The fabric is glued on the ribs instead of being fixed by lacing (or other fixing systems).
- The forward upper and lower fabric edges stop at the rear side of the wing leading edge.
- There is no overlap of the upper and lower fabric covering at both the wing leading and trailing edges.

Figure 9: sketch of the ATEC Zephyr covering design

It is recommended that ATEC modifies the design of the fabric covering, amongst others, by overlapping the upper and lower fabrics at the wing leading edge, positioning the fabric edges at places where the aerodynamic suction is minimal. This in order to avoid that even a limited detachment of the edge of the fabric causes lifting of the fabric, penetration of dynamic pressure and subsequent entire detachment of the fabric.

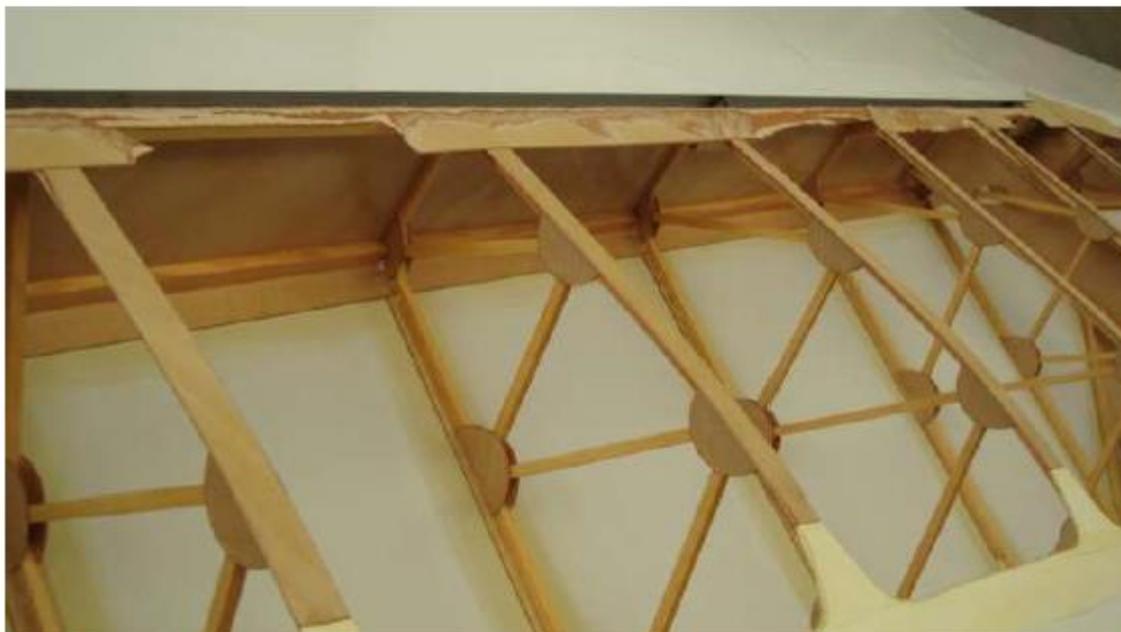
Pic. 2: Fabric coating separated from the upper part of the wing

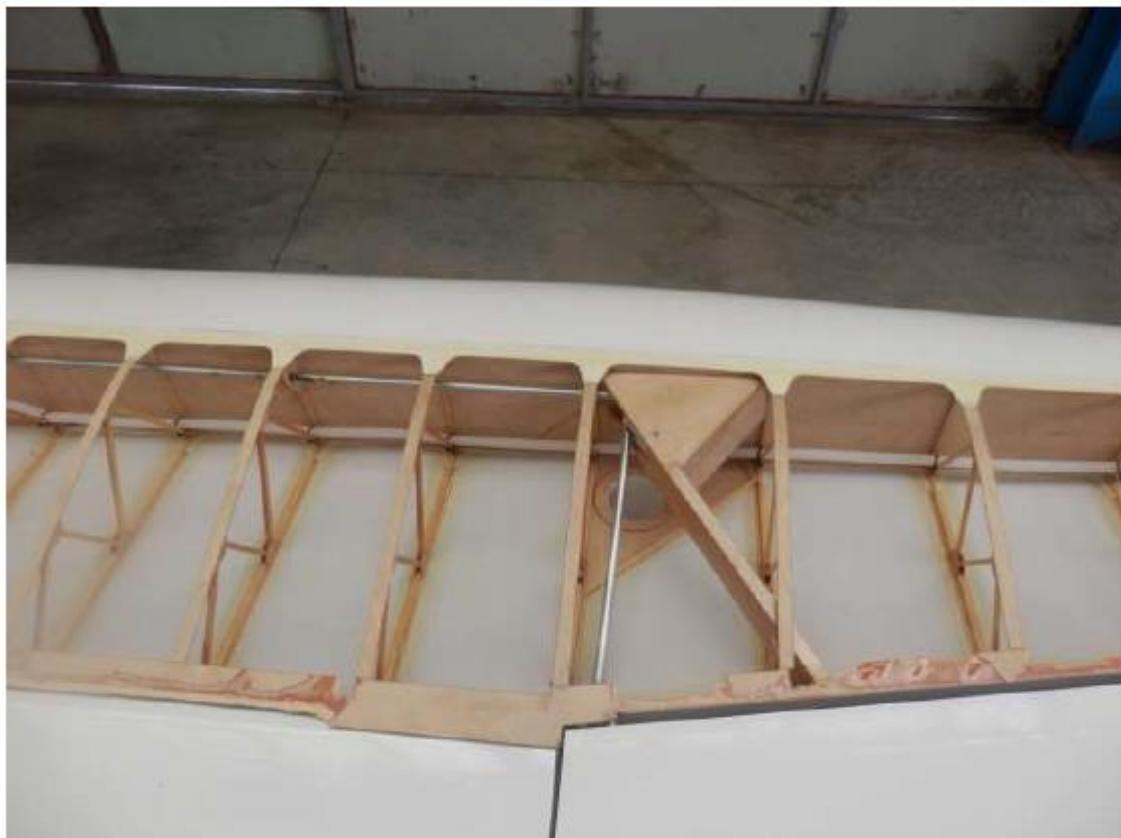
Pic. 3: Fabric coating separated from the upper part of the right wing

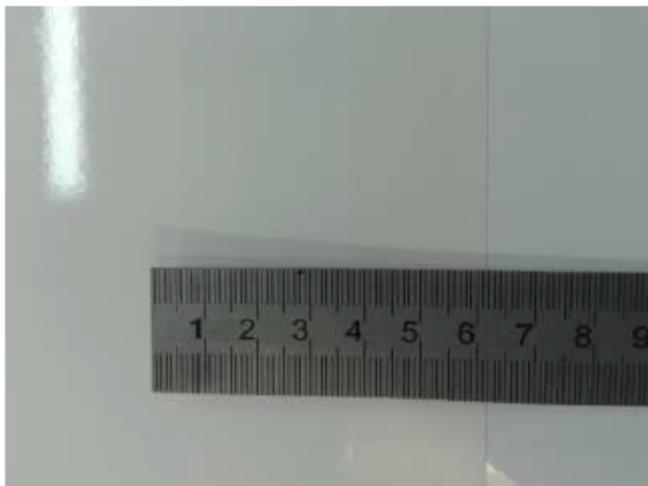
Pic. 4: Detail of the tape covering bonded connection of the coating on torsion box

Check the bonding condition same way as described by the par. 1. Then, cover the connection on the torsion box of the wing and horizontal tail by white plastic tape. Ask the aircraft producer or its authorized workshop for re-coating.
