# Safety Investigation Report

**Ref.:**  
AAIU-2016-06

**ACCIDENT  
PIPER PA-28-181  
AT SAINT-HUBERT  
ON 10 JUNE 2016**

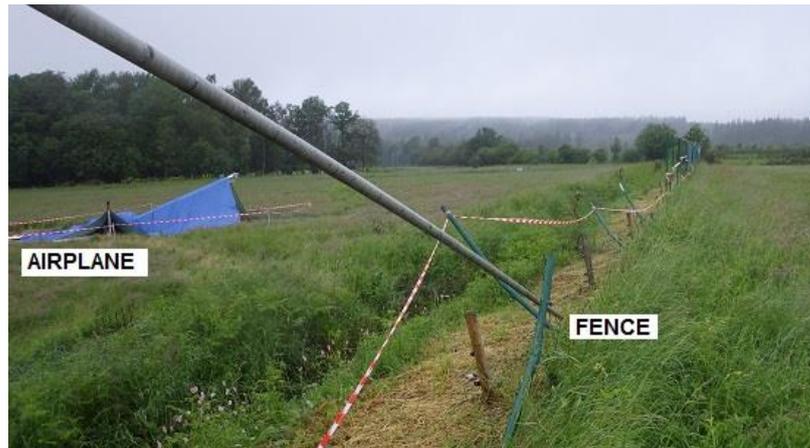
Figure 2 : damaged fence

The fence surrounding the EBSH airfield – a wire mesh supported by poles - was damaged over several meters.

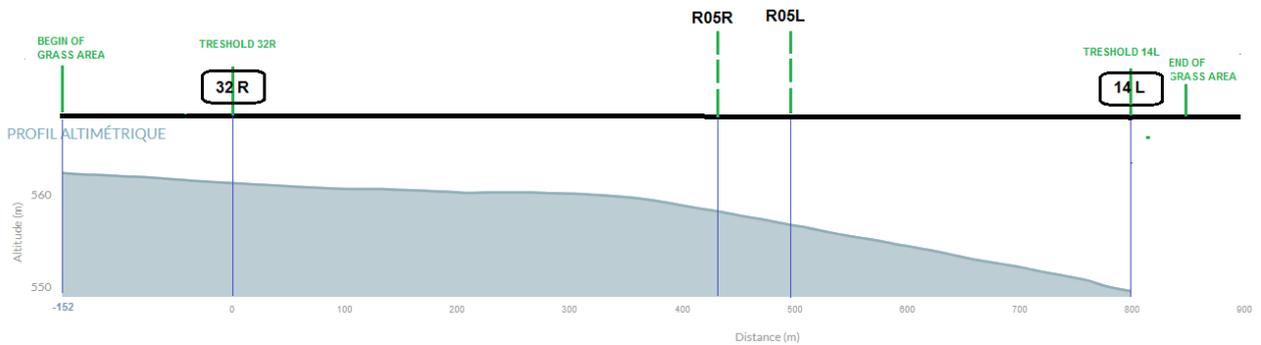
Figure 6 : Elevation profile

The runway surface is uneven as are many grass runways and with a noticeable slope.

The first half of the runway is relatively flat, and the slope increases (2.5%) shortly before the crossing with runways 05/23.

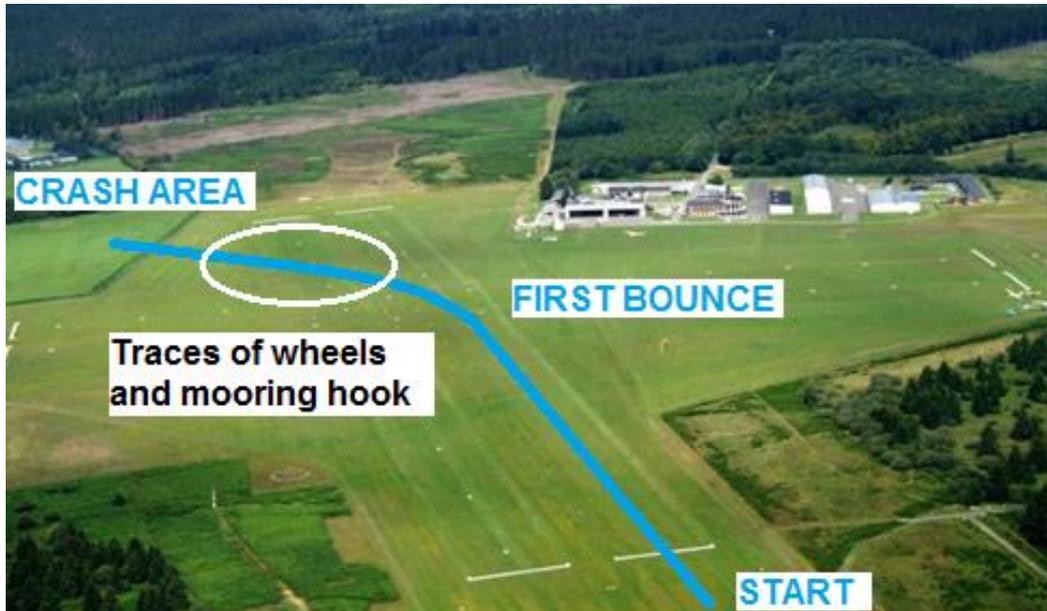
Figure 7 : Flight track

The airplane crossed the parallel runway 32L, the taxiways and went through the airfield perimeter fence. The tyre traces on the grass left by the nose wheel, the main wheels and the mooring hook indicate the airplane went several time airborne, then fell down.

Upon reaching the fence, witnesses saw the airplane pitch up. A witness stated seeing the airplane airborne at a very low height when it hit the perimeter fence. The airplane upturned a part of the fence and crashed 15 m further in a field neighboring the airfield, 1 meter below the airfield surface.

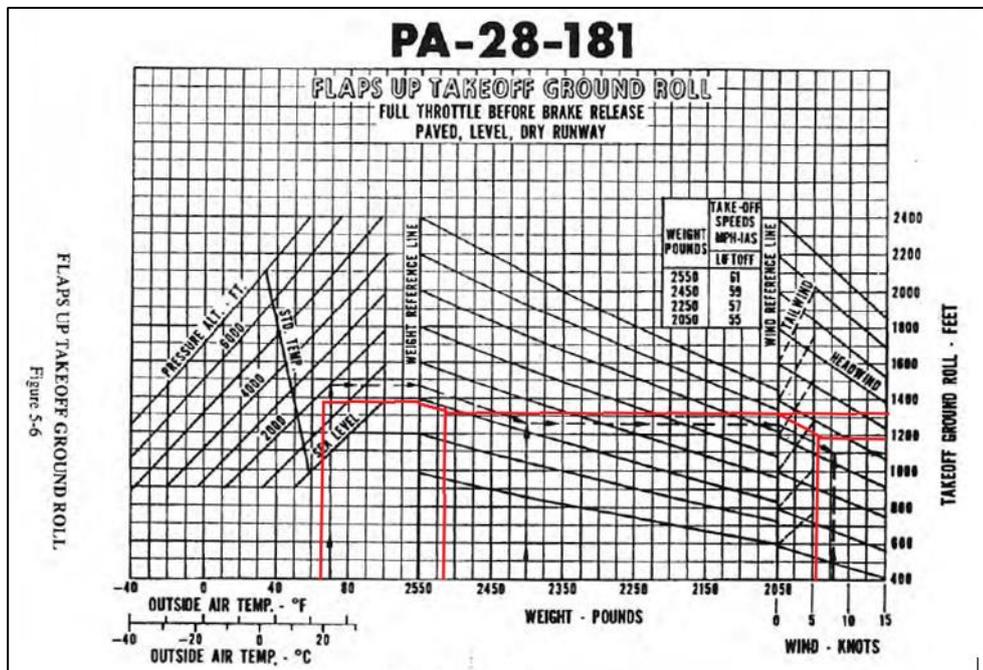
Figure 11

Based on the above take-off ground roll graph the airplane would have normally required a ground run between 1190 ft and 1310 ft ( 363 m – 399 m) taking into account the variable wind orientation and speed between no wind (= 1310 ft) and 6 kt headwind (1190 ft).

These values must be further corrected by factor X1.3 due to the wet grass surface of the runway.

Theoretically the airplane should have reached the minimum lift off airspeed ( $V_R$  53 kt) after a takeoff run distance between 471 and 519 meters which approximately corresponds to the place where the pilot and witnesses reported the first bounce occurred.

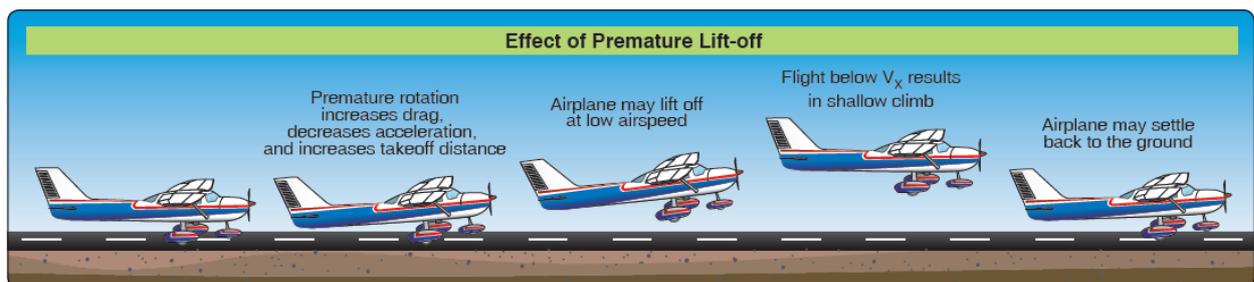
Figure 13

From that point of the airplane trajectory, although the pilot re-applied full power, a series of additional bounces occurred, slowing down the airplane further. The airplane deviated from the planned trajectory and crossed the runway, running on surfaces with high grass.

The traces on the ground of the mooring hook indicates the airplane took a too high pitch at times, maybe at that time due to an excessive elevator back pressure. This would also lead to a premature lift-off below the rotation speed, as described in the figure below.
