Safety Investigation Report

Ref.:
AAIU-2018-07-01

ACCIDENT
Lockheed Model 12 ELECTRA JUNIOR
AT GENK-ZWARTBERG
ON 1 JULY 2018

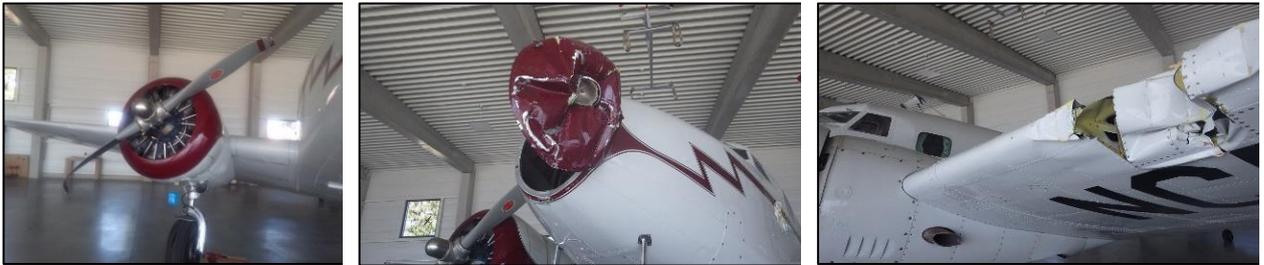
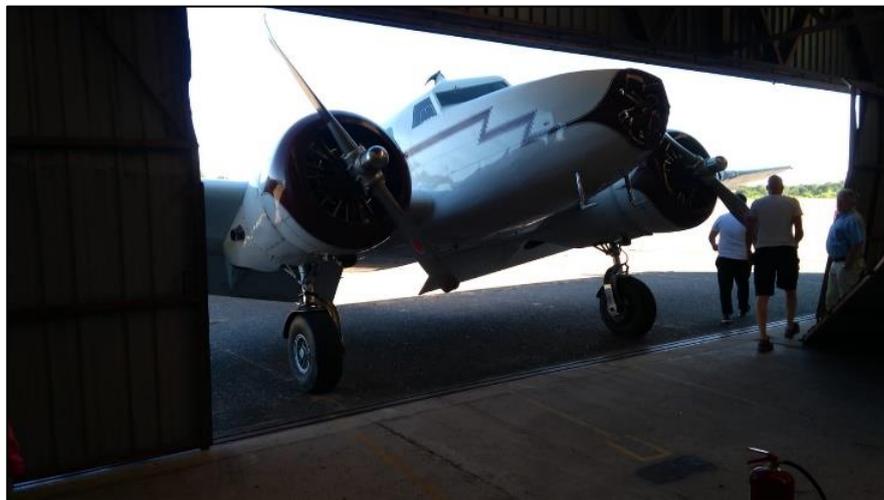
Figure 1: Pictures showing damage to the airplane and the hangar door

The airplane sustained damage to the nose, wing leading edge and RH engine propeller

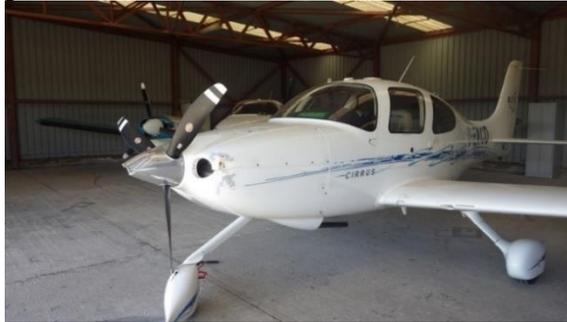
Figure 2: Damage to the Cirrus SR20

The airplane showed damages to the nose wheel, spinner cone, and scratches on the fuselage and wing.

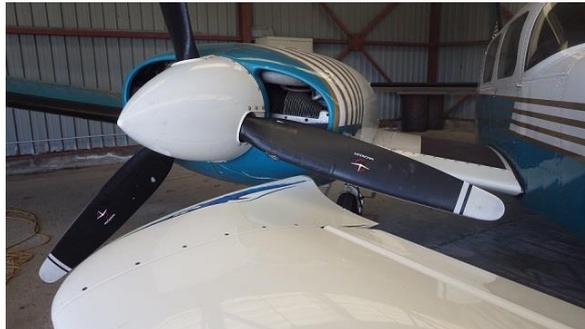
Figure 3: Damage to the Piper PA34 Seneca

Damage to the RH engine cowl.

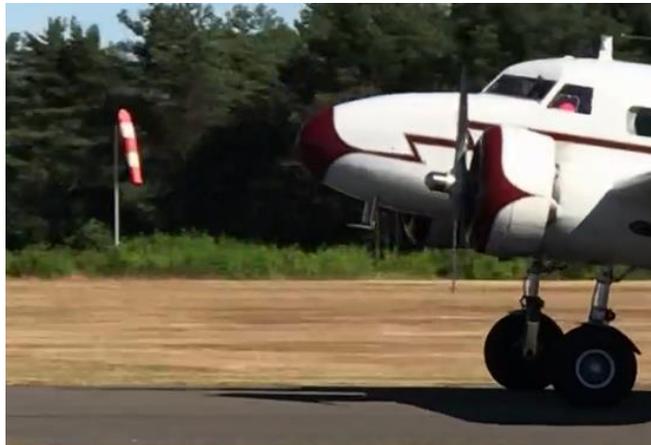
Figure 5: Airfield windsock during landing

As can be deduced from the above tables, the wind at the approximate time of the accident was around 10 kt from 060°, causing a headwind factor of 8 kt and a crosswind factor of +/- 5 kt

At the time of the landing on RWY 03, the wind was coming from 60 degrees, on the right side of the aircraft. To counteract the effect of the wind, the pilot lowered the right wing and compensated by pushing on the left rudder pedal. As the EBZW airfield is bordered by trees, the wind conditions would change close to the ground, with possible turbulent effect.

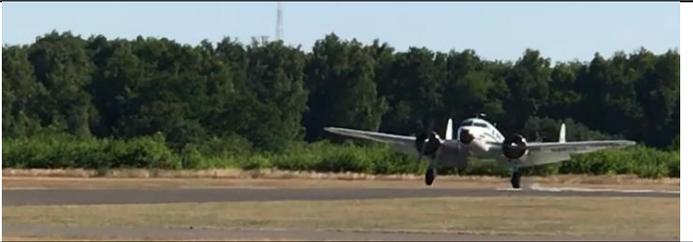
<p>The touchdown occurred very close to the threshold.</p>

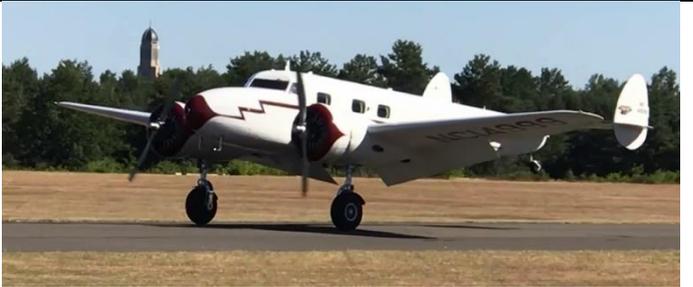
<p>The initial part of the landing roll</p>

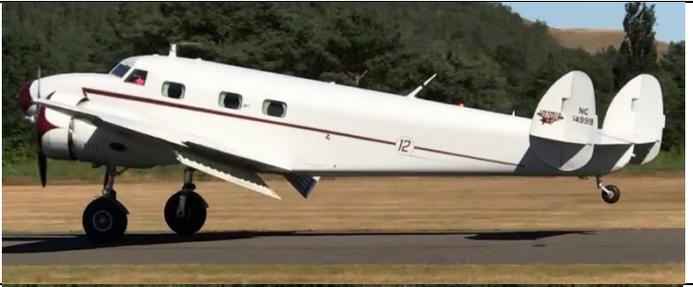
<p>Both rudder deflection to the left.</p>

Nevertheless, from the video taken of the airplane during landing, it is obvious that the pilot maintained the left rudder pedal input upon touchdown and after the tailwheel contacted the runway.

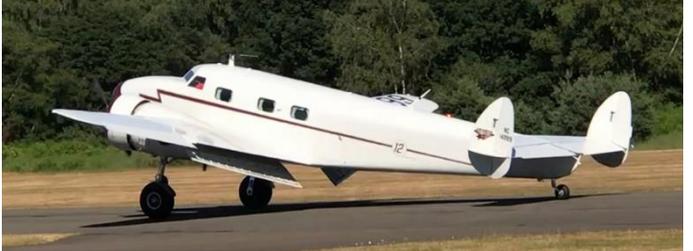
<p>From the moment the tail wheel touches the ground, the airplane deviates to the left. The rudder control surfaces are deflected to the left.</p>

When the tailwheel, mechanically connected to the rudder, contacted the ground, it pushed the airplane tail sideways.

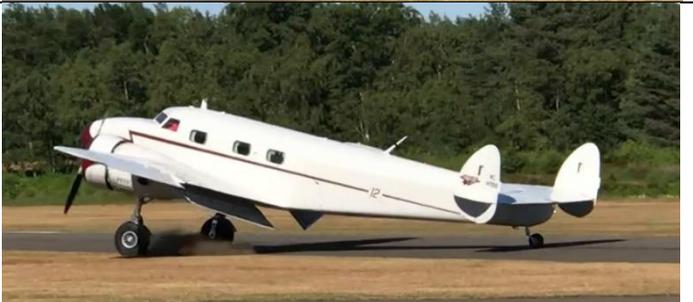
<p>The airplane is turning to the left, exiting the runway. The traces of the tail wheel on the ground shows it is outside the path of the two main wheels.</p>

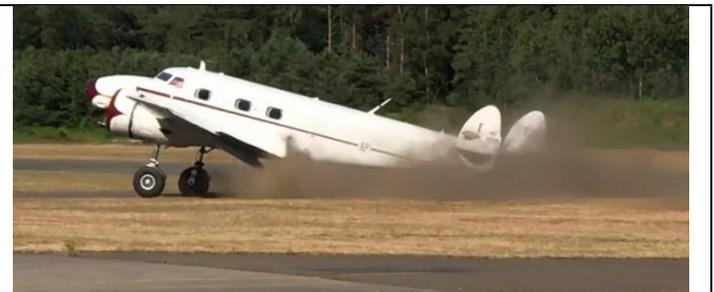
<p>Pilot reports he applies braking to the right wheel. The sound of braking is clearly audible on the video.</p>

The pilot stated his reaction was to apply brakes on the right side, but this was too late and ineffective to prevent the deviation of the airplane.

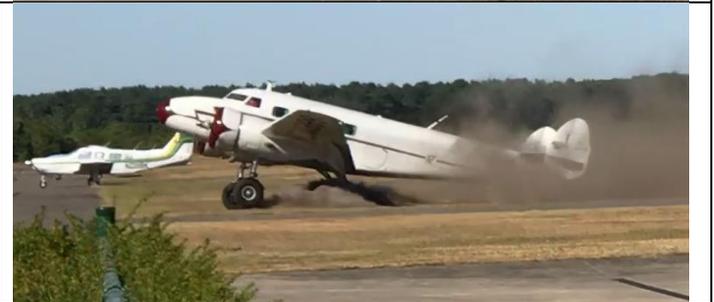
<p>Airplane at 90° from the runway</p>

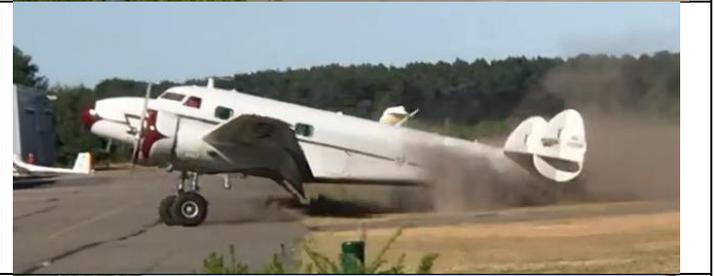
<p>Airplane entering the apron</p>

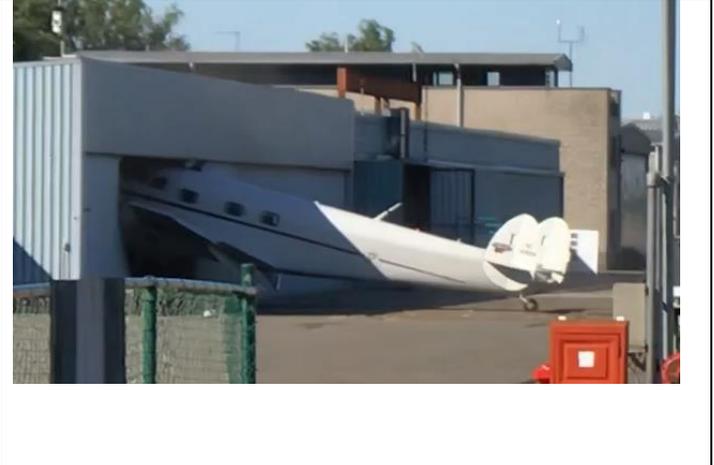
<p>Airplane crash entering the hangar. The pilot reported the shock was felt very light.</p> <p>Several sections of the hangar door were pushed out of their hinges. One door section was thrown inside the hangar, above the wing of a parked Cirrus SR20 and crashed to the ground behind the parked aircraft. Another aircraft, a Piper Seneca was also damaged</p>

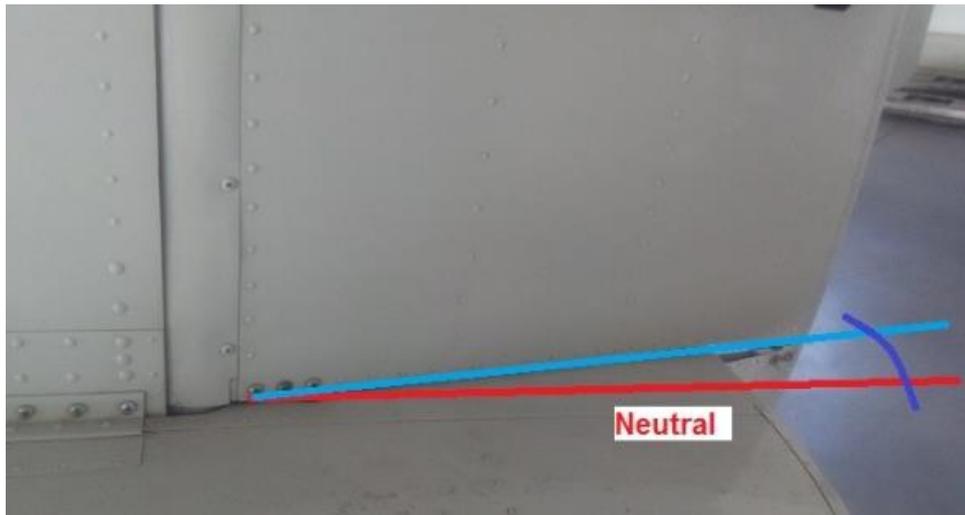
Figure 10 : Rudder pedals when left hand control pedals in neutral position

Nevertheless, the rudder control pedals of the pilot (left position) were found misaligned. The pedals are adjustable on ground. The pedals, when in neutral position, caused the rudder to deflect slightly to the right.

During inspection, the pilot's rudder pedal were found misaligned. To put the rudder in neutral position, the left rudder pedal needed to be more deflected than the right pedal, however the investigation determined that this finding had no direct bearing on the event.

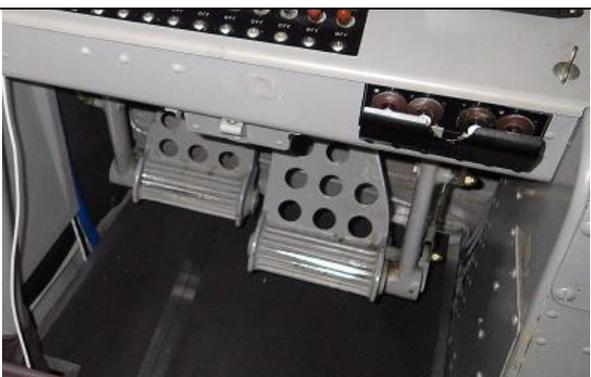
<p>Pilot's (left seat) rudder pedals position when rudder control surfaces are in neutral position.</p>

Figure 11: Pictures showing the misalignment of the left seat rudder pedals

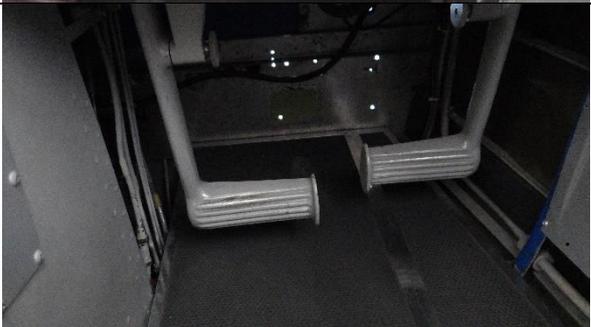
<p>Co-pilot's (right seat) rudder pedals position when the pilot's (left seat) rudder pedal position are aligned.</p>

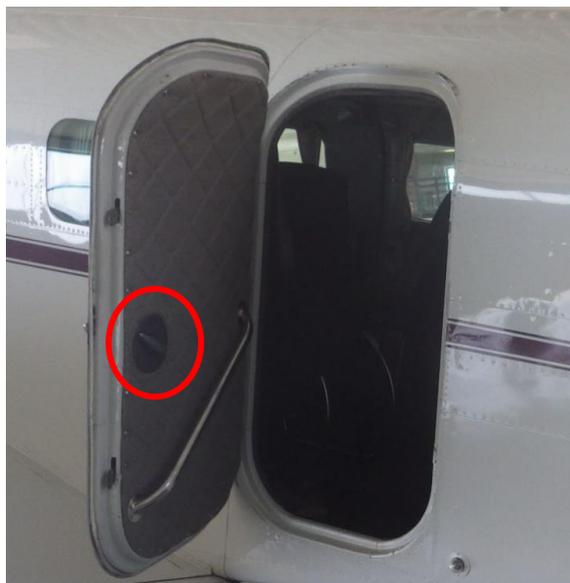
Figure 12: Position of the latch to open the back door

After the crash, the pilot instructed the occupants to evacuate the airplane out of fear that aircraft would catch fire. But as the latch of the (only) door in the back has to be turned clockwise upwards to open, which is for many people 'against nature', it took some time to get it open.

The pilot stated that, in the future, he will make a cabin safety briefing to point out the specificities in case of an emergency and subsequent evacuation.
