# Safety Investigation Report

Ref.:  
AAIU-2019-12-29-01

**ACCIDENT  
ROBINSON R44  
AT WIJNENDALE (TORHOUT)  
ON 29 DECEMBER 2019**

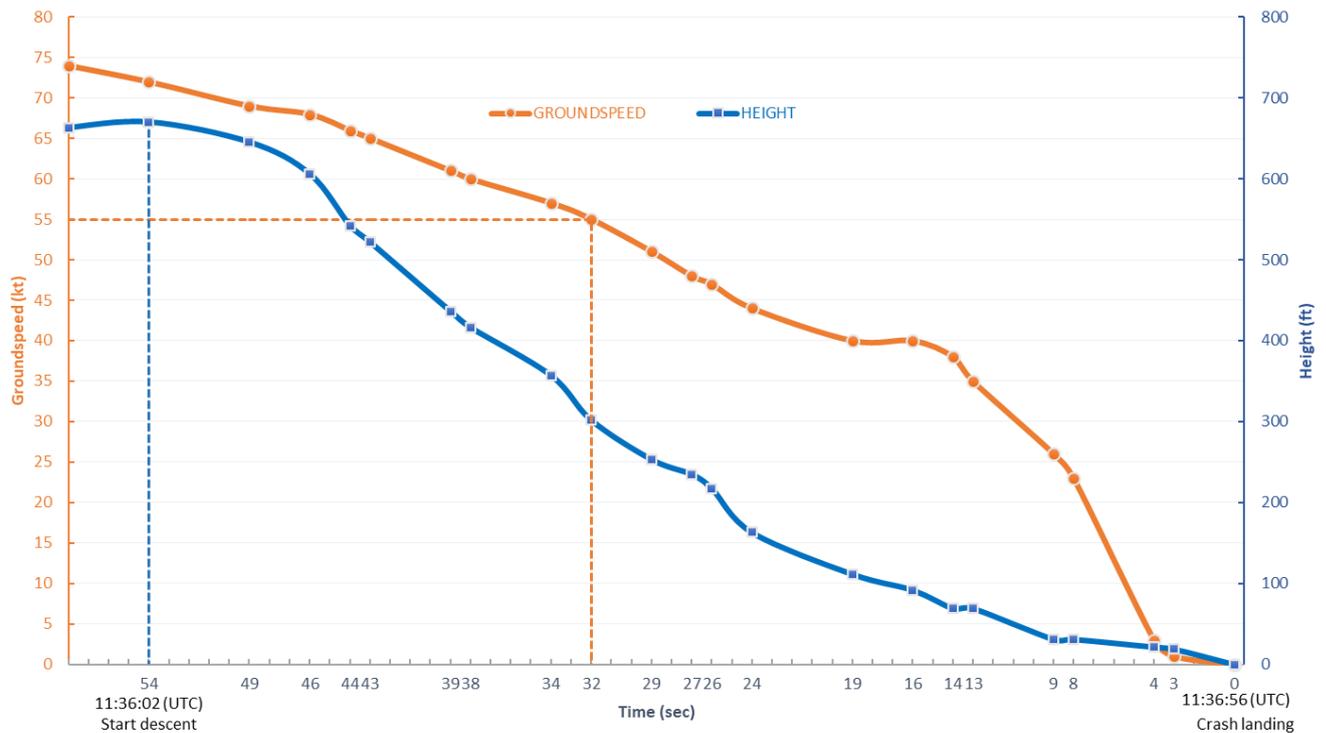
Figure 9 Height (ft) and groundspeed (kt) during the final descent

- The helicopter began to descent at 11:36:02 or 54 seconds before the crashlanding.
- The descent started from a height of 670ft (AGL) or 800ft (AMSL).
- Initially ground speed was 72kt, but then gradually decreased as the helicopter descended. At 32 seconds before the emergency landing the speed dropped to below 55kt. This was at an altitude of about 300ft AGL.

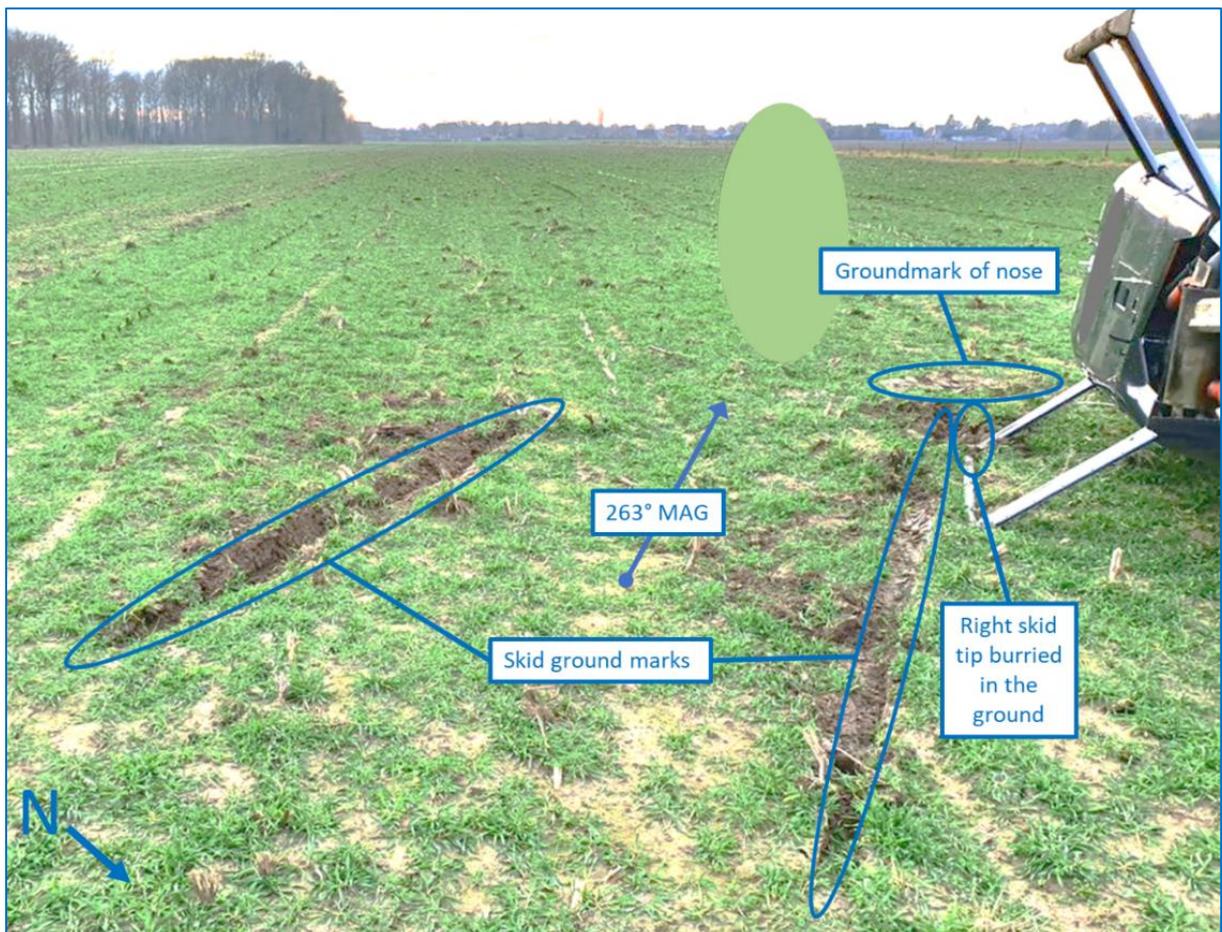
Figure 10 Direction of the helicopter and ground marks of skids and nose

Ground marks of the helicopter skids hitting and sinking in the ground were found at the LH side of the wreckage (see fig. 10). The marks were behind but in the same direction of the nose of the wreckage. The marks were about 10 cm deep and 3 m long. The RH skid ground mark was longer than the LH skid ground mark.

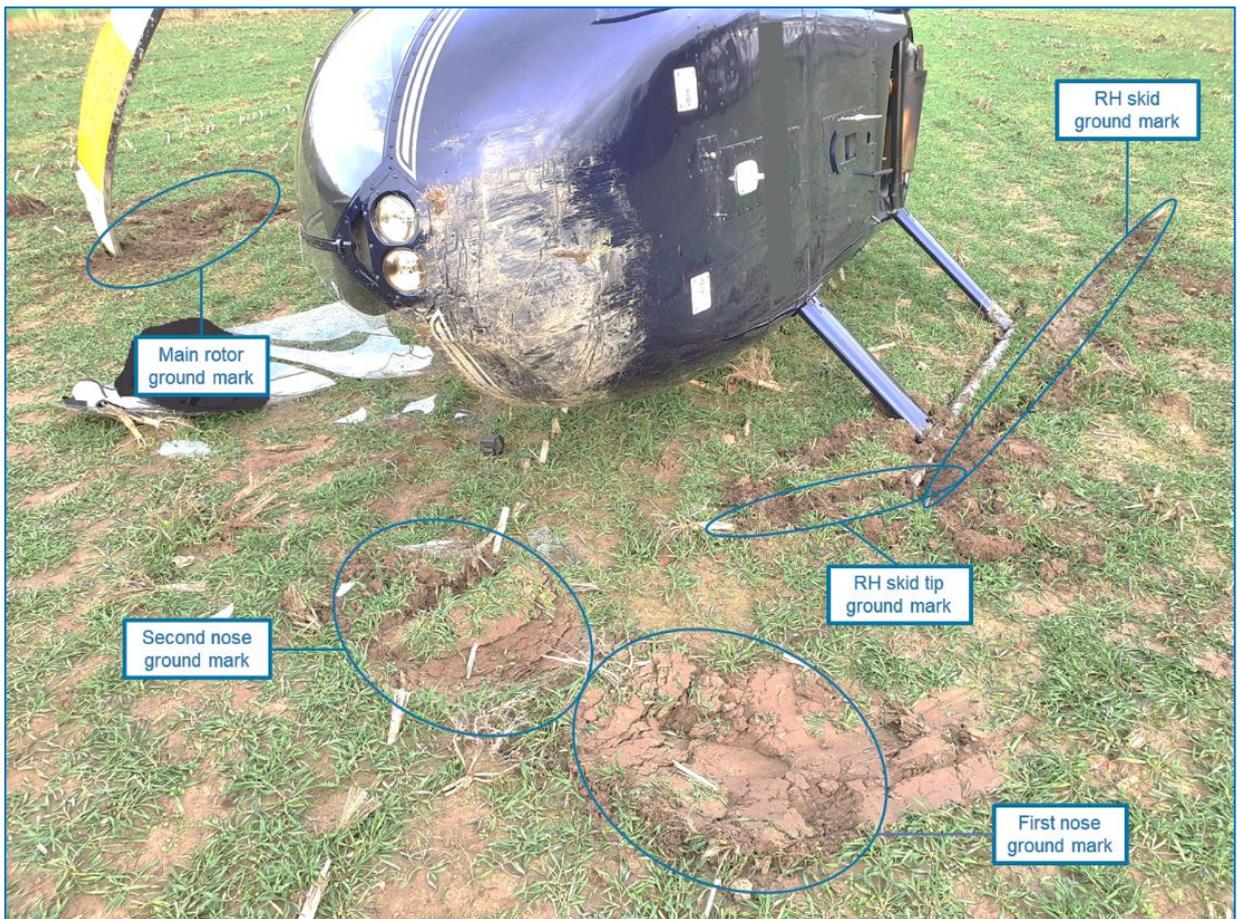
Figure 11 Detail of the nose and RH skid tip ground marks

Several groundmarks of the helicopter's nose were also found showing that the helicopter continued to yaw to the right, pivoting on his RH skid as it tilted forward (see fig. 11).

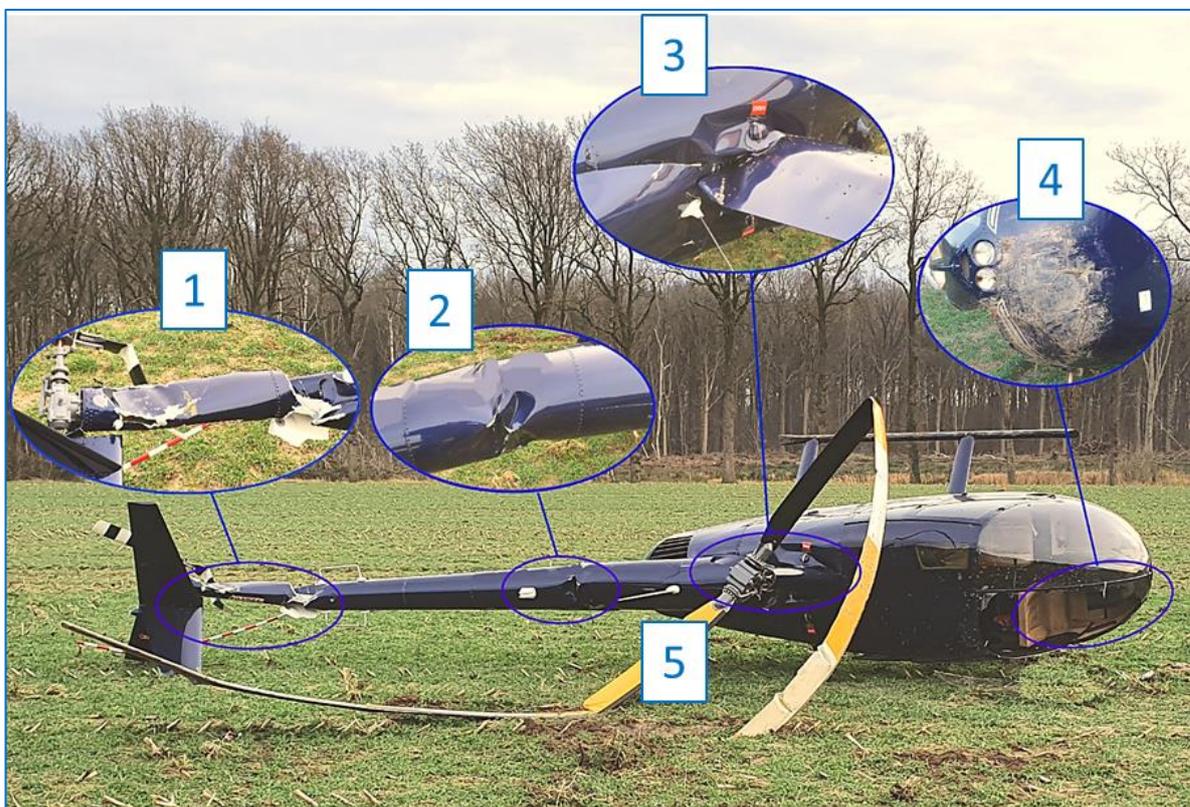
Figure 12 Aircraft damage

The helicopter was still in one piece. The following damages could be observed (see fig. 12):

1. The aft end of tail boom before the tail rotor showed signs of interaction with the main rotor blade tips (yellow paint) and was sheared near its attachment point with the red-white tail rotor guard.  
One tail rotor blade was bent in the direction of thrust and showed interaction with the main rotor blade tips.  
The tail rotor skid was bent and was muddy.  
The lower vertical stabilizer was damaged by compression.  
The red-white tail rotor guard which has 2 attachment points (tail rotor assembly and tail boom) was bent but did not show any (impact) sign of mud.

2. The tail rotor boom showed damage from upwards bending at its connection to the fuselage;
3. The main rotor mast was deformed towards the rear.
4. The nose of the helicopter showed presence of mud up to the windshield. The mud trace is more present on the RH side;  
The right windshield was broken when the pilot and two passengers climbed out of the wreckage.

5. The main rotor blades were damaged but still in one piece.  
Traces of mud at both the blade tips shows interaction with the ground.

The skids showed low or no deformation. The RH skid is muddier than the LH one.

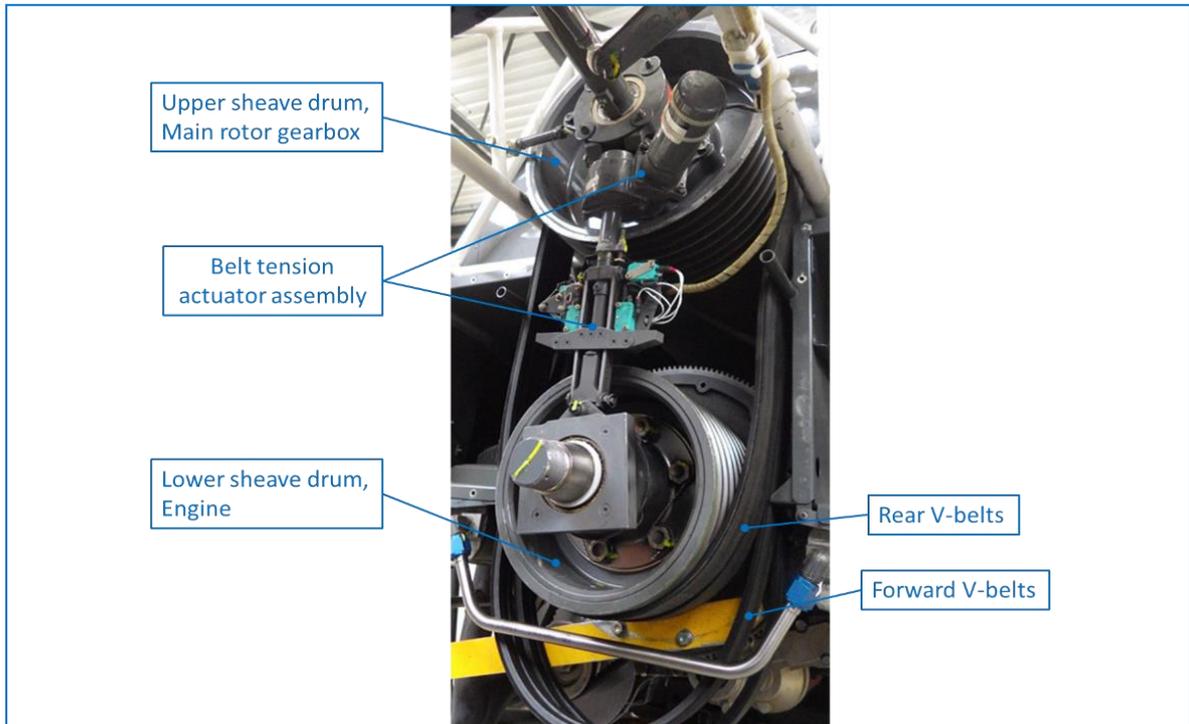
Figure 13 Damage on the drive belt system

- The two forward V-belts were no longer in place on the sheave but in front of the upper sheave (see fig. 13). The two rear V-belts were still present on the drum but were moved forward on the sheaves.

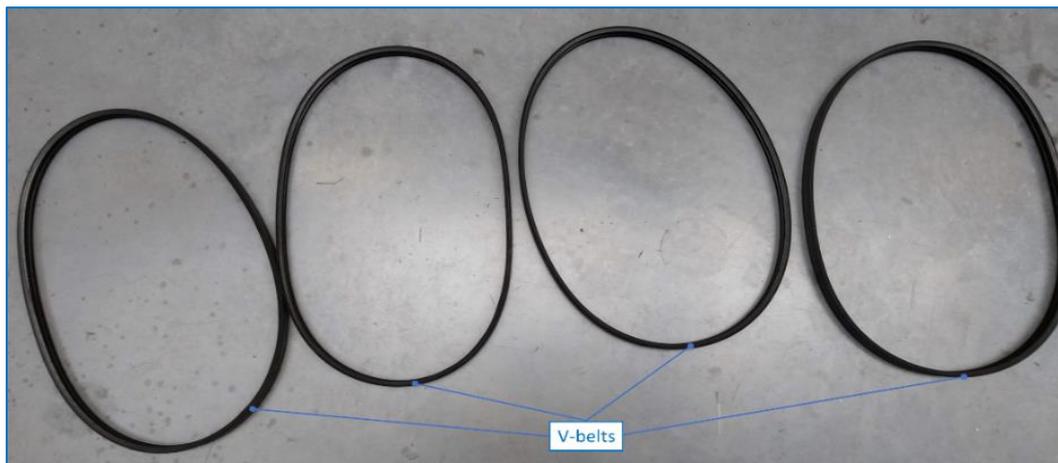
Figure 14 Condition of the V-belts

- The V-belts were in good condition. No sign of damage or abnormal wear or tear was found (see fig. 14):

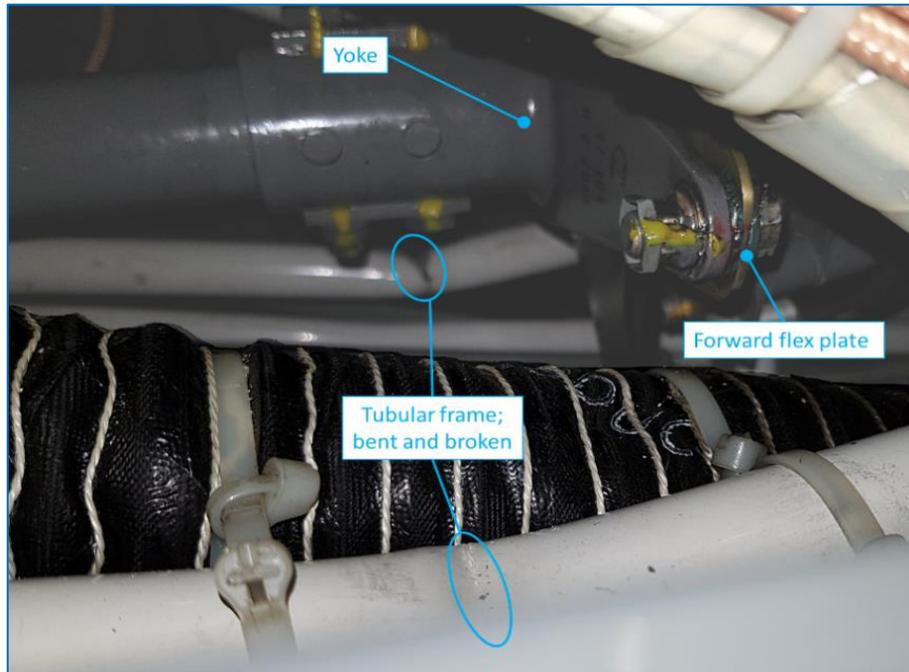
Figure 15 Damage on the tubular frame structure

- The tubular frame that supports the main rotor gearbox and holds the tailcone assembly was bent and broken on both sides nearby the yoke and the forward flex plate (see fig. 15).

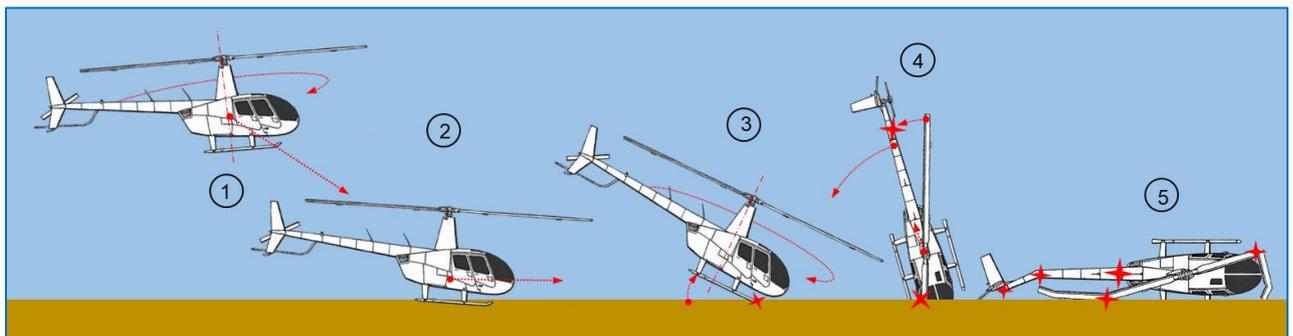
Figure 16 The impact sequence

4. When the nose made contact with the ground, the tilting of the fuselage stopped. As the main rotor hit the ground, the main rotor shaft bent backwards which caused the CCW rotating rotor hit the tail rotor and the boom on the LH side.

5. The blow from the main rotor on the tail rotor and boom made the helicopter fall to the right, where it came to rest. The main rotor blades kept chopping into the ground until they broke and got stuck in the mud.

The investigation could not determine when the tail rotor skid, the lower vertical stabilizer and the tail rotor boom were damaged in the impact sequence.

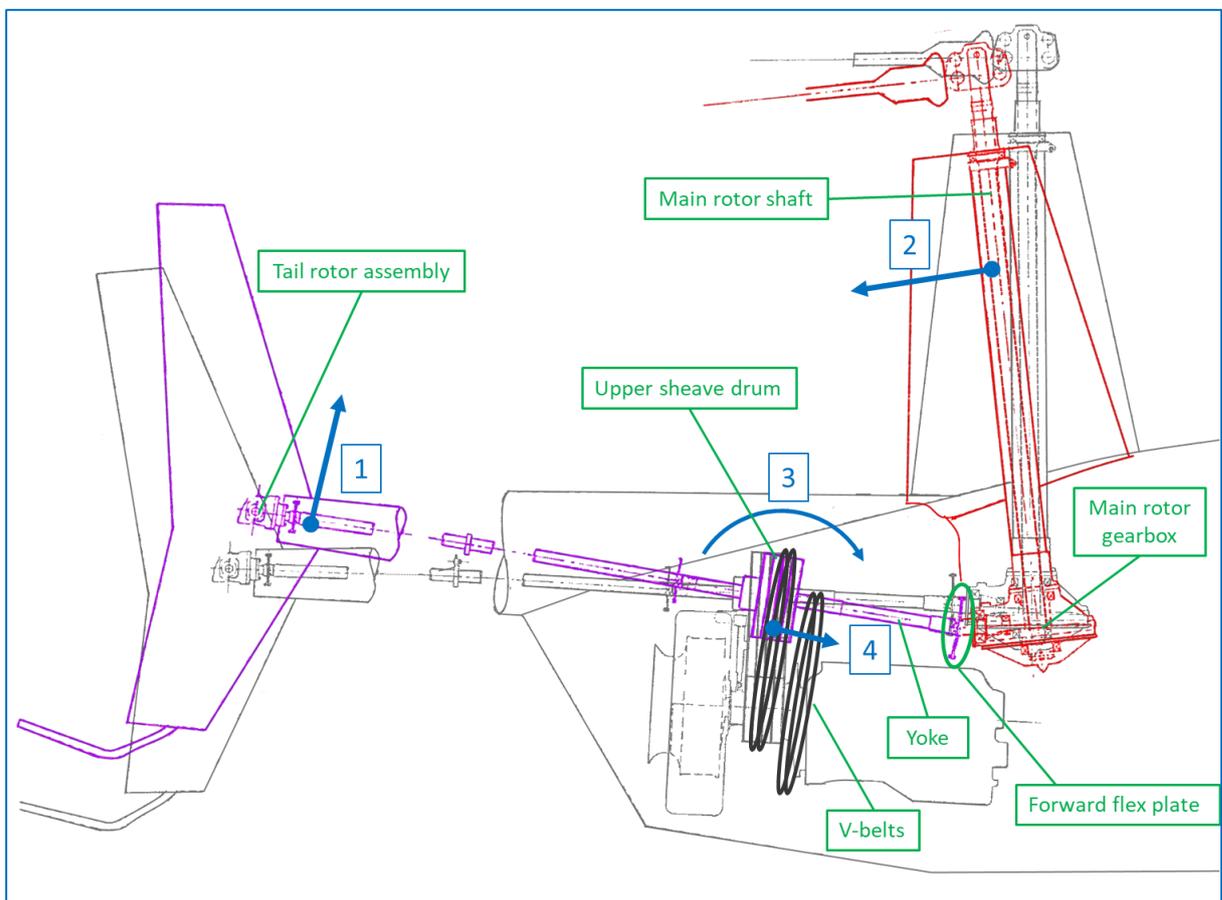
Figure 18 The V-belt drive system failure sequence

When the main rotor hit the ground, the main rotor shaft bent backwards **(2)** and deformed and broke the tubular frame structure near the main rotor gearbox supports.

Both events rotated and moved the shaft and the upper sheave set from its original position **(3)** and resulted in the V-belts moving forward and leaving the upper sheaves to the front of the helicopter **(4)**.
