# Safety Investigation Report

Ref. AAIU-2019-10-31-01  
Issue date: 04 September 2020  
Status: Final

During a touch and go, the landing gear was mistakenly retracted causing a collapse. No one got injured.

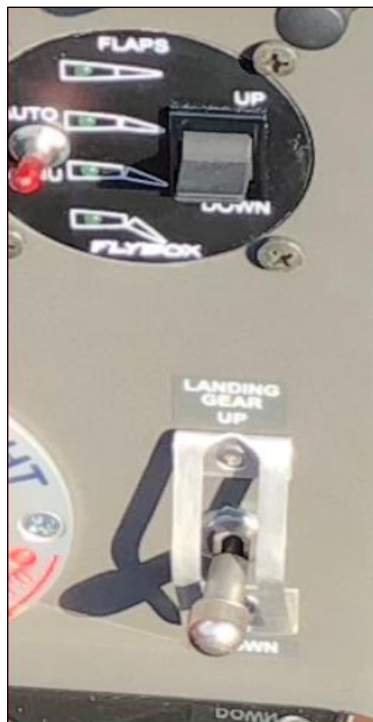
“On the 31st of October 2019, I flew with my passenger from Kortrijk (EBKT) to the airfield of Saint Ghislain (EBSG) as a leisure flight with the intention to practice some landings at EBSG. First we made a full stop to complete the aerodrome administration and pay the landing fees. Upon completion, we went back to the aircraft and prepped for start-up. Once ready, we started rolling toward the holding point of the active runway 09. With all checks performed; ready for departure; we took off on own discretion. We completed two eventless circuits/landings. I had the intention to leave for EBKT after the third and final touch and go. After landing for the third time, during the reconfiguration from landing to take-off, I mistook the landing gear switch instead of the flaps switch. I quickly repositioned the landing gear lever but the harm was already done. With little weight on the nose wheel, it collapsed with as result that the nose went down, the propeller hit the ground and the aircraft’s nose cowling started scratching the runway surface until we stopped moving. We quickly shut down all electrical systems and closed the fuel valve. We then got out of the aircraft, both of us unharmed. We were able to lift the nose up again and position the nose wheel in the extended state to push the aircraft into a hangar offered by the airport commander.

**Figure 1: showing the position of the 2 switches (flaps switch above, landing gear switch below) on the center console**

Due to previous “unwanted” landing gear retractions, the adjusted value has been increased from 80 km/h to 100 km/h - New production (DYN-130-69-ZP Rev. a, dated 24.10.2018).
