Safety Investigation Report

Ref. AAIU-2012-05

Aircraft: PIPER PA-28-181 SN: 28-7690296. The aircraft was registered in Belgium and held a Certificate of Airworthiness and a valid Airworthiness Review Certificate (ARC)

Accident location: On EBGB, Grimbergen Airfield

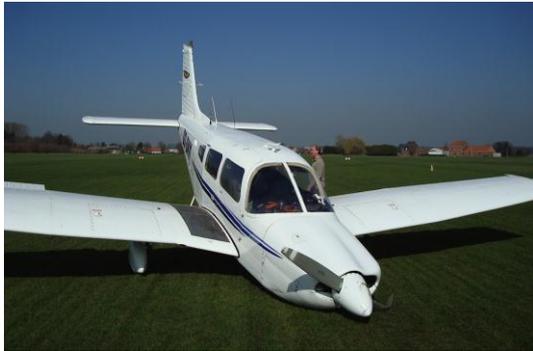
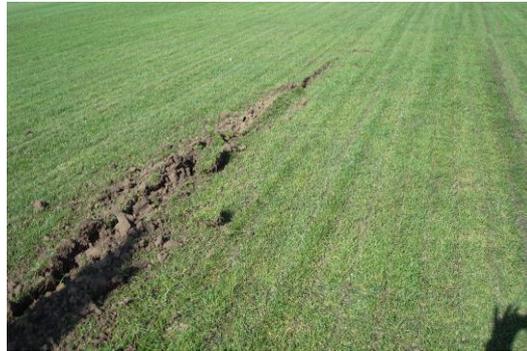
After the initial touch down, the airplane bounced twice. Upon the second impact, the nose landing gear broke and the propeller ploughed into the ground.

The nose gear leg broke upon impact causing the propeller to plough into the ground. The engine mount which is also the nose landing gear support was bent as well as the propeller. The engine cowling was damaged and the engine exhaust system was crushed. At first sight, there was no structural damage to the airframe structure. There was no visible damage to the engine, however a shock load inspection had to be performed as per the engine manufacturer instructions after a sudden stoppage of the engine.

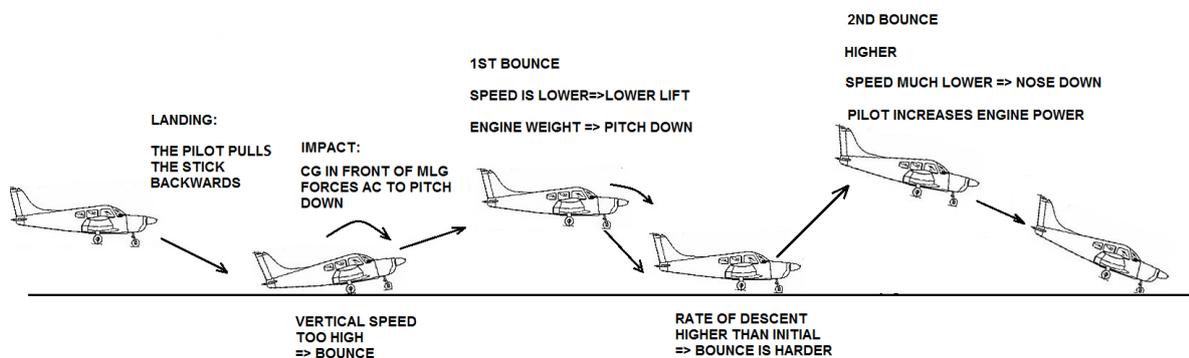
The touch-down was probably performed with an excessive vertical speed. This could have been caused by an inadequate flare (either a late flare, not timely counteracting the inertia or an early flare causing the airplane to stall before touching down). The ground impact was taken either by the main landing gear or by the main and the nose landing gear at the same time. In both cases the airplane would tend to rebound with a nose pitch down attitude since the centre of gravity of the airplane is located in front of the main landing gear. The speed and the lift decreased during the 1st bounce causing subsequently a higher rate of descent than the initial touch down. This had for result to increase the effect of the 2nd bounce. The airplane bounced higher, loosed additional speed and the tendency to a pitch down attitude increased. The pilot did not report specific action on the elevator to control the phenomenon. However, he reported he selected full engine power during the second rebound in order to stabilize the airplane (generally, the aircraft will pitch up with full application of power), but the engine did not accelerate as expected.
