Safety Investigation Report

Ref. AAIU-2014-8

Abstract

Upon reaching the destination airfield after a navigation flight, the engine of a Cessna 152 airplane coughed, and stopped working. The airplane was damaged as a result of the emergency landing.

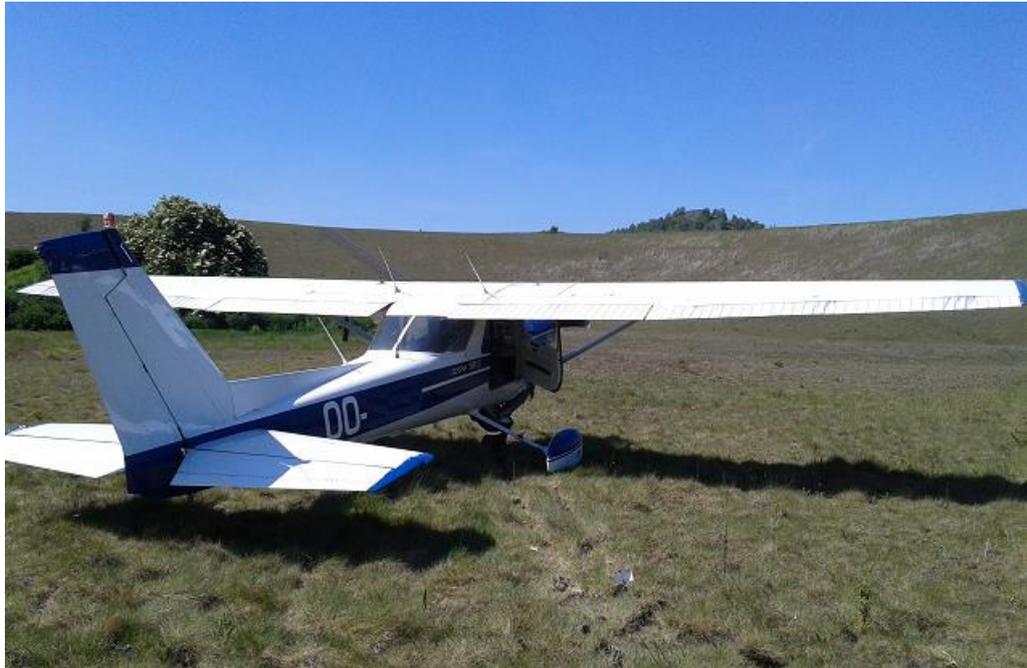
Fig.1. the airplane

The landing was normal, but at the end of the landing roll, the nose wheel fell into a ditch, and broke off.

The emergency landing is a mere consequence of the engine failure, and the selected terrain for the landing looked flat from above, but featured obstacles, ditches, that caused the damages.

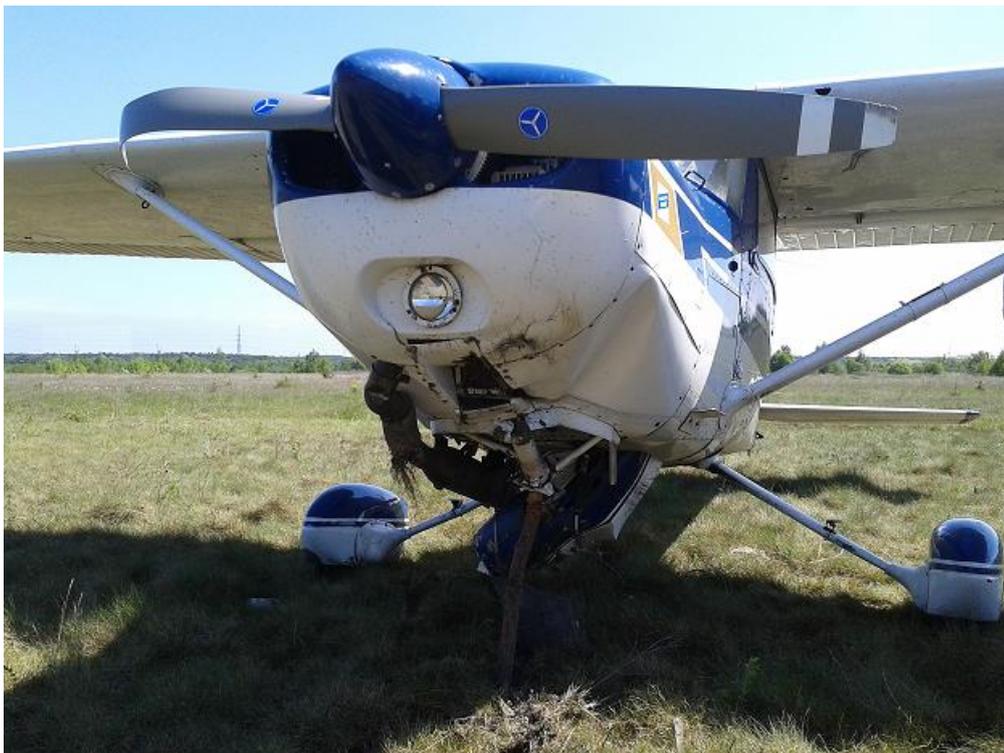
Fig.2 airplane NLG damage

The Nose landing gear was damaged, and the fuselage structure bent.

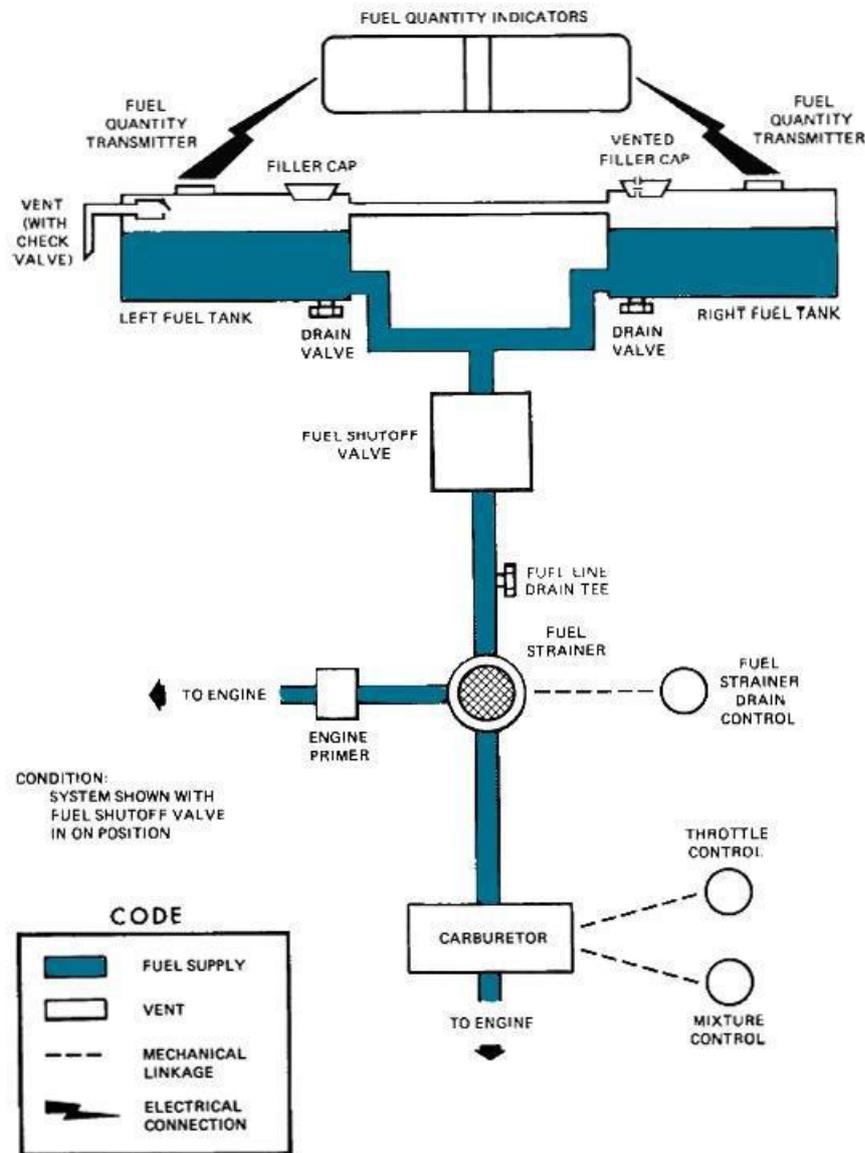
Figure 5: Fuel system

As there is no fuel pump, venting is essential to the system operation. This is accomplished by a crossover line connecting the right fuel tank with the left fuel tank. The left tank is vented via a vent tube protruding into the airstream. This tube is fitted with a check valve to prevent fuel spillage. The tank filler cap of the right tank is also vented.

As stated in the POH in section 2 on page 2-7, the tanks should be re-topped after each refuelling to assure maximum capacity due to the cross-feeding between the fuel tanks.
