**FINAL REPORT ON THE ACCIDENT
TO THE BEEHCRAFT 77
REGISTERED OO-PBL IN CHARLEROI
ON JANUARY 10TH 2009**

Ref. AAIU-2009-01
Issue date: 22-11-2010
Status: FINAL

Beechcraft "Skipper" BE77.

Charleroi Brussels South Airport EBCI

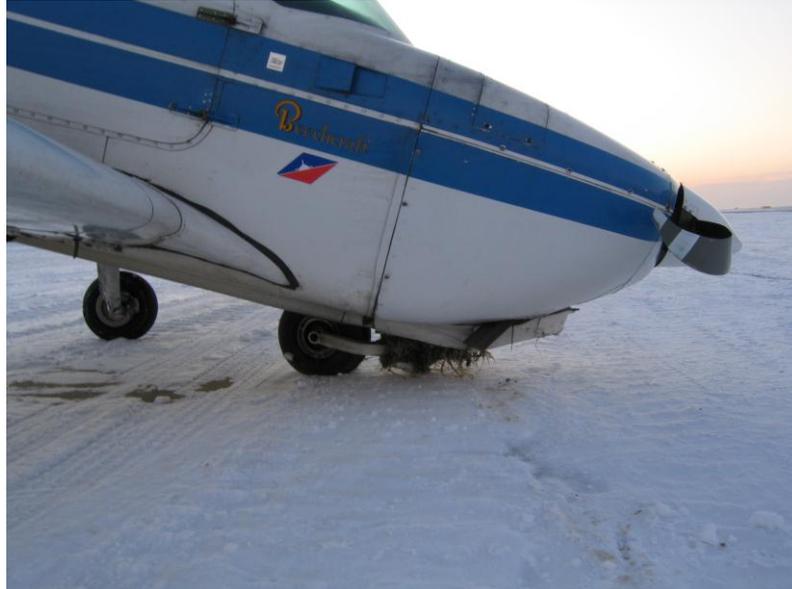
The landing gear nose wheel leg was bent backwards and the torque link was bent.

Figure 1: Bent nose wheel leg.

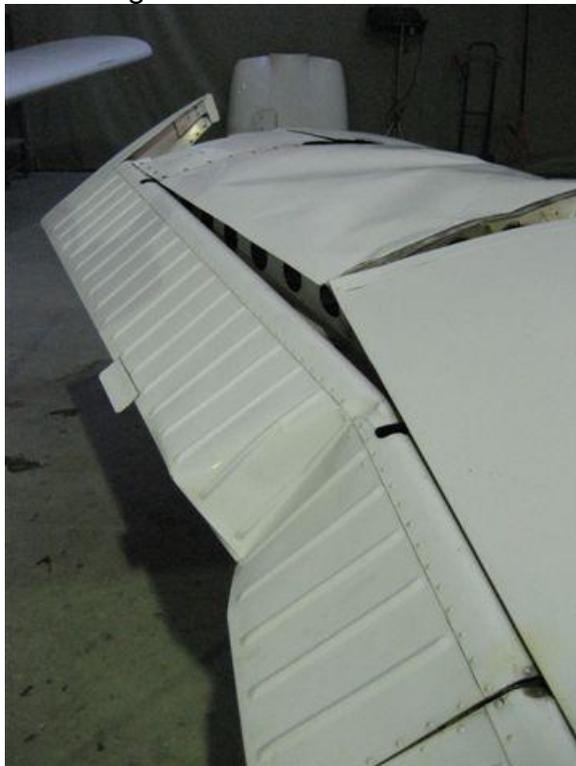
The left wing (spar, flaps and aileron) was damaged due to impact with the signalisation sign.

Figure 2: Damaged flaps and ailerons on left wing.

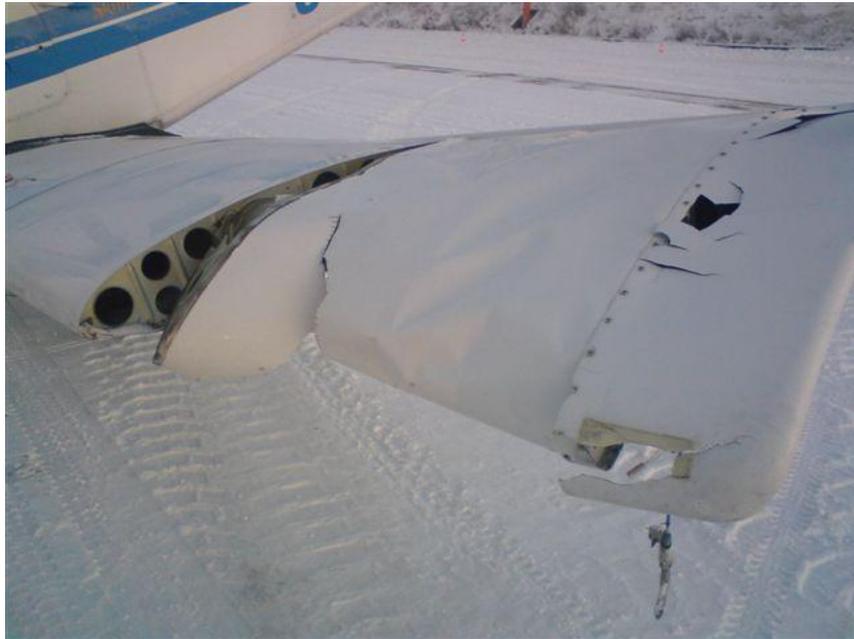
Figure 3: Damaged left wing spar.

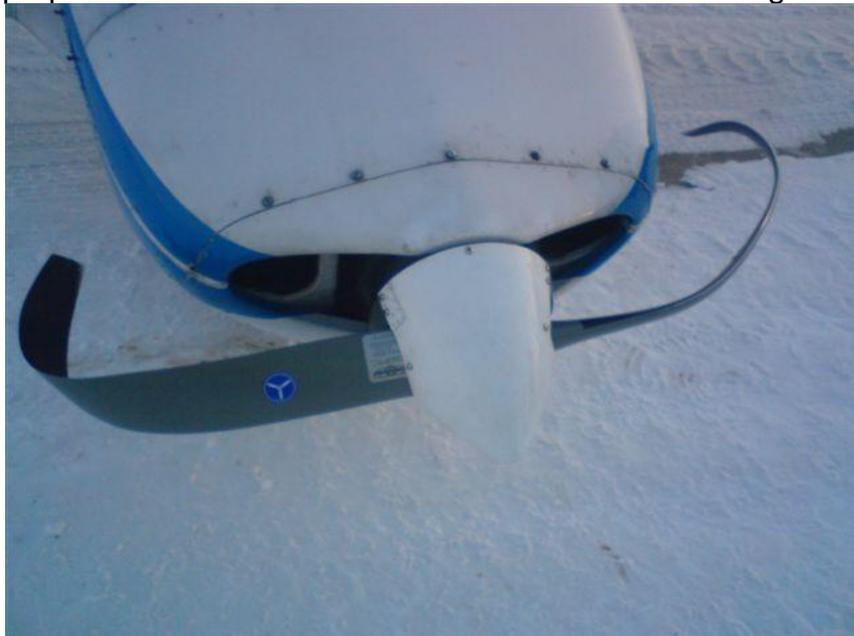
The propeller was bent backwards due to contact with the ground.

Figure 4: Bent propeller due to impact with ground.

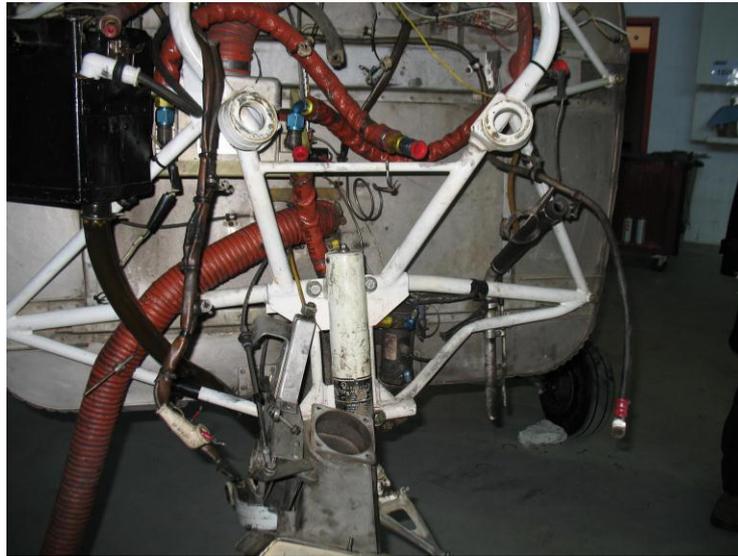
Figure 5: Dented engine support assembly.

The engine support assembly was bent in several places as shown above.

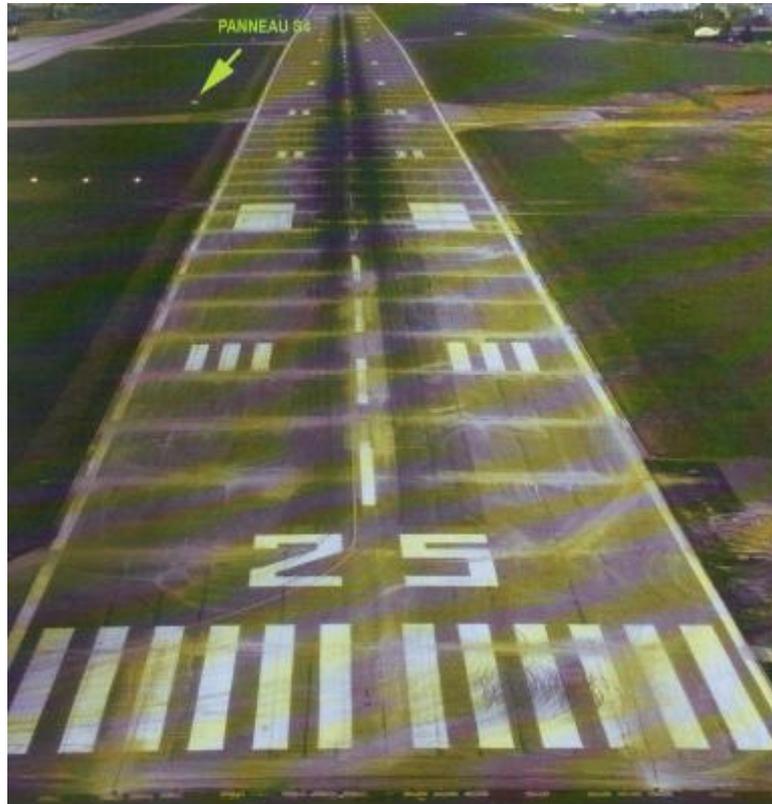
Figure 7: View runway 25 and S4 sign.

The signalisation board (S4), located left of the runway at 16.50m, was damaged.

The accident happened on the runway 25 at approximately the height of the S4 signalisation board, shown in the pictures below.

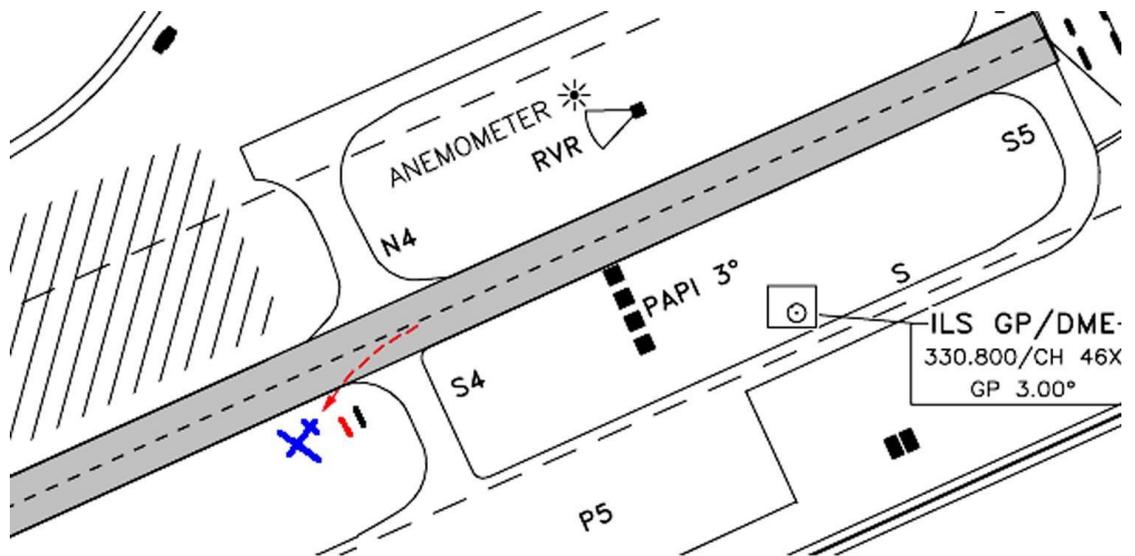
Figure 8: Estimated trajectory and position of signalisation board S4.

The final position of the aircraft was about 10m further than the initial position of the S4 sign. The sign's initial position was 16.5m from the border of the runway. After impact with the plane's left wing the sign ended up about 4m of it's initial position.

Red arrow: estimated trajectory of the plane
 Black line: signalisation board S4 - initial position
 Red line: signalisation board S4 - final position after impact (approx. 4m from initial position)
