Safety Investigation Report

Ref. AAIU-2011-21

Abstract

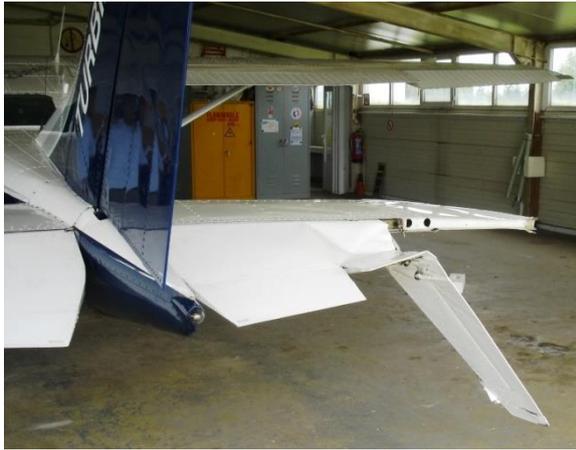
Damage: Significant damage to the right hand stabilizer and elevator.

Figure 1: View from rear.

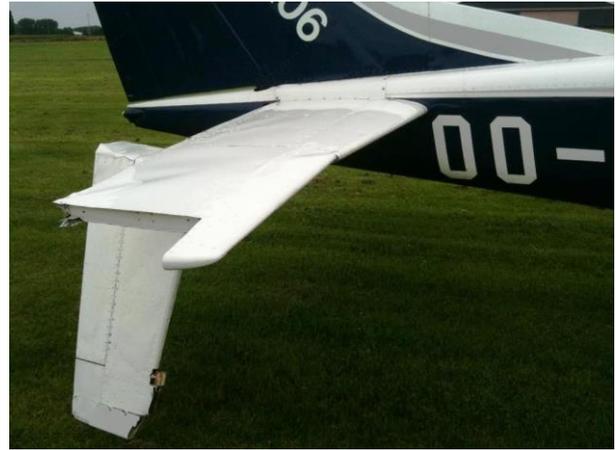
Figure 2: Side view of the R/H stabilizer.

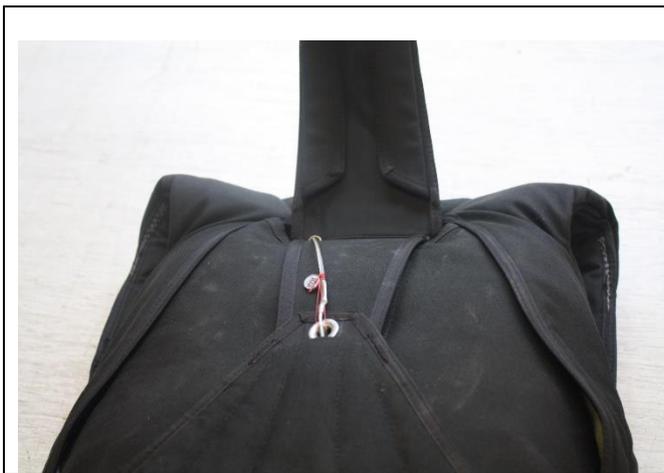
The parachutist explained that the reserve parachute suddenly deployed when he was moving out of the airplane. The wind pulled him violently out of the airplane causing the parachute to hit the tail of the airplane. By chance the parachutist himself didn't hit any part of the airplane and the parachute did not stay attached to the airplane structure. Moreover, the reserve parachute remained sufficiently operational up to the ground, despite the damage to one section of the canopy and one broken steering line. Careful examination of all the parachute parts did not find any pre-existing anomaly. The cause of this premature deployment of the reserve parachute could not be determined with certainty. However examination of the parachutes container shows an inadvertent activation of the reserve parachute control cable could have occurred due to a raised protection Velcro strap at the upper part of the parachutes container. When the protection is raised, the control cable is dangerously exposed to any kind of friction with the airframe structure. The possibility exists that the Velcro and the cable were caught by a protruding object located on the ceiling or at the door frame. The Australian Parachute Federation published a warning poster, enclosed at the end of this report, showing different scenarios of premature opening.

Figure 3: Rear upper view of the container with the Velcro strap open.

The accident was caused by the premature deployment of a parachutists reserve parachute. The reserve parachute control cable was probably pulled out by an inadvertent contact with a protruding object located on the ceiling of the cabin or on the door frame.

During the first instructors meeting organized after the accident the instructors of both the concerned parachute club and the VVP federation (Vlaams Verbond van Paraclubs) discussed about this accident. It was decided to use some pictures of the damaged airplane as didactical material for the training of future instructors and a mutual check of the parachutist equipment before getting on the plane was again encouraged. VVP federation also stated they will use the poster³ originating from the Australian Parachute Federation to promote this safety action.

The FWCP federation (Fédération Wallonne des Clubs de Parachutisme) stated that possible premature deployment of a parachutists reserve parachute was already considered as a major event the time before the accident and that the instructors were already very sensitized to this potential danger. FWCP stated also that a “pin check” was a standard safety practice in the parachute clubs. This “pin check” is performed inside the airplane, immediately before the beginning of the jumps.
