## Safety Investigation Report

ACCIDENT TO  
SOCATA MS880B  
AT EBUL  
ON 14 APRIL 2012

Ref. AAIU-2012-07  
Issue date: 05 July 2013  
Status: Final

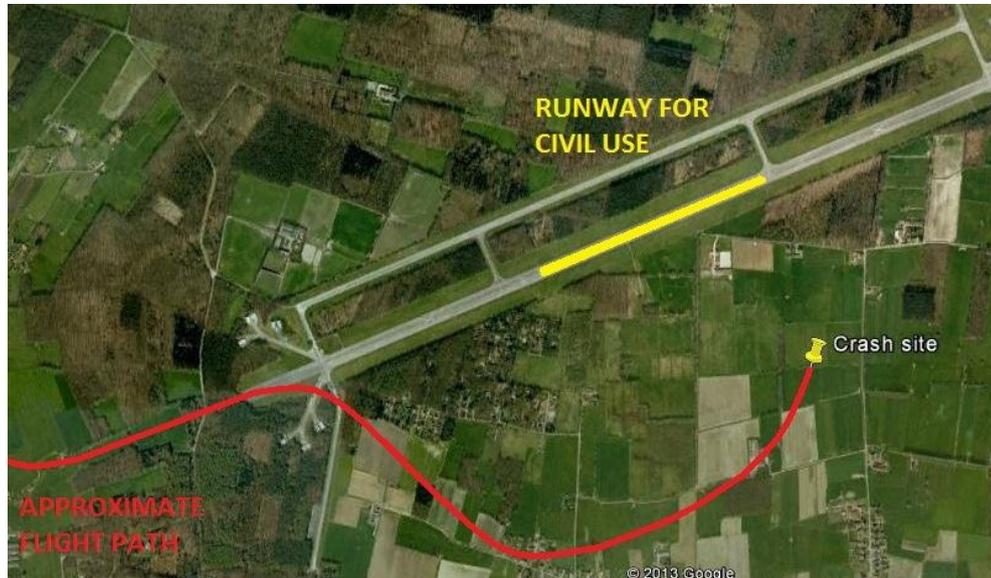
### Flight path and crash site

The flight path was reconstructed based on the declaration of the pilot. Considering he had missed the approach, the pilot decided to stop the exercise when he was flying at around 1000 ft above the threshold of the Air Defence runway.

The airplane made a right hand turn followed by a left turn. The exact position of the airplane when the pilot realized the engine was no more operating is unknown.

The crash site is located at around 650 meters from the axis of the runway.

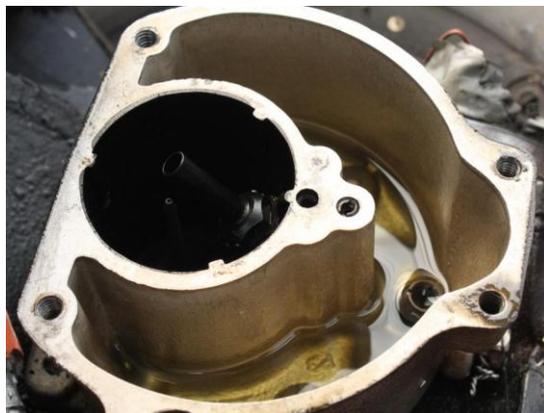
- Finally, the carburettor was removed from the engine taking special care to avoid spillage of the fuel remaining in the float chamber. Thereafter the carburettor bowl and the throttle body were carefully disassembled showing that the fuel level and quantity remaining in the carburettor bowl was insufficient to feed the main nozzle.

The carburettor was carefully inspected in order to find the reason of the low quantity of fuel found in the bowl. The "Nose down" position of the airframe after the accident could not explain such a significant loss of fuel. The float and the float valve and seat did not show any anomaly. The fuel inlet strainer was clean.

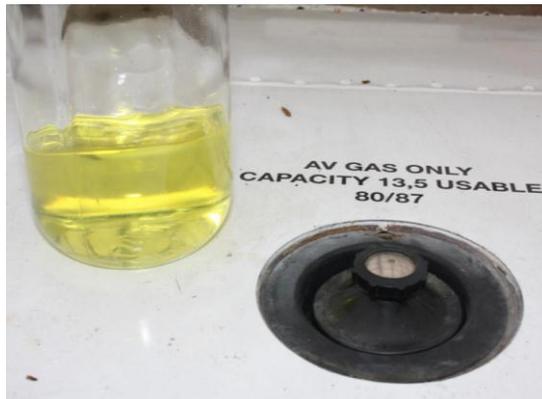
The fuel found inside the tanks and in the carburettor was a “yellow/green” coloured automotive fuel.

No STC authorizing the use of automotive fuel was found to be applied to the airplane. The mechanical fuel pump was tested and found serviceable.

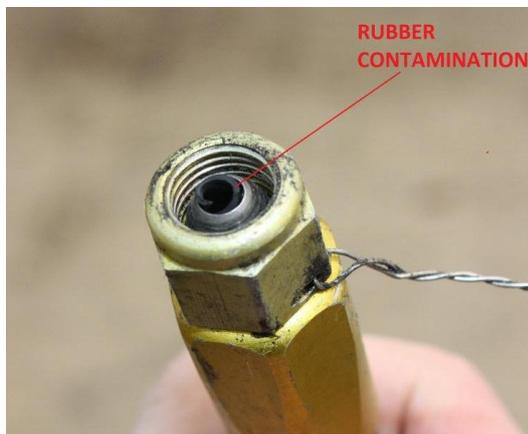
The contaminated flexible line was inspected again and it was determined unlikely that the rubber shaving contamination could have moved and fully obstructed the fuel flow.

Additionally, fuel flow had been proven to be sufficient to feed the engine when full engine power (and consumption) was applied.

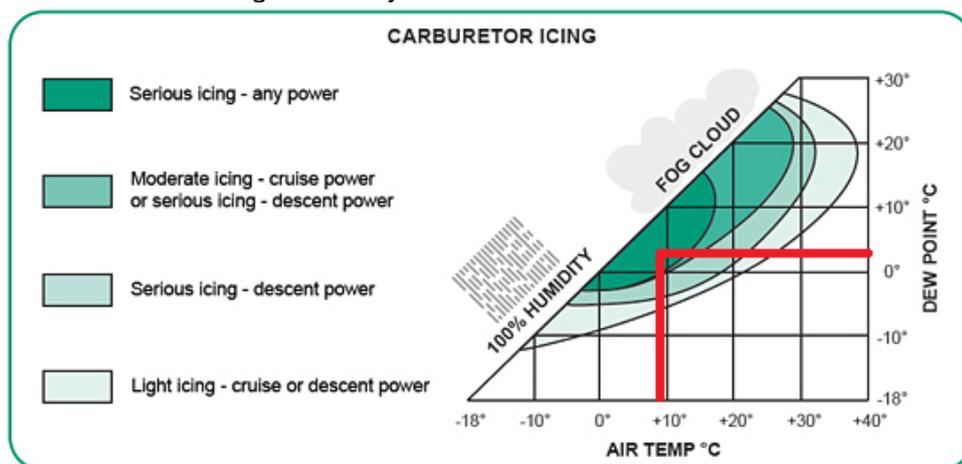
- As seen on the hereunder graph, the meteorological condition were such that carburettor icing was likely to occur.

Therefore, a carburettor icing was considered as a potential cause of the engine failure during the first step of the investigation. However, this hypothesis could not be demonstrated as the signs of carburettor icing rapidly disappear.
