Safety Investigation Report

Ref. AAIU-2012-12

Aircraft: Cessna 152.

Accident location: On Saint-Hubert Airfield – EBSH

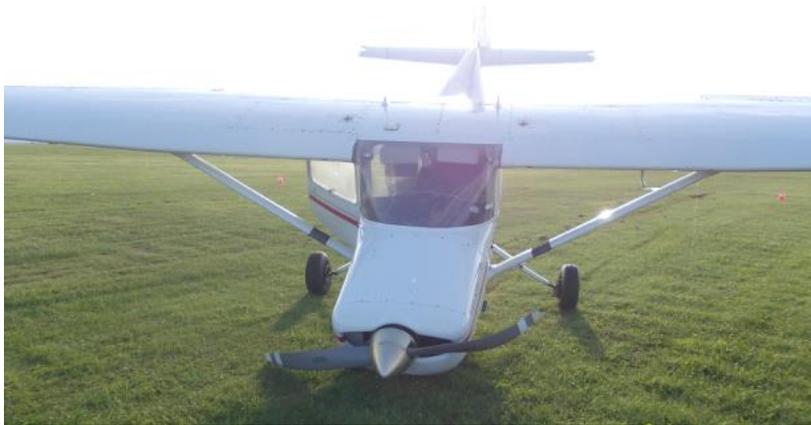
The airplane touched down 200m after the threshold, rolled for 100m, then bounced once on the runway. The airplane lifted off from the ground. The pilot in command then pushed the stick forward, and the airplane pitched down and hit the ground with the nose wheel first causing a second rebound, higher than the first one, at 2 or 3 meters from the ground.

The nose landing gear broke upon impact when contacting the ground after the second rebound. The pilots climbed out, uninjured.

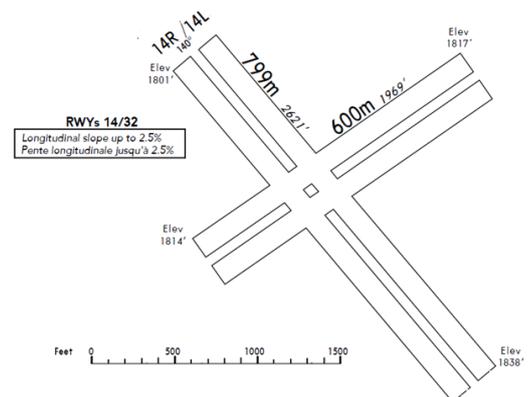
The runways surface is uneven as are many grass runways, and with a noticeable slope.

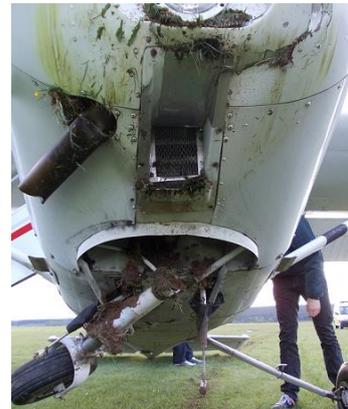
- Rupture of the nose landing gear leg.
- Rupture of the engine mount.
- Scratches and dents on the cowlings.
- Propeller blades bent.
- Deformation to the firewall.

The airplane was declared as being damaged “beyond economical repair”.

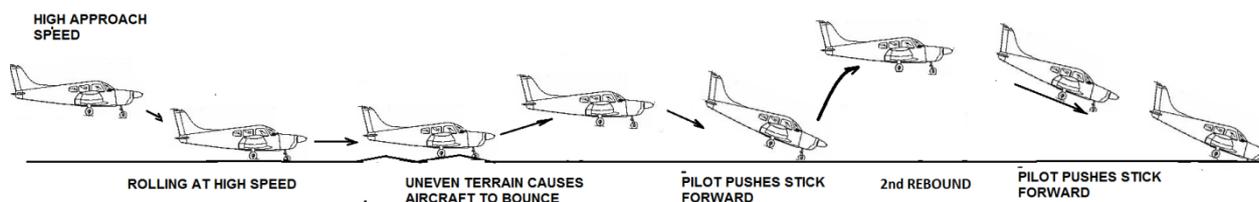
The irregularities of the terrain combined with the high rolling speed, may have caused the airplane to shoot back in the air. The pilot continued pushing, or pushed the nose down more when the airplane was bouncing, forcing the plane to pitch down and to contact the runway surface on the nose.

Most landing accidents related to rebounds occur after several rebounds. The first rebound with a runway contact on the nose causes the airplane to bounce again, and higher. This phenomenon when repeating is called porpoising³. It may end up in breaking the Nose Landing Gear, as in this case, or may cause a propeller strike.
