Safety Investigation Report

Ref. AAIU-2013-25

Aircraft type: Boeing 757-200

Accident location: EBBR - Brussels Airport, Belgium

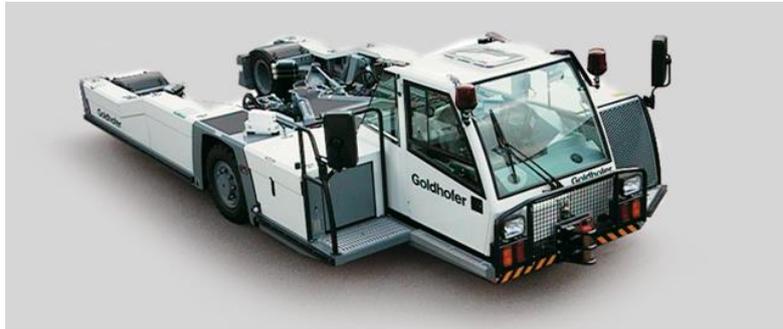
Figure 1: Goldhofer AST-3 L 140 tractor

The equipment used to perform the pushback was a towbarless (TBL) aircraft tractor Goldhofer AST-3 L 140 (S/N 1896), for medium speed towing and ramp operation with aircraft range from AVRO RJ70 up to B767/A300. It has a 2 men cabin with 2 steering wheels and is fitted with two amber flashing lights which were lit at the time of the collision.

The towing truck sustained severe damage and was taken out of service for repair by the operator.

Swissport makes/made a study to investigate the possibility to install flags on the tugs which would be fixed on an extendable horizontal arm.

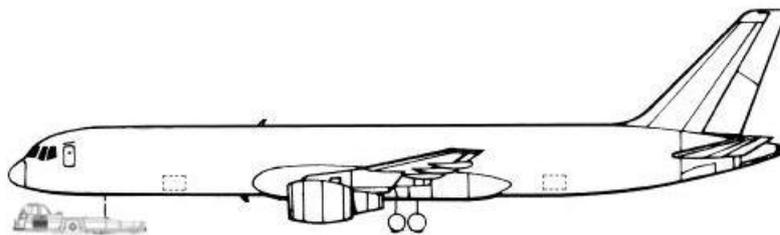
Figure 2: Sketch (not to scale) showing the position of the tug when nose is lifted

As shown in Figure 2, the cabin of the tractor disappears behind the nose of the aircraft when the nose is lifted. Even when the tractor moves forward in front of the aircraft, it has to cross the 23 degrees angle in order to become visible for the flight crew. The amber flashing lights on the tug were illuminated but were not effective as it was daylight and the lights were covered by the belly of the aircraft.

Both US Airways/American Airlines as Swissport made the safety suggestion to add a flag on the tug to make it visible to the flight deck. However as shown in figure 2, a flag on a vertical extended aerial isn't possible as it could scratch the fuselage of the 757. An horizontal extended flag introduces other safety risks with it.

AAIU(Be) recommends that Swissport investigates the possibility to change to cordless headsets for their ground operations. This in order to eliminate the need for the disconnection of the headset near the nose landing gear whilst the tug is still under the aircraft and out of the flight crew's sight.

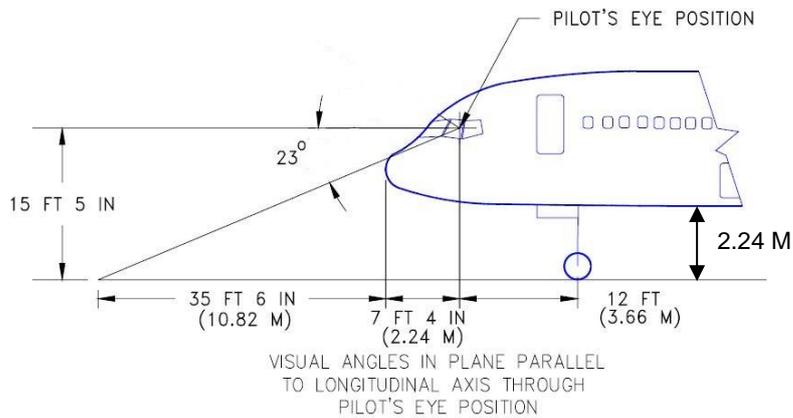
Figure 3: The visual angle from pilot's eye position

The tug with a height of 1,65 m would become visible when approximately 6,5 m in front of the aircraft nose.
