Air Accident Investigation Unit

**FINAL REPORT ON THE ACCIDENT
OCCURRED ON 12/08/2006
AT KEIHEUVEL
ON A FOKKER S-11 REGISTERED
PH-HTC**

Ref. AAIU-2006-01
Issue date: 18 October 2007
Status: Final

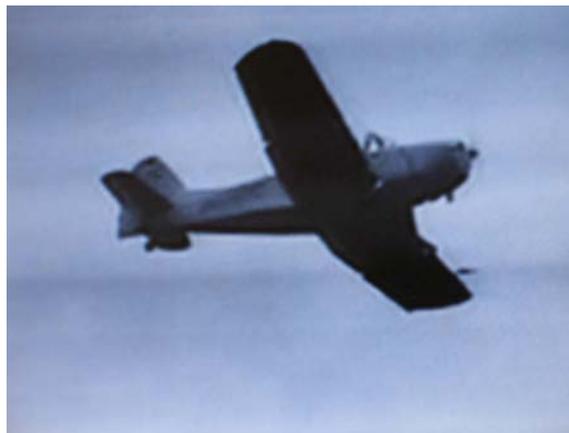
Aircraft presentation

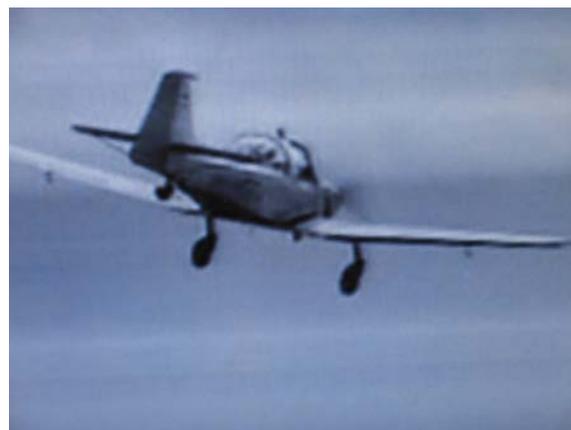
Pilot is waving

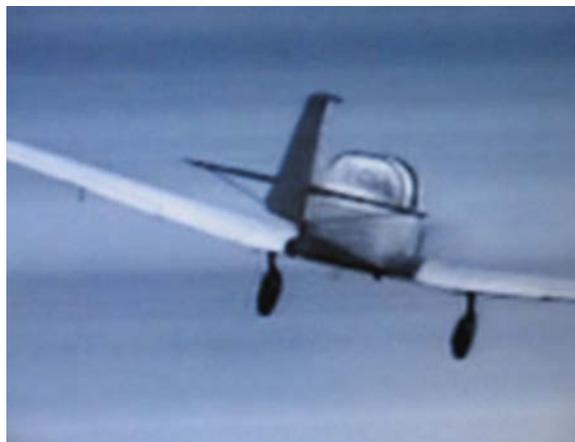
Aircraft slipping

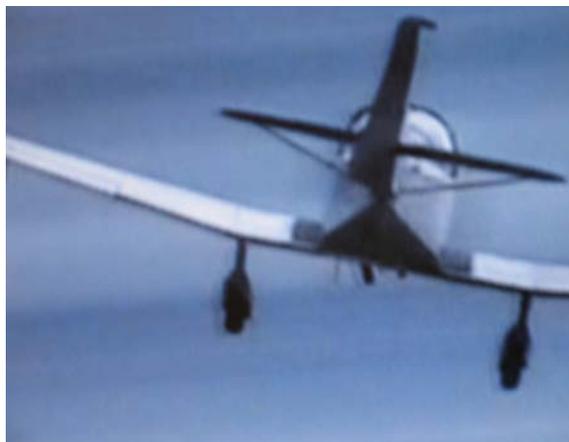
Right wing low

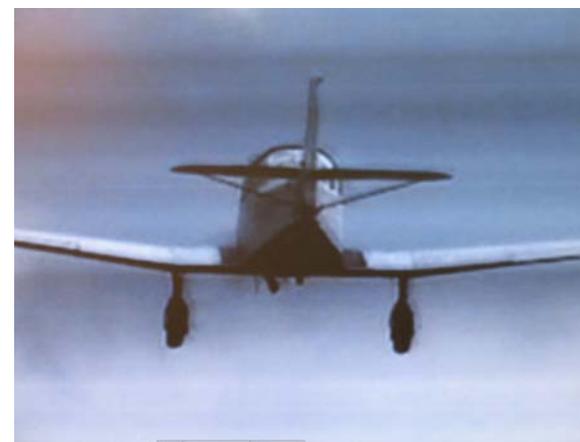
Correction with rudder

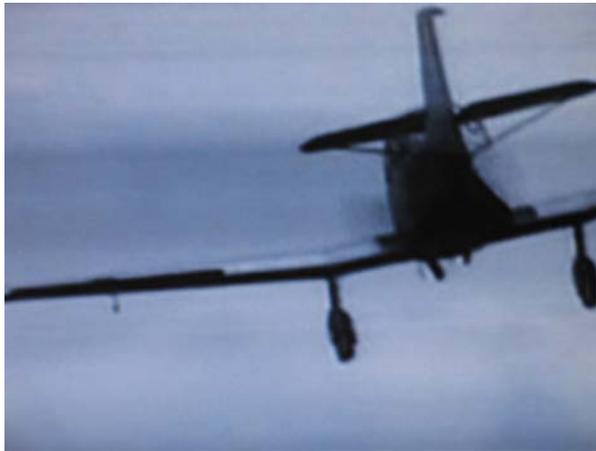
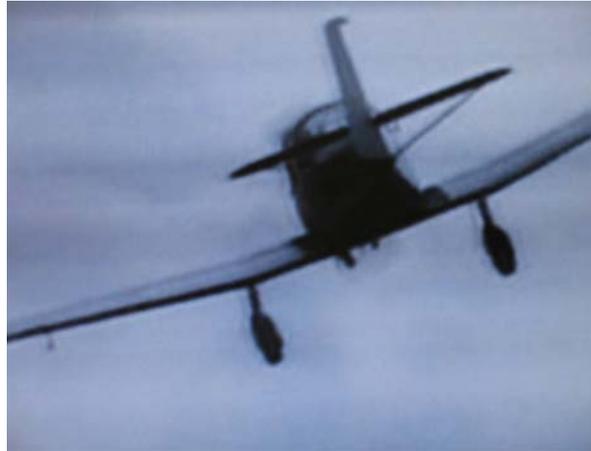
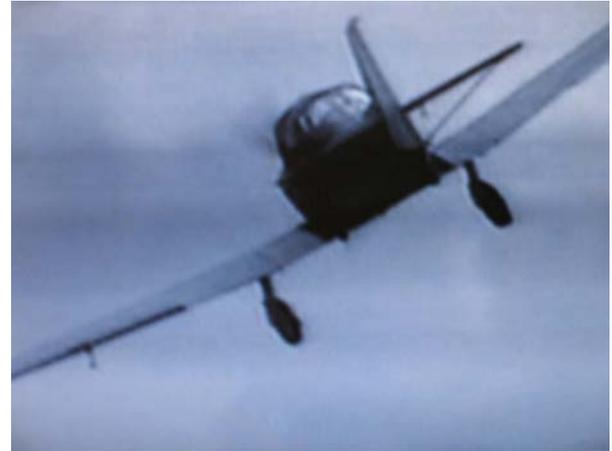
Banking turn

After the pilot experienced the engine trouble, he pilot leveled his aircraft, by giving a short input on the rudder, and engaged in a bank turn to the left. We assume that the intention of the pilot was to steer 180°, and land the aircraft on Runway 07. This decision caused the stall of the aircraft, with the incipient spin as a consequence.

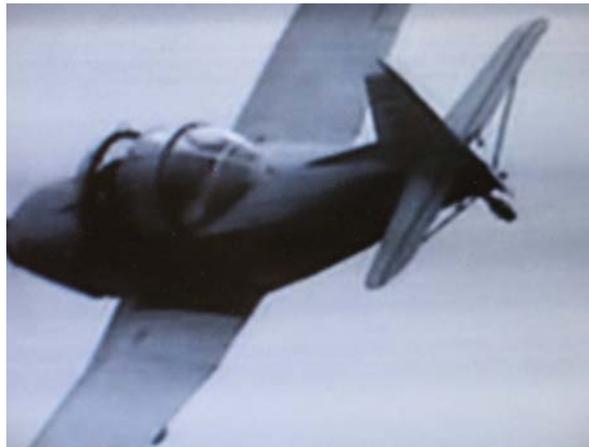
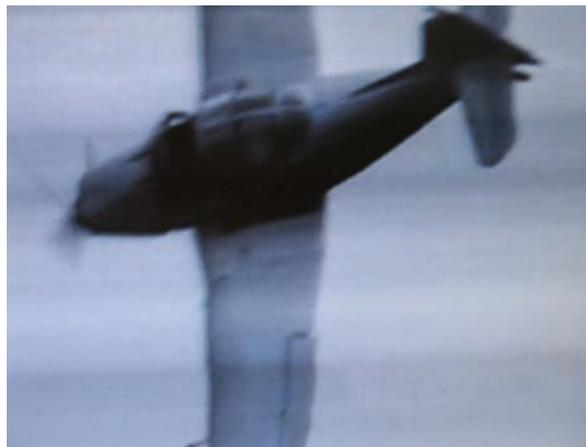
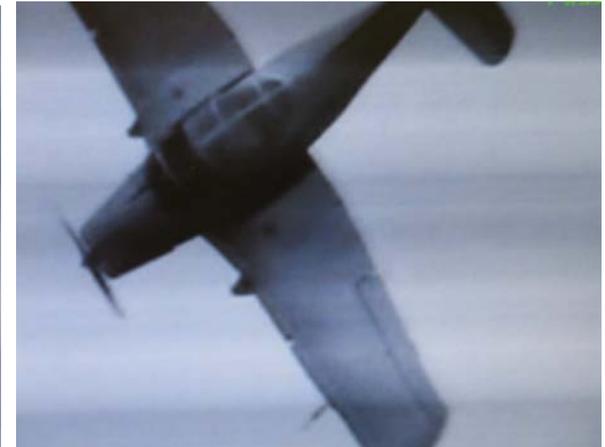
Incipient Spin

During a bank turn, performed at low speed and low altitude, the aircraft stalled, entered in an incipient spin, and crashed to the ground.

A sensibilization campaign by BCAA towards pilots is recommended, in order to identify the dangers of stall / spin at low altitude.

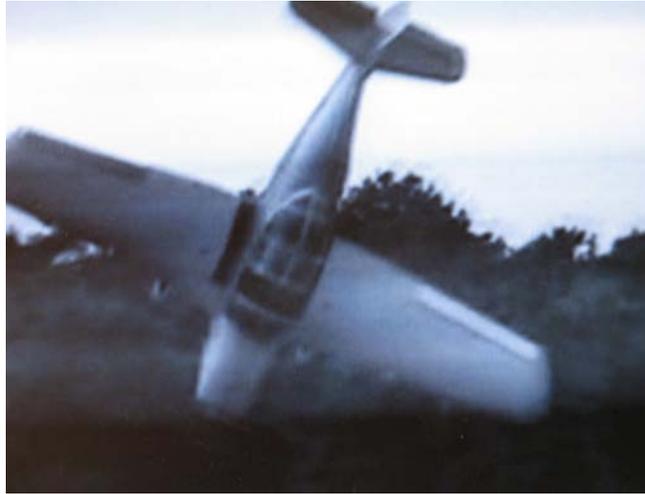
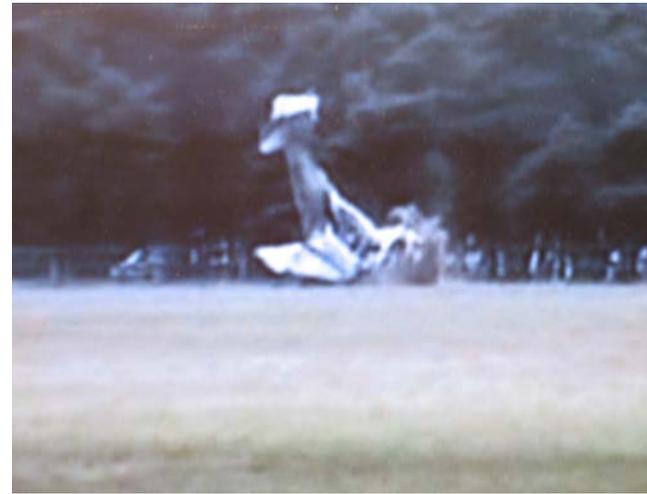
Crash

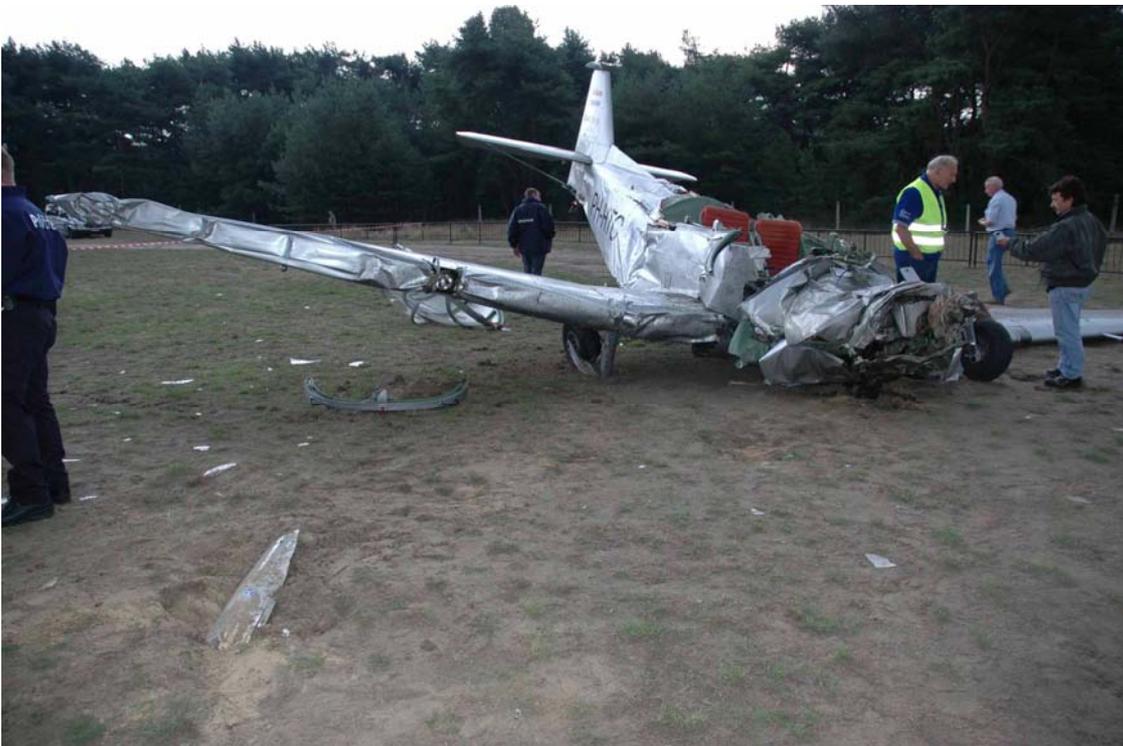
The aircraft was destroyed by impact forces.

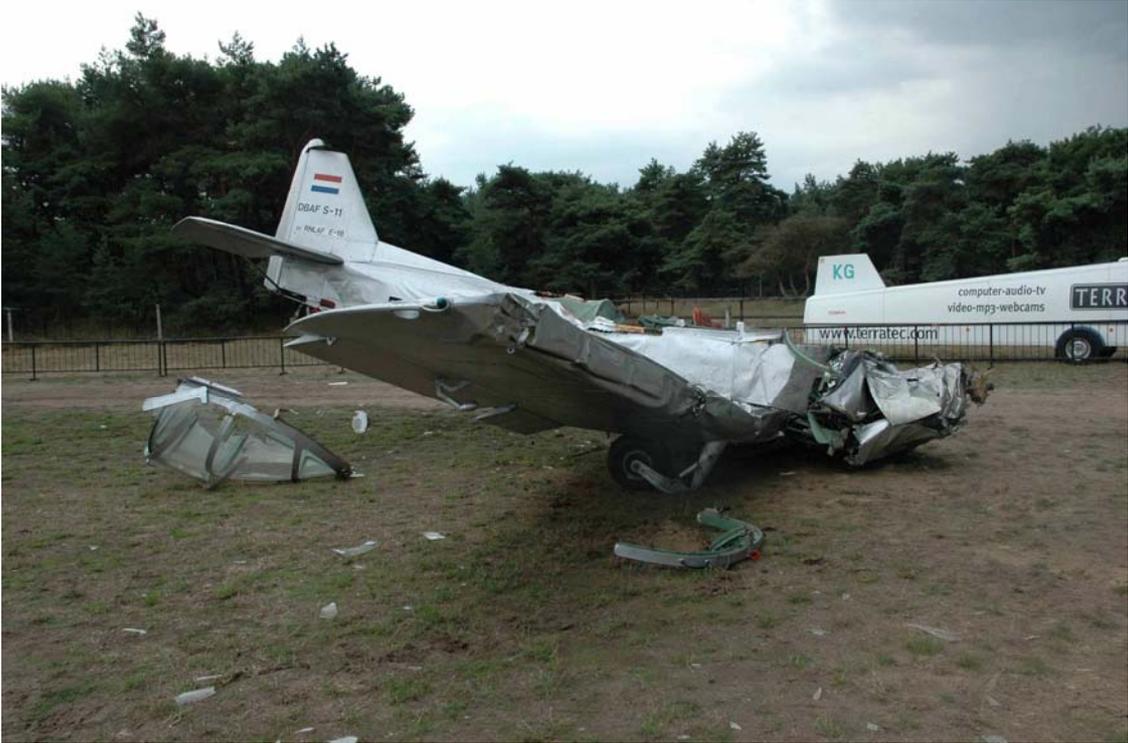
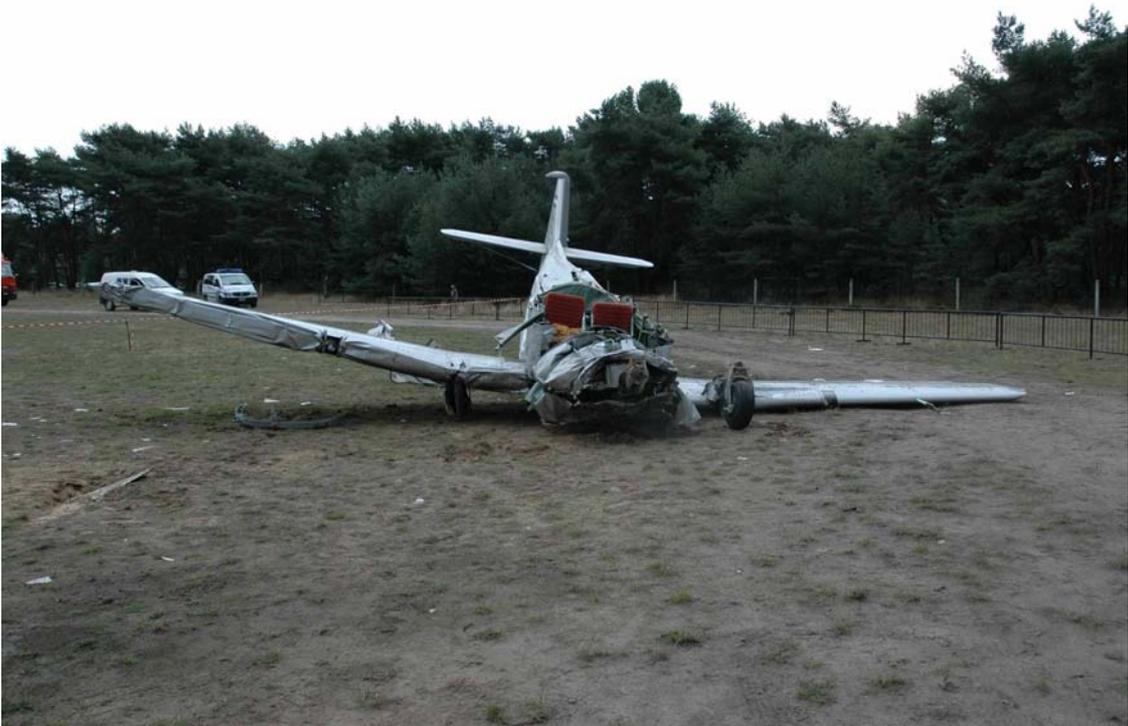
The wreckage lies at 215 m from the front end of Runway 07, and 50 m south of the runway axis. The nose of the aircraft is pointing NNE. The airplane crashed vertically on the engine, and then fell backwards.

The propeller broke on impact, and the two blades, severed at the hub, were found separated by a distance of ca 10 meters, indicating that the engine was not delivering high power upon impact.

The pilot was sitting on the left seat, but due to the force of the impact, was found between the 2 seats.

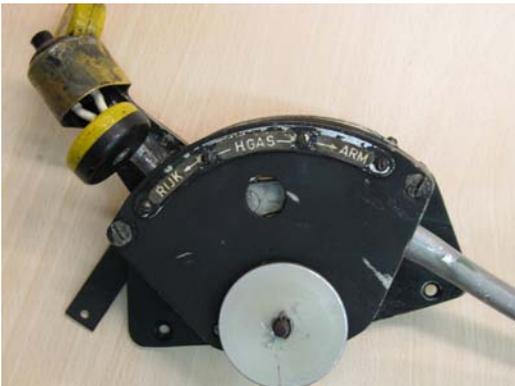
The movement of the mixture control lever is uncommon, as the “lean” position is forward. This is in contradiction with CS 23.779.

Idle, mixture rich

- Have their movement made conform to CS23-779, or
- Introduce a locking mechanism that would prevent the inadvertent movement of the controls, when adequate for the type of controls, or
- Have a warning placard placed in the cockpit.

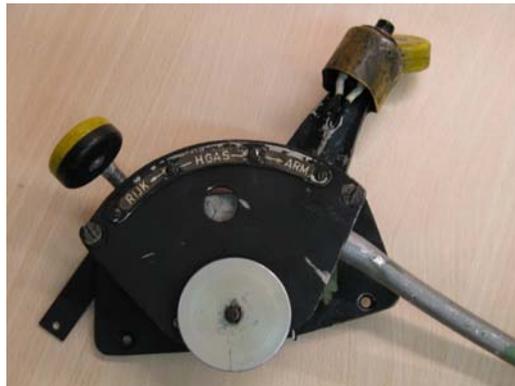
Full throttle, mixture rich

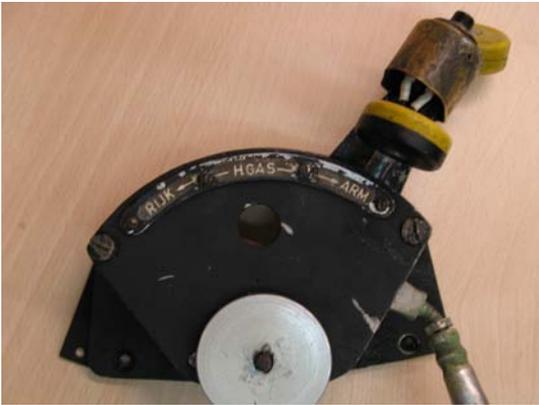
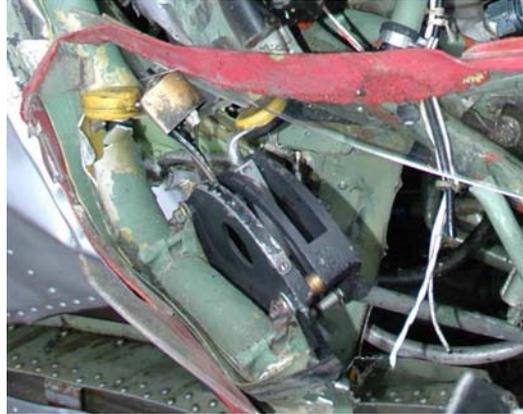
The throttle control lever and the mixture control lever were both found forward in the wreckage of PH-HTC.

Position of the control unit, as found in the wreckage.

The fact that the Control lever was found in a forward position doesn't give an absolute certainty that it reflects the actual position of the lever, as set by the pilot.

The connection between the control lever in the cockpit and the command lever on the engine is made through rigid rods. The control rods, attached to the control lever, showed evidences of buckling; thus compression, that would – normally- push the control lever to the 'rich' position.

However, the impact of the aircraft with the ground caused initially a crushing of the structure and this movement of the engine (towards the rear) may have resulted in a forward movement of the mixture control lever.

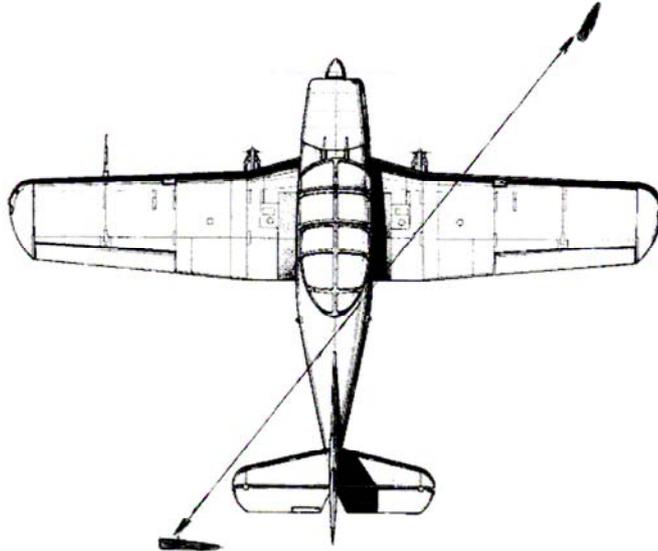
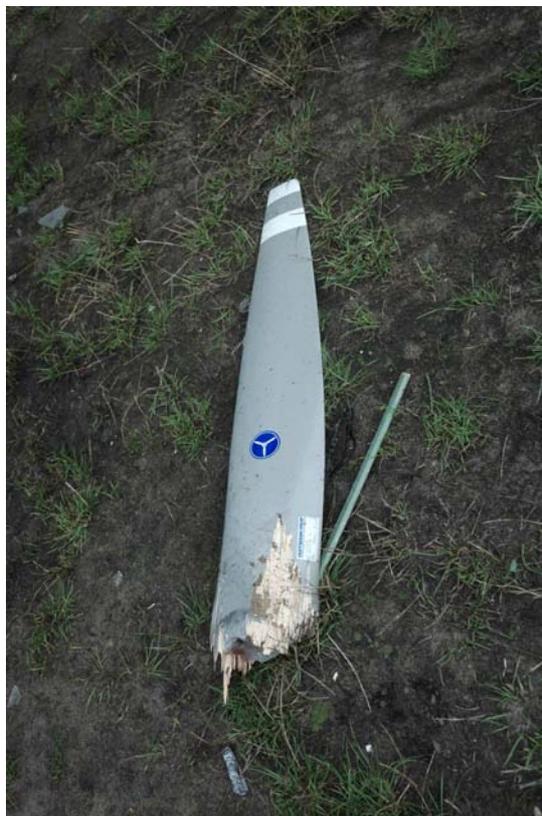
The propeller broke upon impact, and were severed at the hub. The two blades were found at 10 m distance, more or less symmetrically from the impact point.
