**Air Accident Investigation Unit**

# **FINAL REPORT ON THE ACCIDENT TO GRUMMAN AA-1-B (OO-PMS) IN CHARLEROI ON JULY 28,2007**

**Ref. AAIU-2007-11**

**Issue date: 24 January 2008**

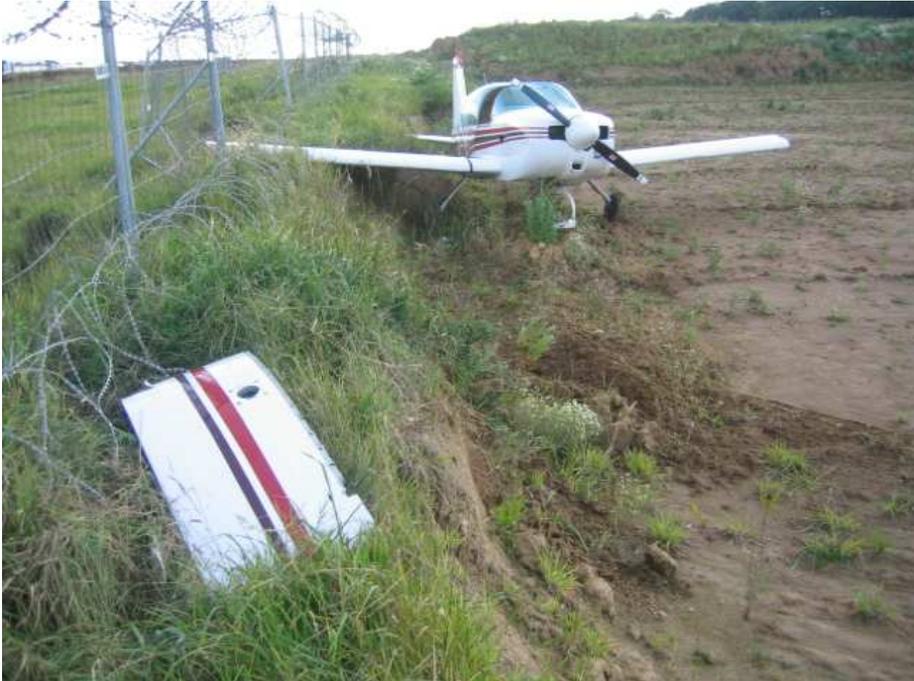
The left wing tip was severed from the wing. The left aileron was damaged. The cover of the right wing navigation lights was destroyed.

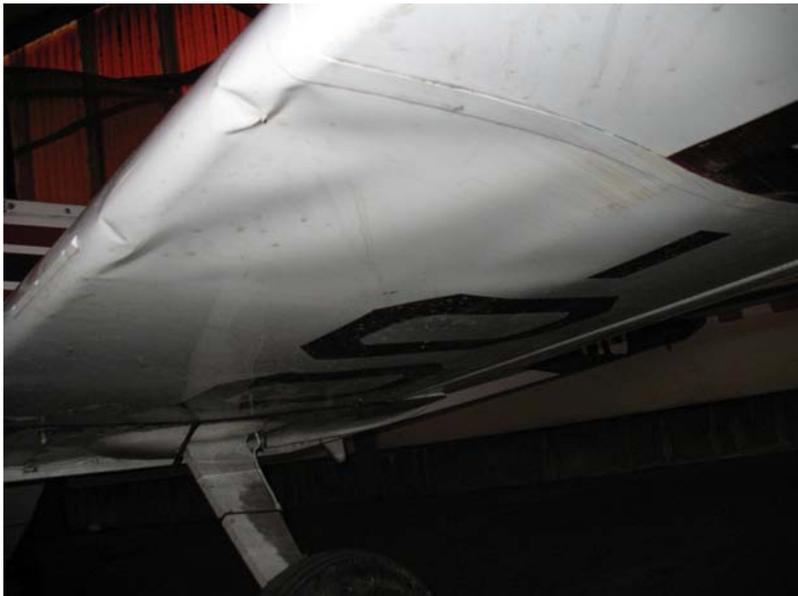
The underside of the wings was damaged. The upper surface showed local distortions.

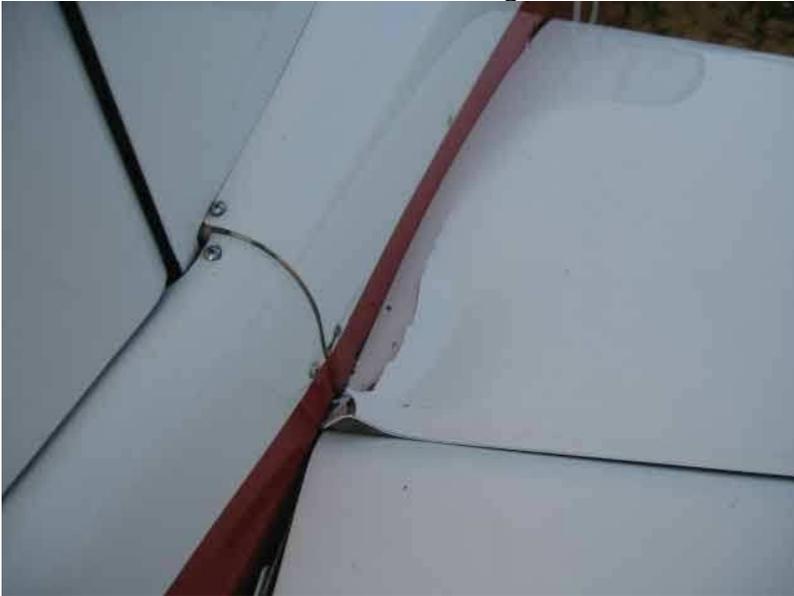
The RH Horizontal Stabilizer was damaged.

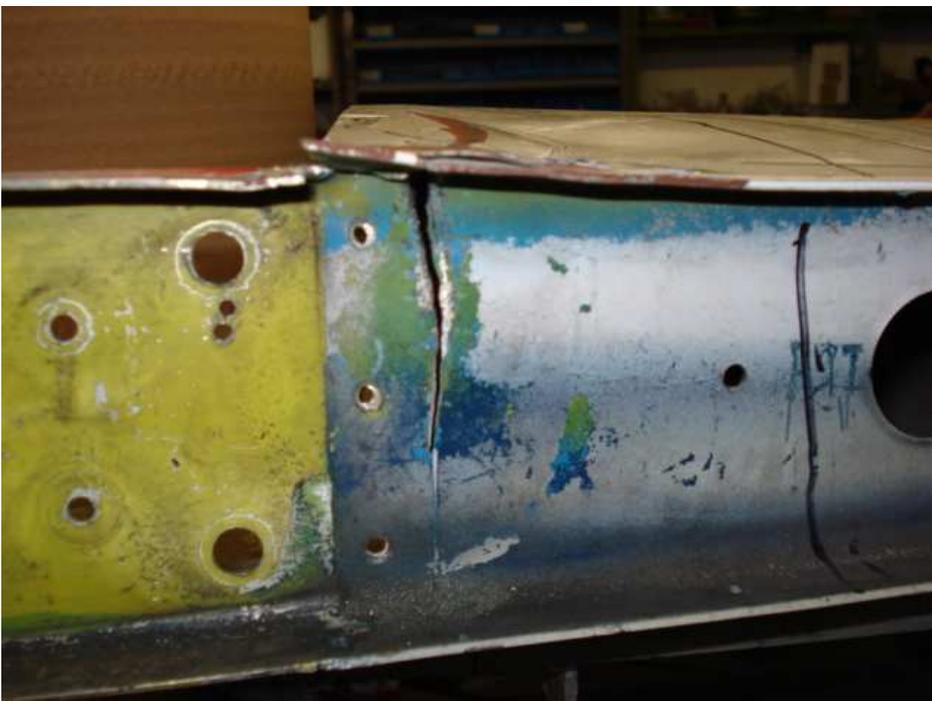
The Rear spar of the RH Horizontal stabilizer was found cracked.

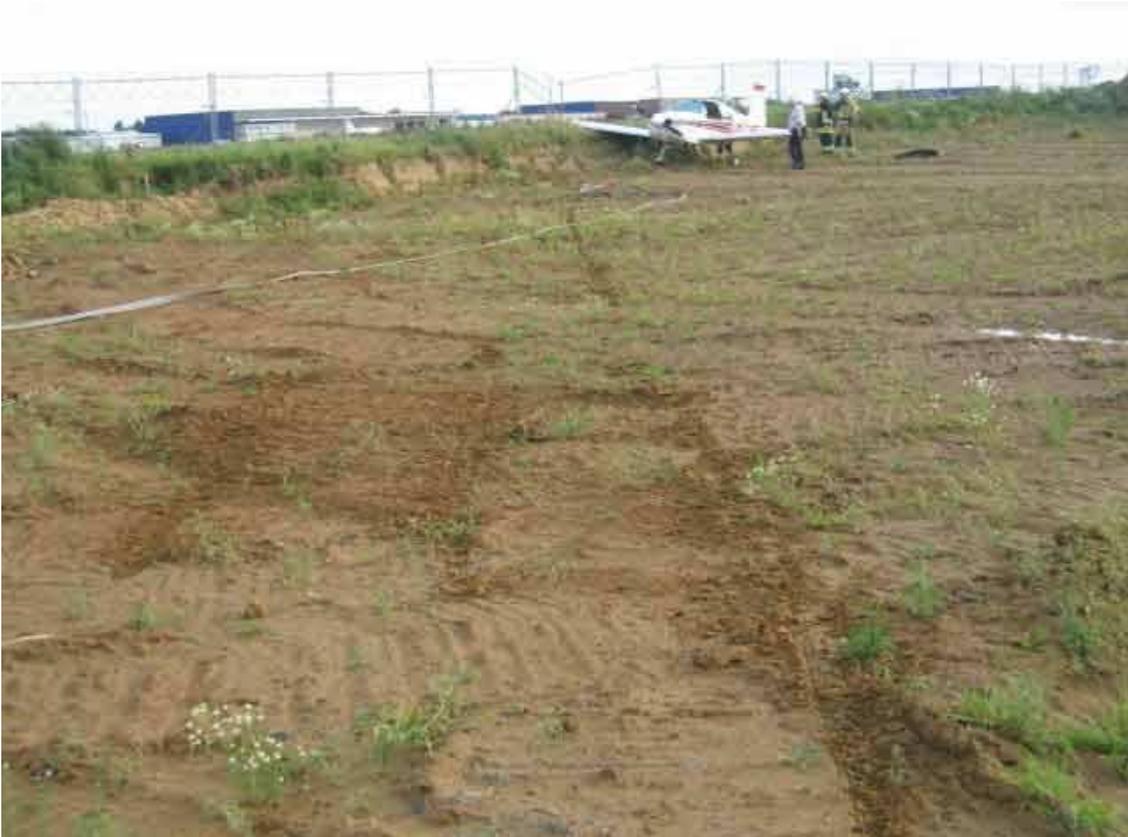
The aircraft touched the ground parallel to the runway, rolled for 60m, then veered towards the embankment slope bordering the airport perimeter.

When impacting the embankment, the aircraft rotated 180°, the left wing contacted the embankment and perimeter fence. The aircraft stopped at 92m from the Runway 25.

The terrain was reasonably hard and flat.

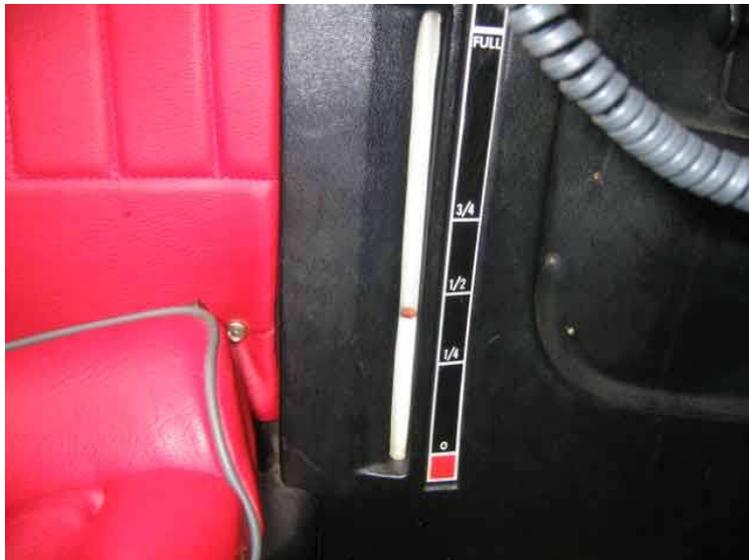
Fuel quantity is indicated by two vertical sight gauges on the left and right cabin walls.

The gauges are accurate on the ground, but in flight their accuracy is reportedly unreliable.

To improve readability, FAA AD 78-13-04 mandated incorporation of Grumman American Service Bulletin 75-7. This bulletin introduced a colored marker in the tube.

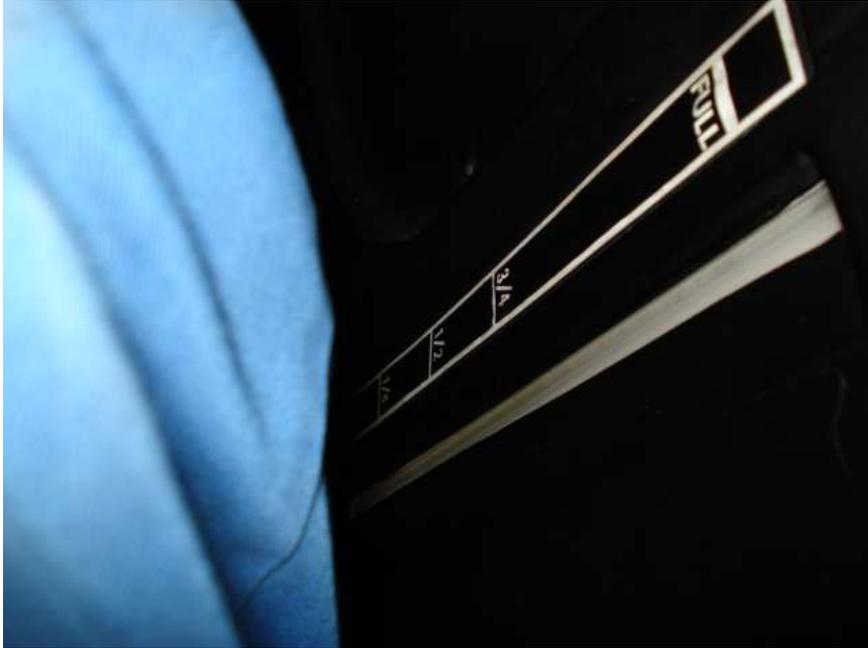
View of the LH fuel gauge, from the pilot's position.

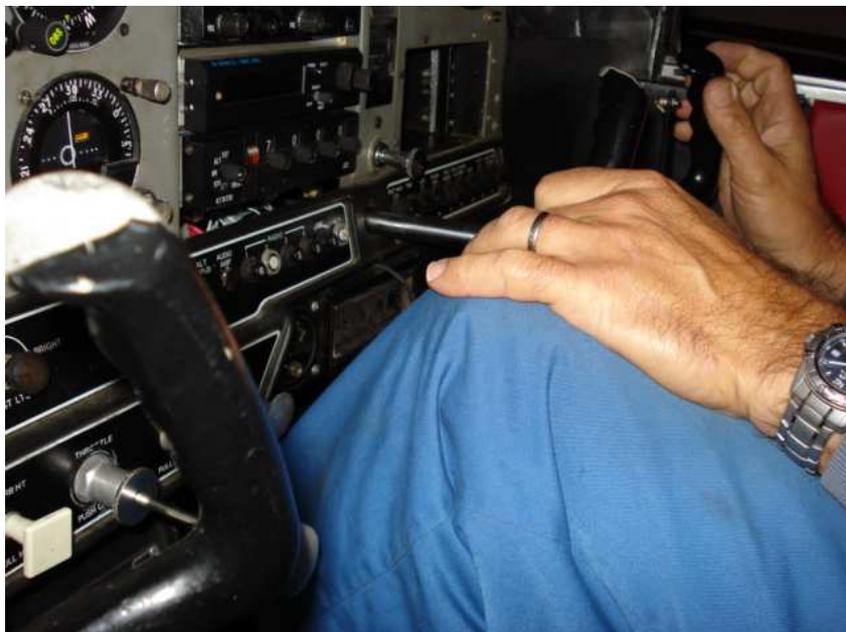
Fuel gauges are notorious unreliable on many aircraft. On the Grumman AA-1B, there's an additional phenomenon; with one passenger on board, they are simply not visible.

View towards the RH fuel gauge, with passenger on board, from the pilot's position.
