Air Accident Investigation Unit

**FINAL REPORT ON THE ACCIDENT
OCCURRED ON 05/08/2007
AT AYWAILLE
ON AN EUROCOPTER AS350 BA
REGISTERED OO-HCW**

Ref. AAIU-2007-12
Issue date: 30 April 2008
Status: Final

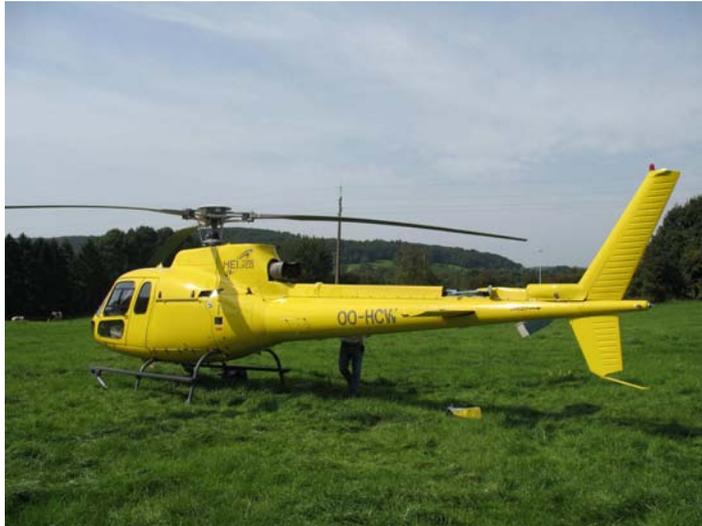
The helicopter performed a sliding landing, in a field, with a very light slope. The impact of the rotor blade with the aft rotor shaft occurred during landing slide.

The terrain is flat, but with irregularities, that could have induced bumping during the landing.

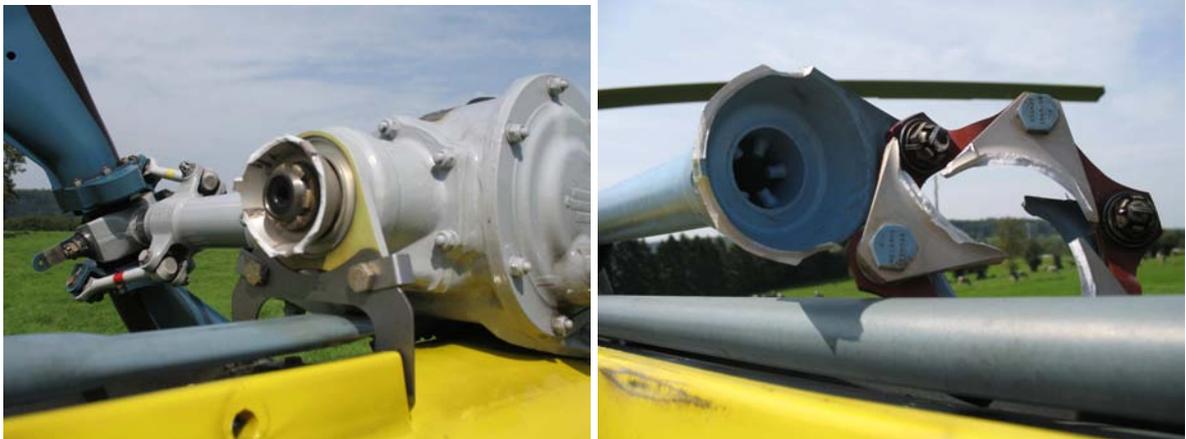
The tail rotor drive shaft is severed at three locations. Starting from the rear of the helicopter, the first rupture is located at the connection between the rear flector and the aft transmission gear box. The flector is stretched out. The rupture surfaces are characteristic of an overload, in this case an axial load.

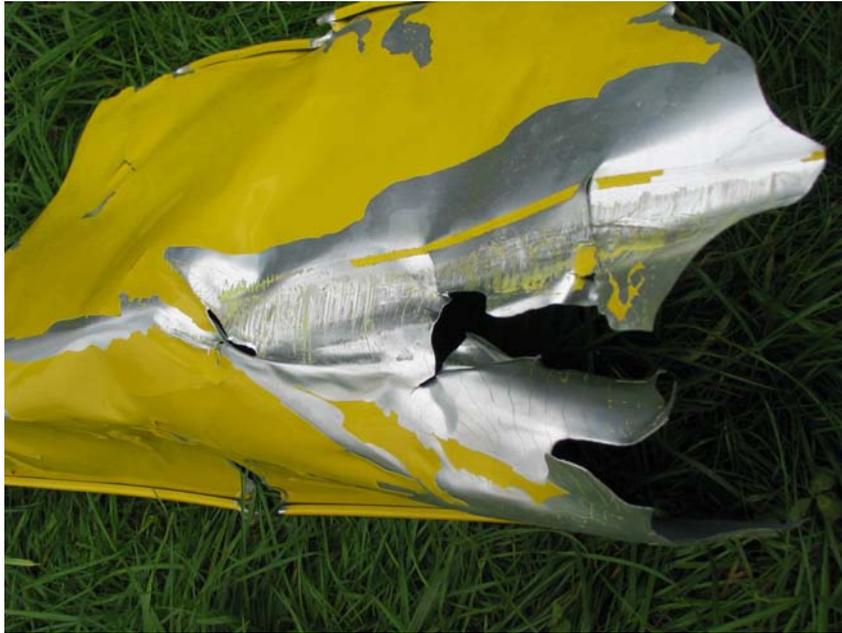
The intermediate rupture of the shaft is due to a contact between the shaft and one of the main rotor blade; yellow and blue paint were found on the “yellow” blade.

The damages found on the cowls are also consistent with a collision with a main rotor blade.

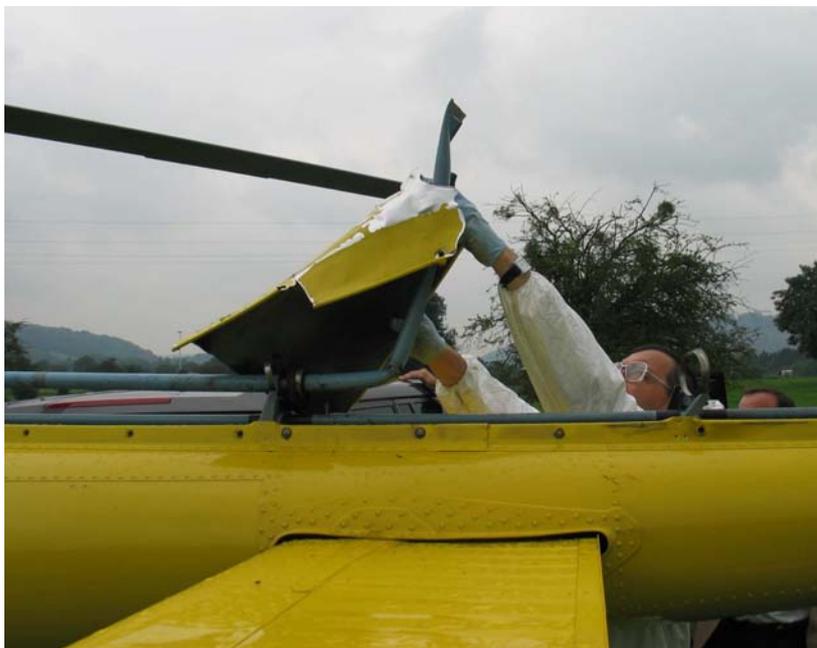
The last rupture shows the characteristics of a bending rupture; the shaft is bent for over 90°

The inspection of the rupture faces shows there were due to high loads. There was no obvious indication of corrosion or prior cracks.

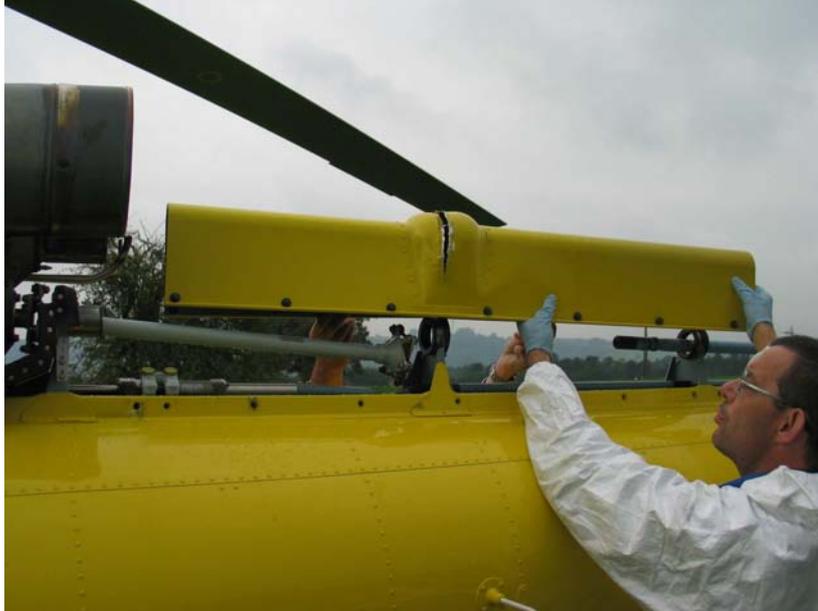
The shaft is disconnected from the front end of the boom ; the intermediate flector has « machined » the anti-torque pitch angle control rod. This shows the mechanical continuity of the control rod.

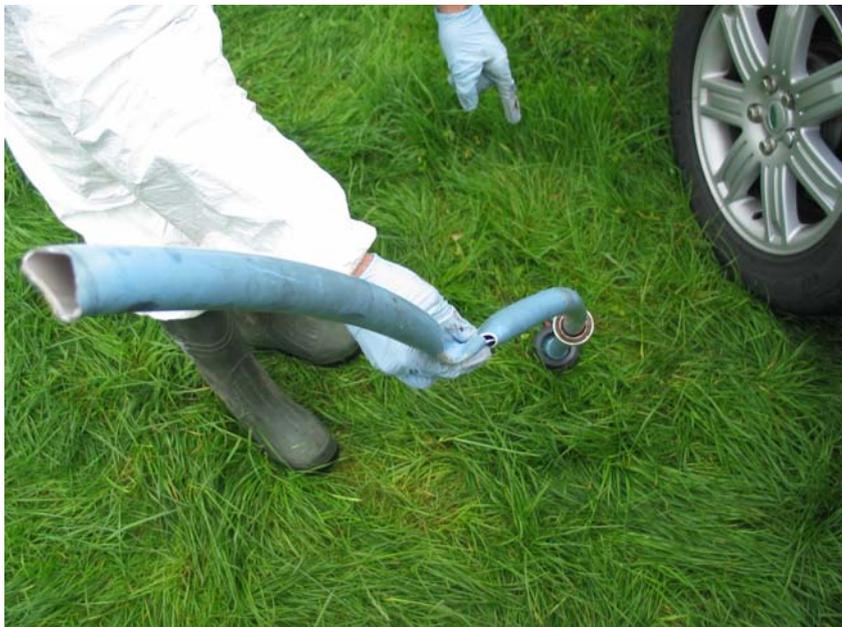
Finally, when assembling the severed parts of the shaft, we notice it follows the shape of a screw, which indicates the ruptures were done while the shaft was transmitting a torque.
