Investigation Report.

Status:	Final
Date:	23 January 2008
Time:	13:20 UTC
Type:	Reims - Cessna F150M
Operator/Owner:	Air Rent Services
Registration:	OO-RMU
C/N / msn:	CofA: 2970 msn: 1339
Engine(s):	Continental O-200A
Crew:	Fatality: 0 / Occupants: 1
Passengers:	Fatality:0 / Occupants: 1
Aircraft Damage :	Heavily damaged
Location:	Fagnes de Malchamps 3 km S of EBSP.
Phase:	landing.
Nature:	Private flight
Departure Airport:	EBSP – Spa airfield
Destination Airport:	EBCI – Charleroi Airport
Flight Number:	Not applicable

REF: AAIU (Belgium) 2008-2.

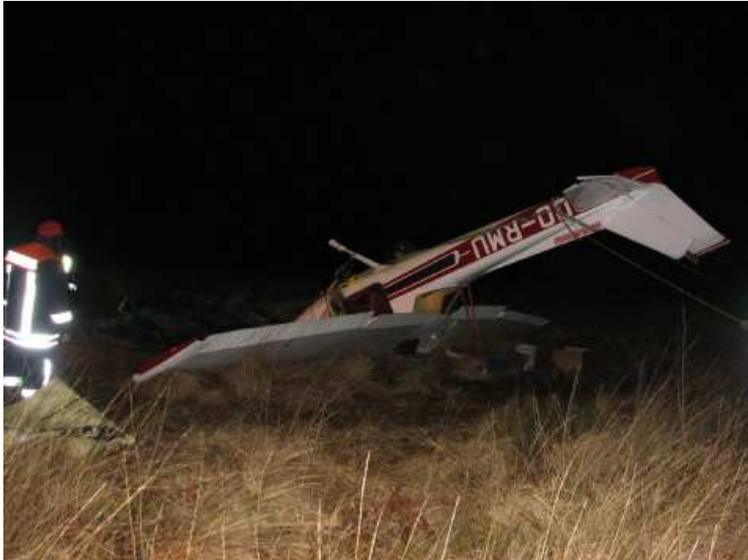
The ground is a peat bog, quite soft and marshy, and the aircraft decelerated rapidly. The Nose Landing gear hit a trunk and the aircraft overturned.

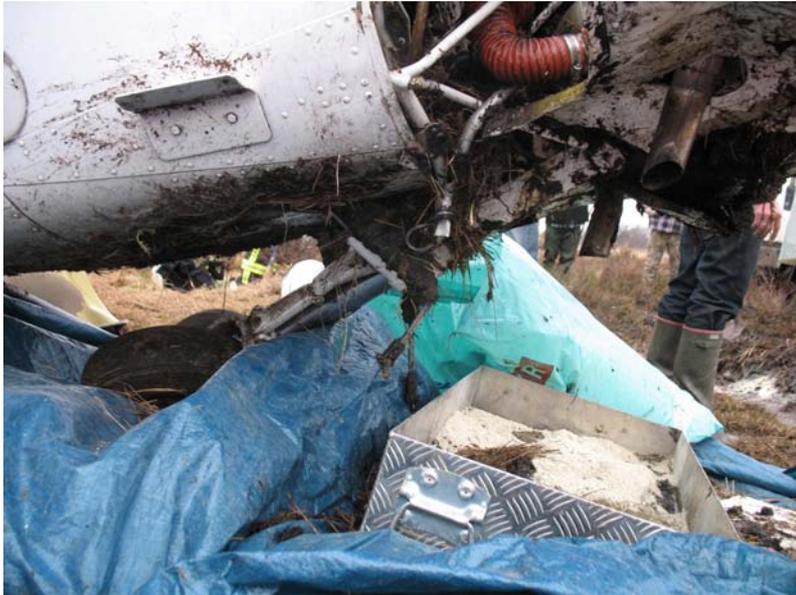
The nose landing gear leg is ripped out of its attachment points.

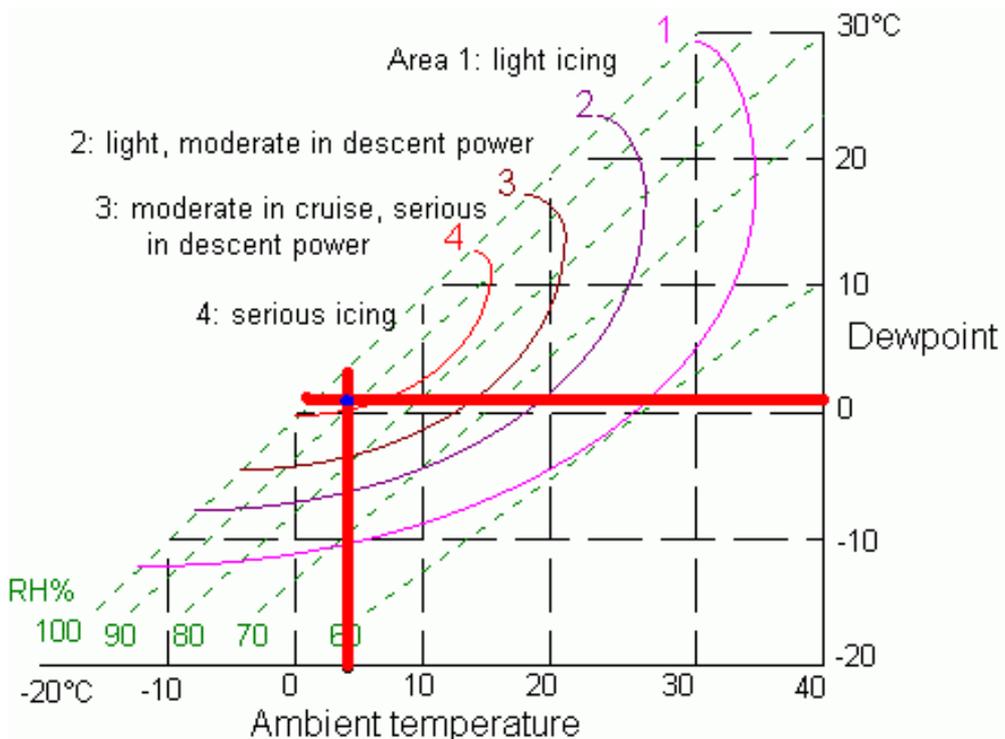
If we report the figures of temperature to the carburettor icing chart, we find:

The graph shows that the probability to experience carburettor icing was high, at all engine power settings.

The probability of icing is increased if fuel flow is not leaned – the excess fuel injected into the intake airstream increases the refrigeration.

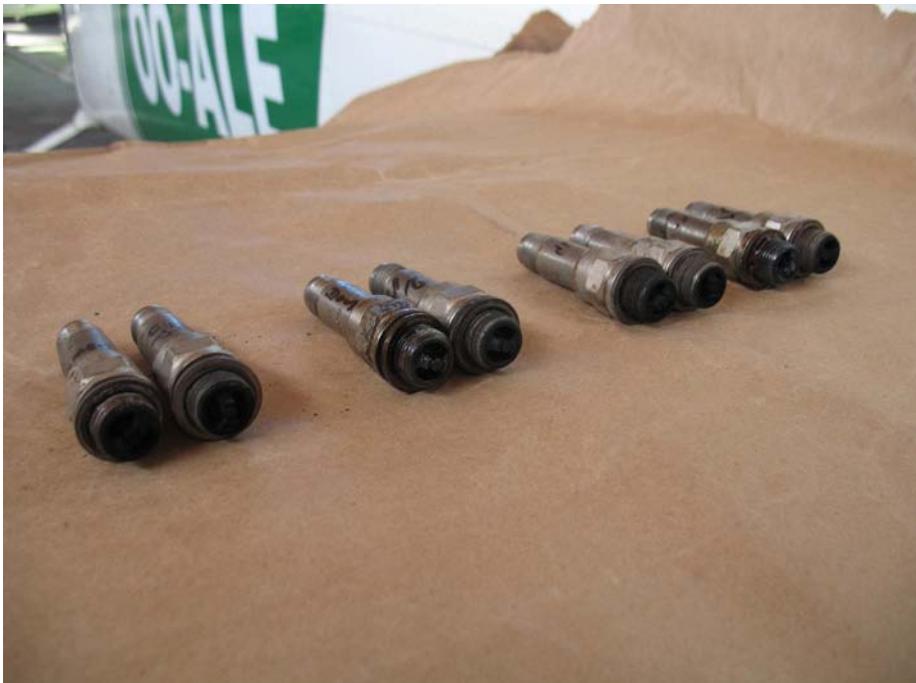
The spark plugs, however, showed signs of abnormal rich mixture.

These conditions are compatible with the icing conditions and the report of witnesses showing “black smoke” through the exhaust.

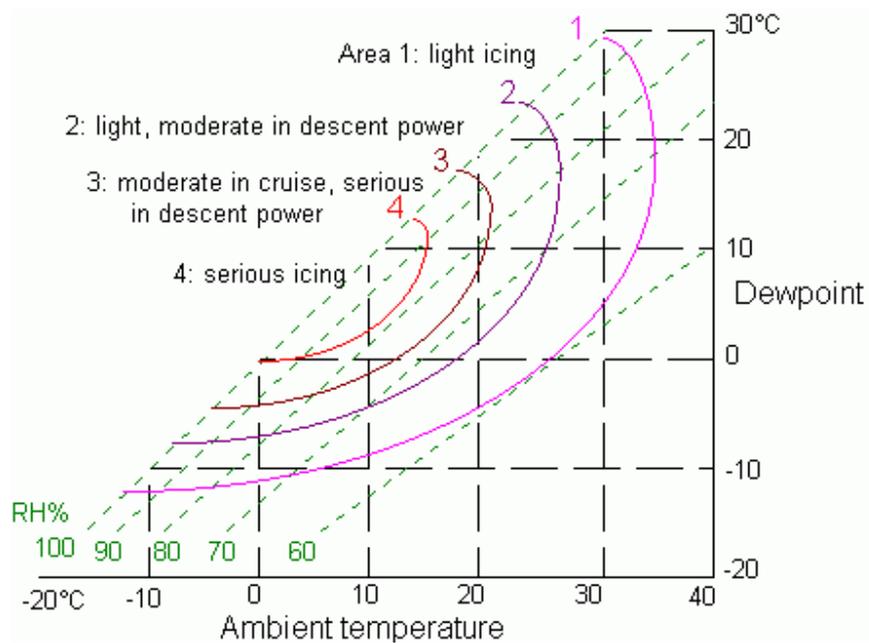
The formation of carburettor ice is likely to occur in wet, cold air; the diagram hereunder reflects the potential danger
