Safety Investigation Report

Ref. AAIU-2014-16
Issue date: 7 June 2016
Status: Final

Classification:	Accident
Level of investigation:	Standard
Date and time:	26 July 2014 at 18:06 UTC
Aircraft:	Hot Air Balloon - Libert L3400
Owner:	Private
Accident location:	Football field in Eeklo
Type of flight:	General Aviation - Airshow
Phase:	Take-off
Persons on board:	One pilot, one pax
Injuries:	None

During the 29th 'Meetjeslandse Balloonmeeting', an hot air balloon hit a light pole on the launch area during take-off. No one got injured.

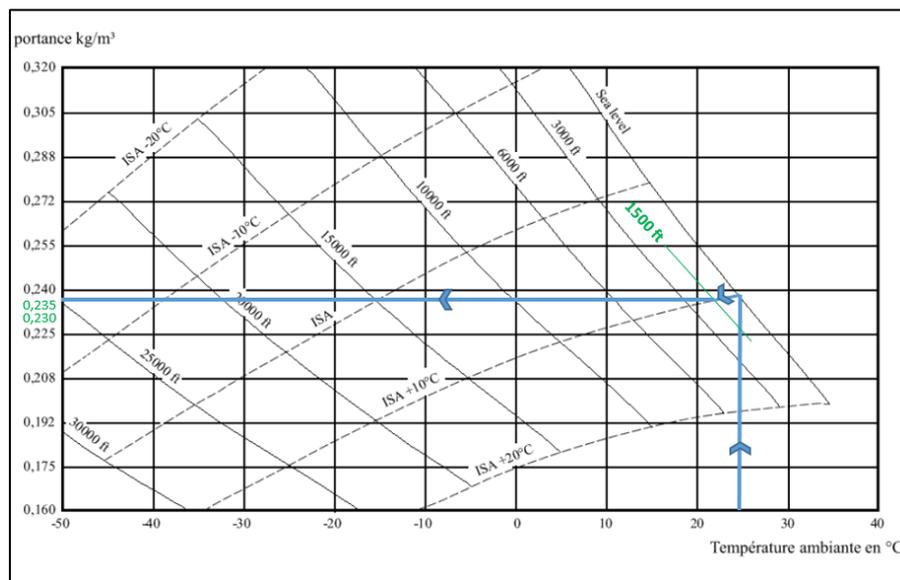
Figure 1: performance chart to calculate available lift

The available lift can be calculated by using a chart in the flight manual. The calculated total lift available at cruise altitude of 1500 ft with a temperature on the ground of 24° C and a temperature within the envelope of 100°C is 0,237 kg/m³ x 3400 m³ (volume of envelope) = 805,8 kg. So this would have been the maximum allowed weight at take-off. The actual total weight at take-off was 557 kg, giving a margin of more than 248 kg or 2433 N net buoyancy force (when the balloon is heated to 100° C). Divided by the actual mass, this gives an initial acceleration of 4,36 m/s², hereby neglecting the air resistance.

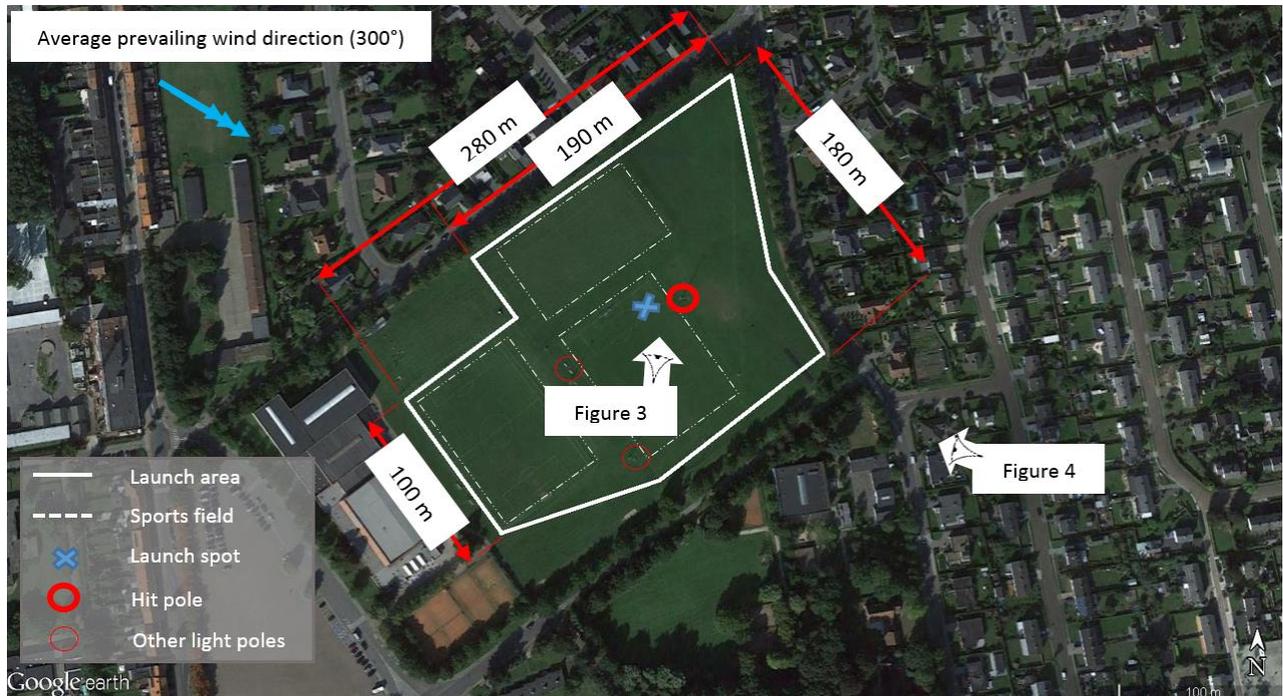
Figure 2: Launch area

The launch area consists of a grass ground, containing three sports fields, of the communal sports site in the built-up area of the city of Eeklo and is surrounded by trees. The white border on figure 2 shows the area that is used for the inflation and launching of the balloons. The remaining grass area is used for funfair, tents and a music stage.

One of the sports fields (a football pitch) has 3 light poles with a height of 19,5 m. For the first editions of the event, these poles were laid down. This is possible by means of an hinge system, used for repairing and replacing of the lights. However, in consultation with the balloon crews, the organisation decided to let the poles stand in the subsequent editions.

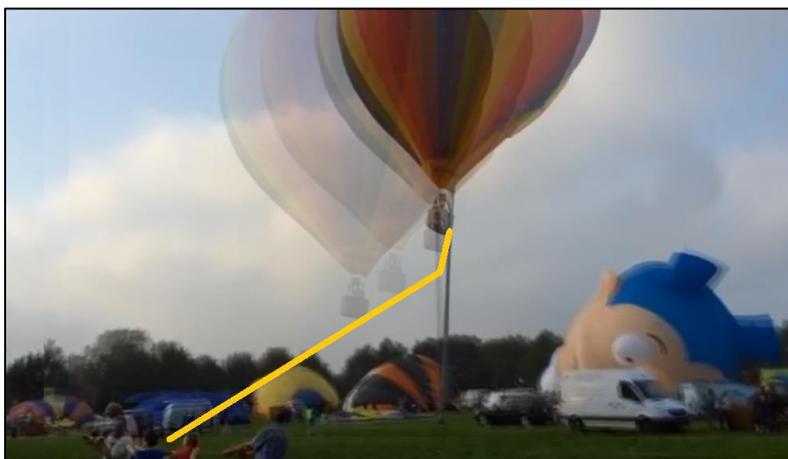
Figure 3: Reconstructed take-off path

The balloon held a GPS with recording functions but was not (yet) activated. The accident was recorded by a video camera by someone of the public. However, the beginning of the launch itself was not filmed as the camera had just turned away to film another balloon. By superposing different shots the take-off path was reconstructed, see figure 3.

The envelope almost immediately hit the pole after take-off. Due to the mass it was containing, the pole bent a bit before it ripped open the envelope. It quickly began to deflate while still climbing due to the inertia. The basket slid upwards against the pole. Eventually the balloon was arrested by the horizontal load tapes wrapped around the socket. When the envelope was deflated further, the basket fell some meters back down but kept hanging by the load tapes.

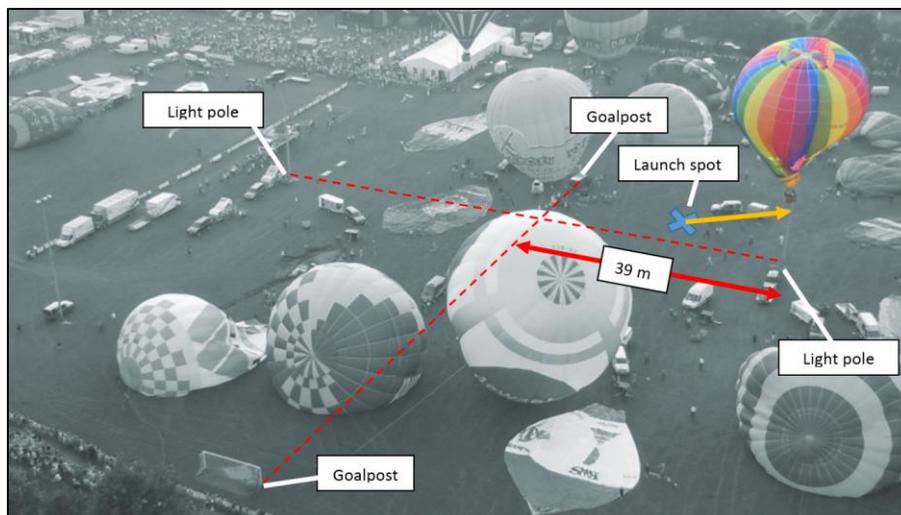
Figure 4: Aerial view of the launch area during the collision (taken from another balloon)

From the crew of the balloon that took off prior to the accident balloon, the Air Accident Investigation Unit received a picture showing the collision with the light pole.

The pilot declared that the balloon was on a distance of 50 metres from the light pole. However, by analysing the video and pictures it was concluded that the basket was actually standing between 20-25 metres from the pole. This means that the envelope was on a distance of 10-15 m from the pole.

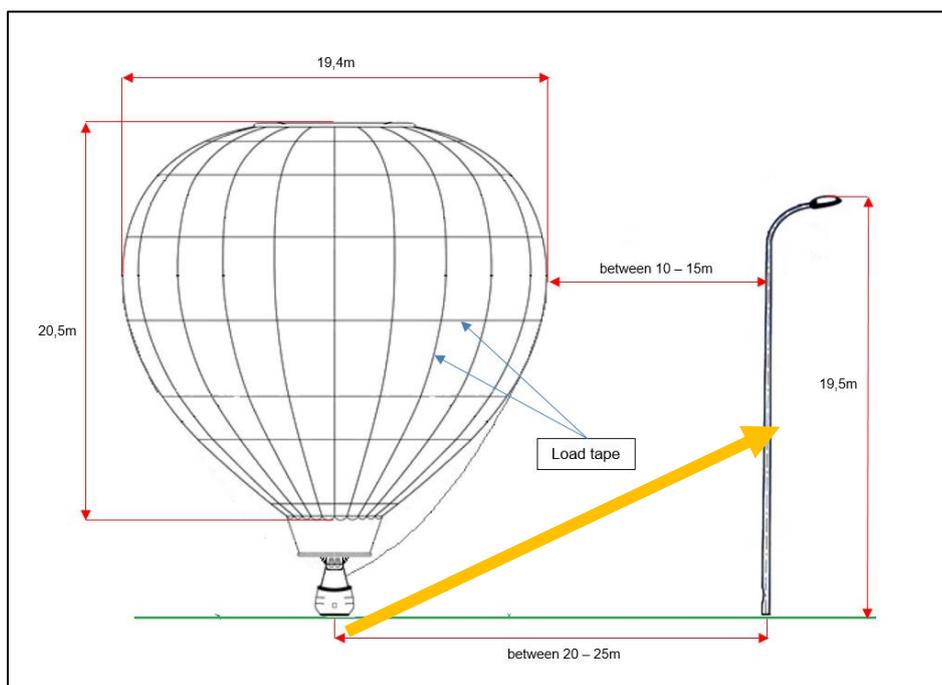
Figure 5: Sketch with relevant dimensions (not on scale)

- The balloon was airworthy and its load was within limits
- The balloon (equator of the envelope) was at the limit of the 15 metre distance from an obstacle as prescribed in circular CIR/GDF-07
- The balloon immediately took a heading of approximately 60 degrees clockwise from the expected flight path

It is recommended that the organisation 'Meetjeslandse Balloonmeeting' instructs the flight crews to take-off from a launch spot with a distance from any obstacle of at least two times the height of that obstacle within 60 degrees left and right of the expected flight path, and this only as a bare minimum.

- flight crews have to take off from a launch spot with a distance from any obstacle of 15m or at least two times the height of that obstacle (whichever is greater) within 60 degrees left and right of the expected flight path
- 'weight off' take-off procedure has to be used

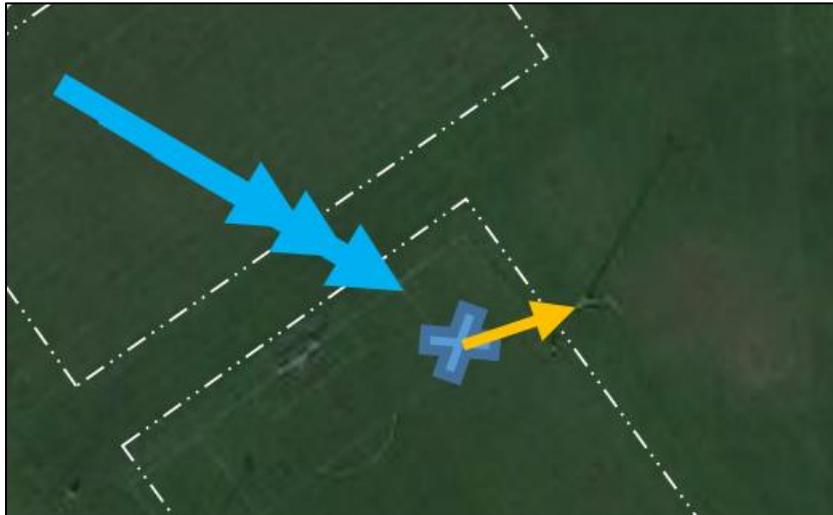
Figure 6: Take-off path (orange) compared with average wind direction (300°)

The last measured prevailing wind direction was 300°, variable between 280-320° which means an expected take-off direction between 100 and 140°. This was confirmed by pibals and also the balloon that took off prior to the accident balloon followed the expected flight path. However according to the pilot, and confirmed by the reconstruction on figure 6, the balloon immediately took a heading of 60-70°, which is about 60° clockwise from the expected direction.

The already airborne pilots didn't notice any sudden change in wind direction. Therefore the reason of the deviation is highly probably due to the surface properties; the line of trees in combination with inflated balloons still on ground could have caused (temporary) some light wake turbulence.

The cause of the accident is an unexpected change of wind direction highly probably due to turbulence caused by the surface obstacles. A contributing factor is that the hot air balloon was taking-off too close to the light pole, making it impossible to perform any recovery action.
