Safety Investigation Report

Ref. AAIU-2014-17
Issue date: 14 June 2017
Status: Final

Classification:	Accident
Level of investigation:	Standard
Date and time:	03 August 2014 at 11:00 UTC
Aircraft:	Piper PA-28-235. C/N: 28-7110004 (manufactured in 1971) registered in the Netherlands.
Type of engine:	One Lycoming O-540 engine
Accident location:	Aerodrome of Koksijde (EBFN)
Type of flight:	General Aviation – Cross-Country
Phase:	Landing
Persons on board:	2 pilots, Dutch Nationals.
Injuries:	None
Abstract

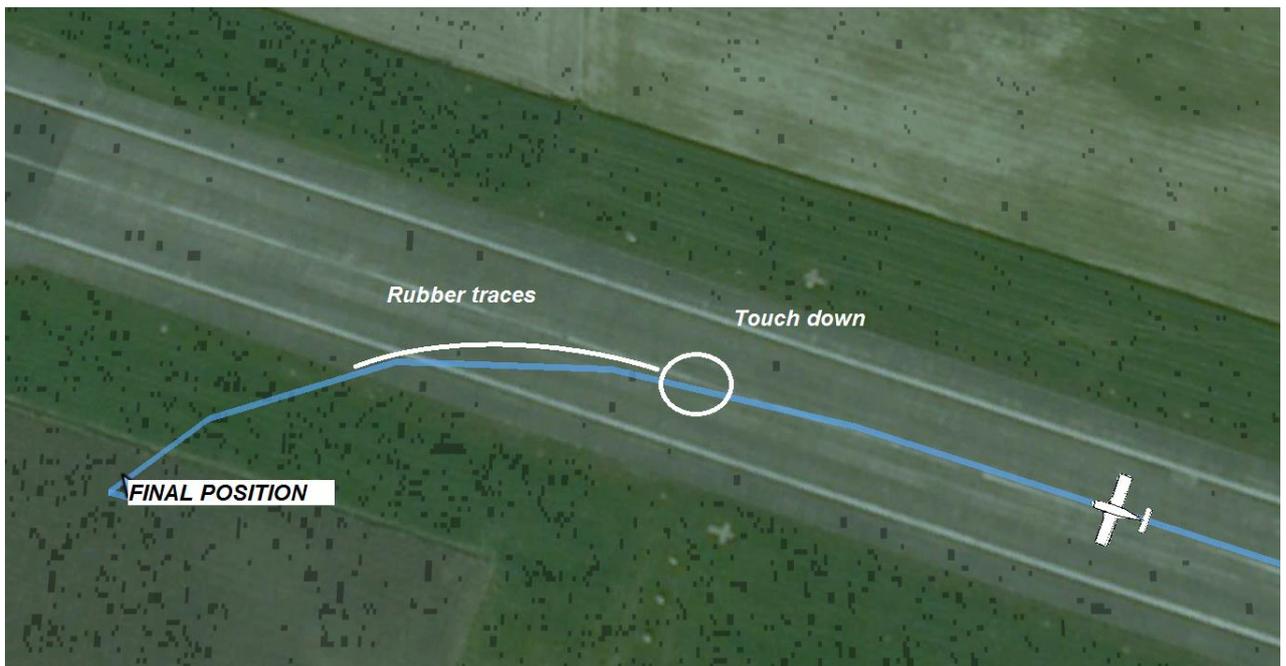
Figure 2: touchdown and deviation on RWY 29 at EBFN

The pilot probably applied pressure on both brake pedals at or immediately after the landing causing a right wheel lock up and an unbalance between the braking efficiency of the wheels. The wheel locking up (right in this case) will brake less than the other wheel causing a deviation to the left. A reflex reaction of the pilot could have been that he increased the pressure on the right rudder/brake pedal, causing the phenomenon to be maintained.

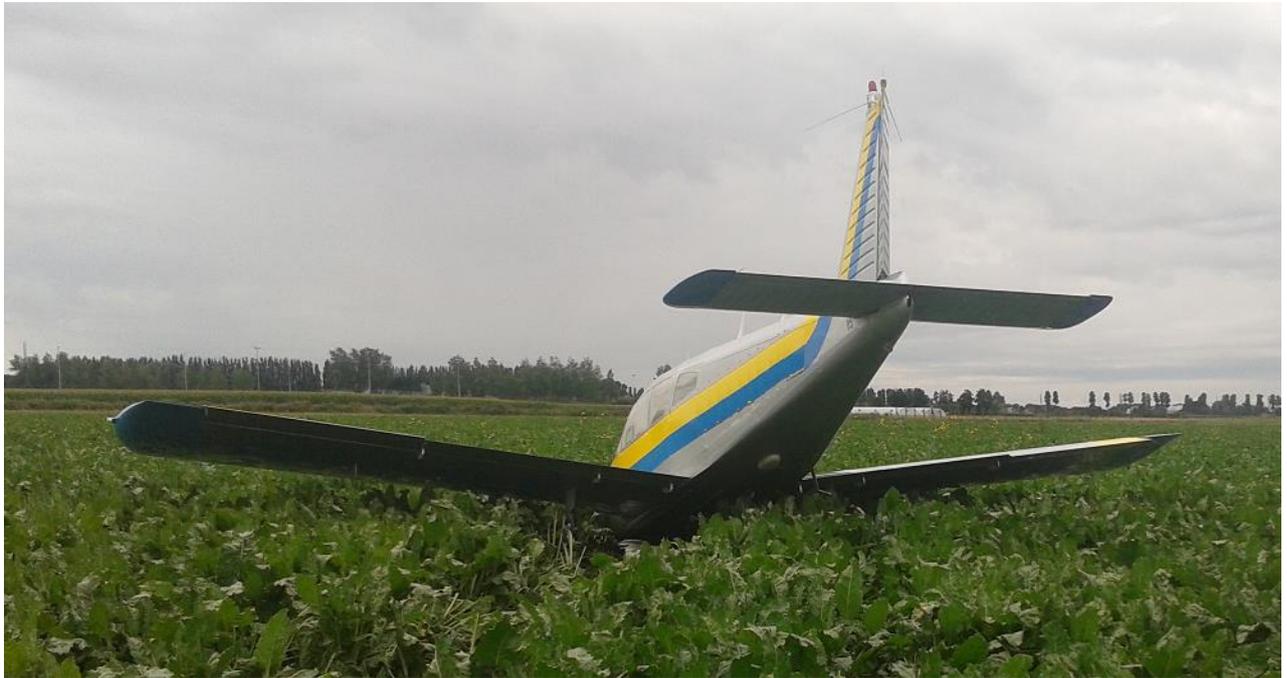
The pilots on board could not prevent the deviation, in spite of their efforts, and the airplane came to a stop in an adjacent field.

Figure 3: final rest position

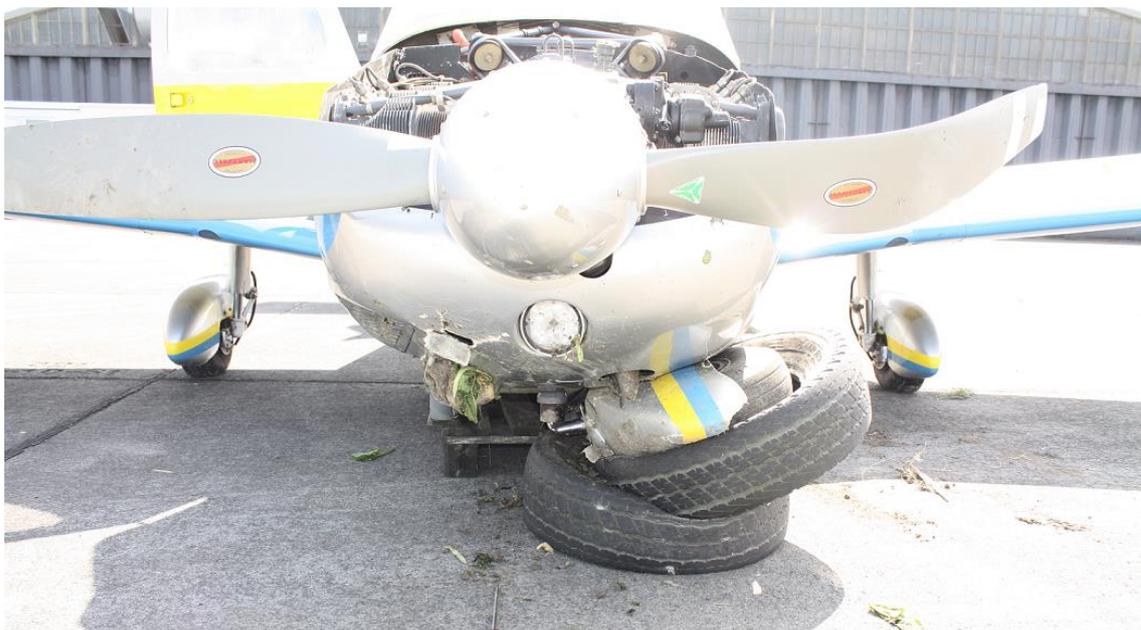
Figure 4

The nose landing gear leg was broken, the propeller bent, and there was visible damage to the engine firewall.

The damage is localised at the nose landing gear and one propeller blade.

The nose landing gear leg is bent 90° rearward.

One propeller blade is bent backwards.

Some tubes of the nose landing gear support structure were found deformed.
