Safety Investigation Report

Ref. AAIU-2019-01-29-01

In 2019, 3 similar ground accidents occurred on the Limburg Regional Airport (EBST). Although the aircraft damage can be considered as substantial, the risk for injuries is very low. For this reason one limited desk investigation was initiated for these 3 events.

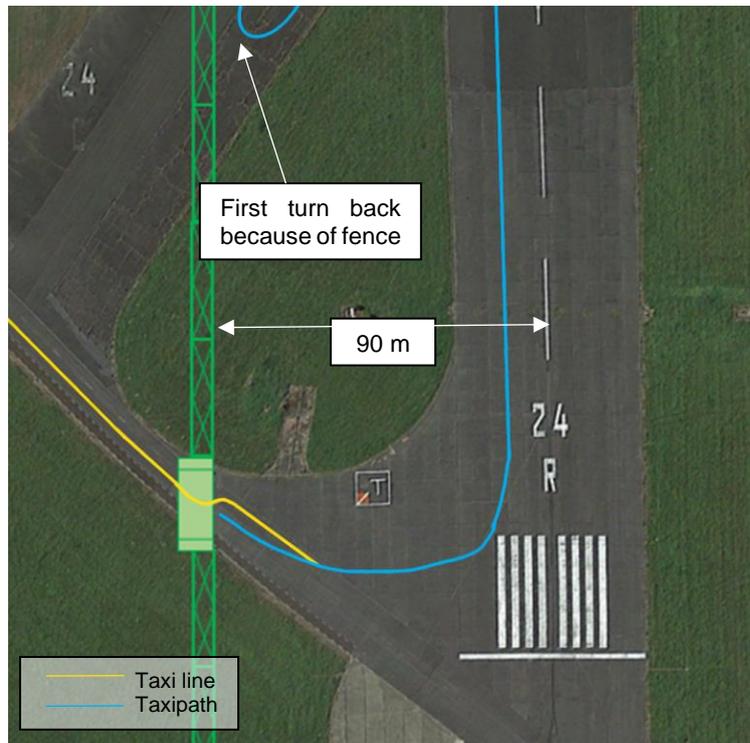
Figure 1: sketch showing the fence, gate (indication in green) and taxi line.
Google Earth image dates from 2016

The fence was installed end 2018 further to the changes to the runway configuration – the grass runway 24C (see Figure 1) was to be removed. The fence stands 90 m from the center of runway 24. The width of the gate is 19,48 m. The distance between the taxi line and the gate in open position is 9,95 m at the northeast side and 9,53 m at the southwest side.

- The fence was painted in a dark green color. It does not stand out against green grass background
- The width of the gate does not allow for much deviation from the taxi line (and is not conform GDF-04)
- The angle of the gate/fence with that taxiway asks for some extra maneuvering, hence the curved taxi line. A perpendicular angle with the taxiway would have been better.

AAIU(Be) is of the opinion that a gate perpendicular on the taxiway, not requiring any maneuvering close to the gate, and somewhat wider would have been better.

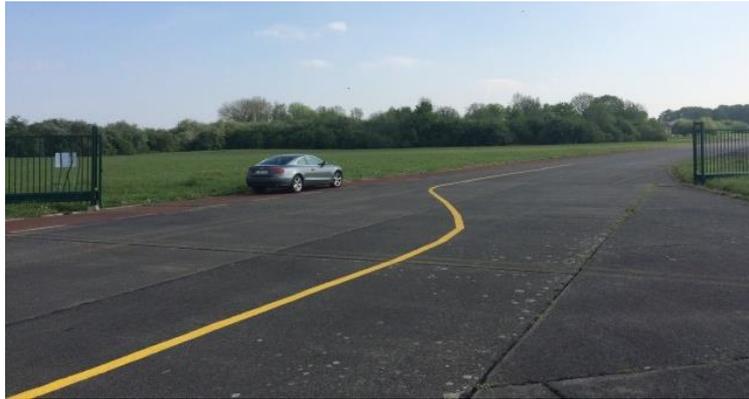
Figure 2: curved taxi line and green gate against green grass

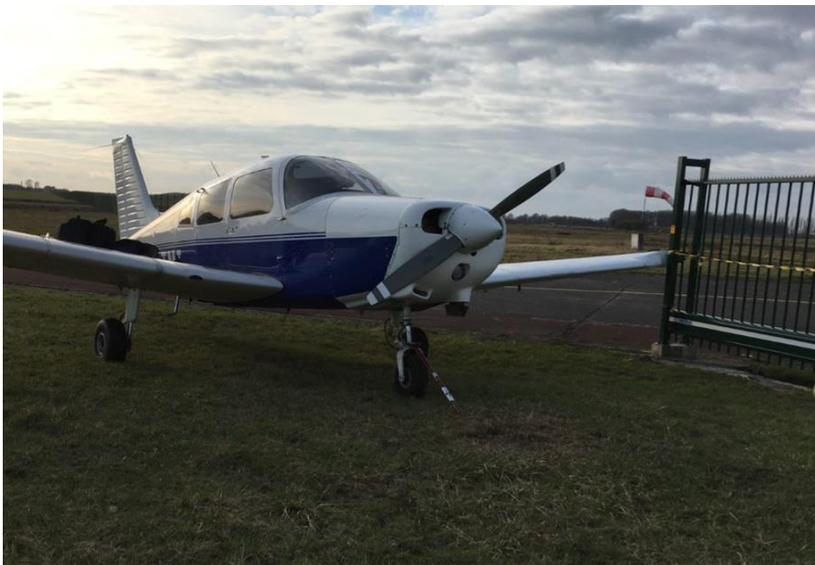
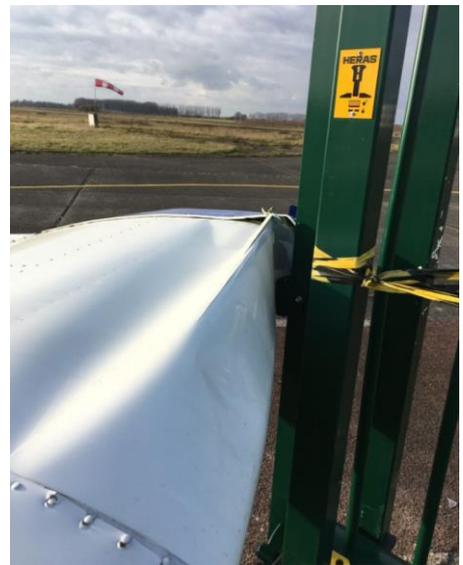
The aircraft took off from Antwerp Airport (EBAW) for a cross-country flight to EBST, where runway 24R was in use. After one touch and go, the aircraft landed and exited the runway to the right. However, this taxiway was obstructed by a fence. The pilot, who was the only occupant, then decided to turn back and backtrack on the runway and exit via another taxiway. On this route, a gate was recently installed. The pilot was not familiar with this configuration and did not notice, nor followed the curved taxiway line that would have led him to the centre of the gate. Maintaining his aircraft left to taxiway line, he did not realize his aircraft might interfere with the fence post this way. The left hand wing hit the edge of the gate, causing substantial damage. The aircraft came to a halt in the grass next to the taxiway. The pilot immediately stopped the engine and safely vacated the aircraft.

Figure 3: Pictures showing gate and damage

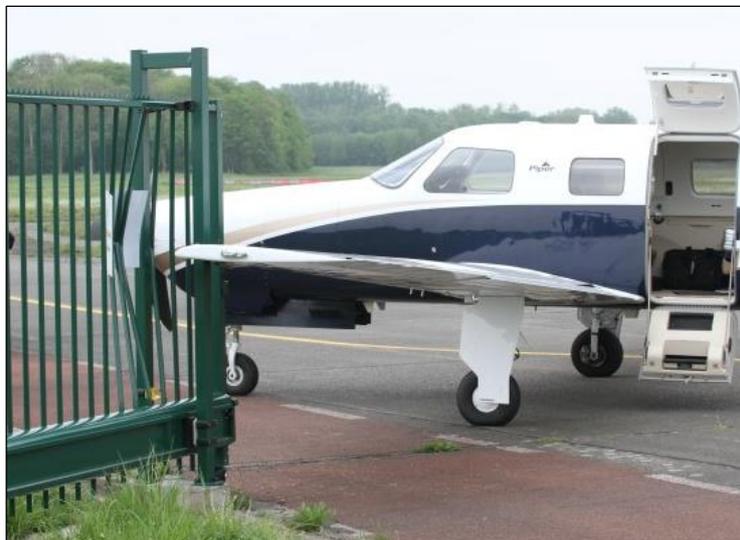
After landing on runway 06, the aircraft taxied to the parking area. As for the previous case, the aircraft did not follow the taxiway line and the tip of the left-hand wing hit the fence.

Figure 4: the PA-46 right after the collision, showing the deviation from the taxi line

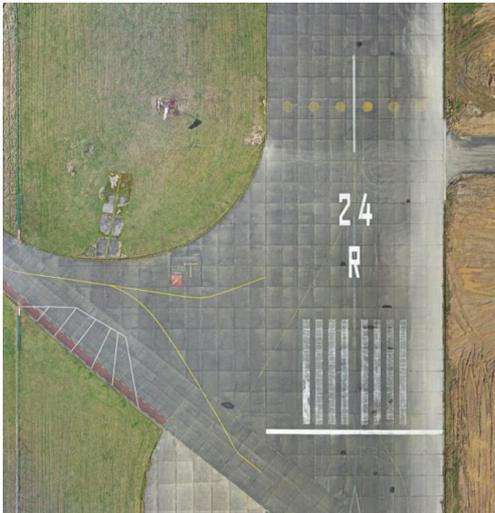
Figure 5: aerial view of improved situation

The new situation, eliminating the short zigzag in the taxiway and the red/white markings on both ends of the fence is undeniably an improvement.

- applying red/white markings on both ends of the fence;
- extending the yellow taxi line to the end of the runway - hereby eliminating the short zigzag- so that the taxiway can be intercepted earlier when taxiing from the runway.

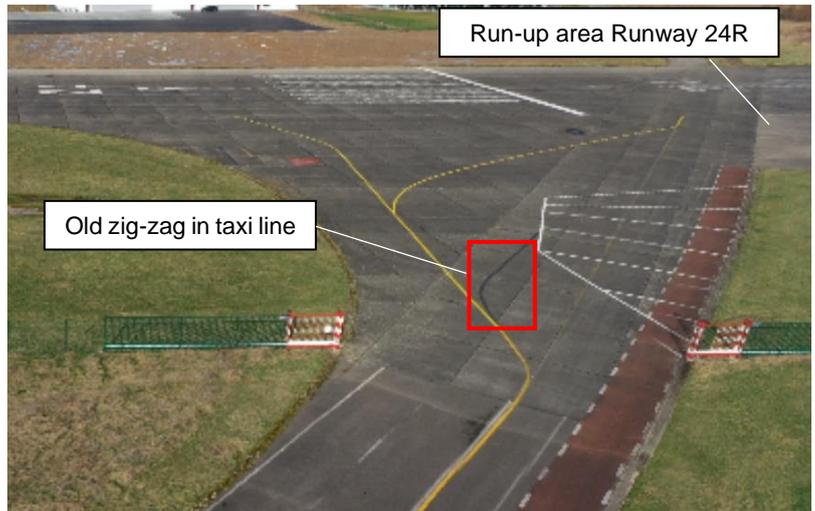
Figure 6: other view showing the change in the taxi line

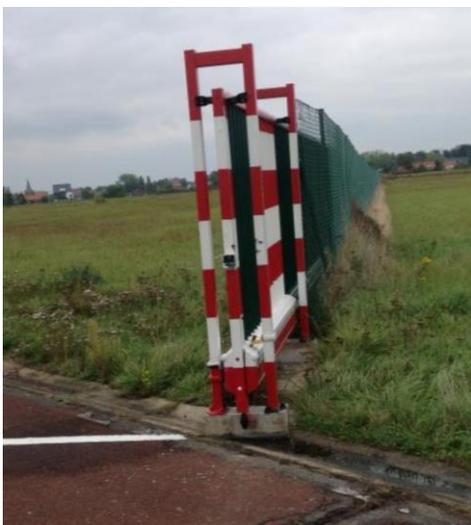
A Diamond DA40 operated by a solo student of Ostend Air College hit the same fence but with the right hand wing when taxiing back to runway 24R after a stop at EBST. The yellow taxi line was again not followed.

Figure 7: markings at the touched fence

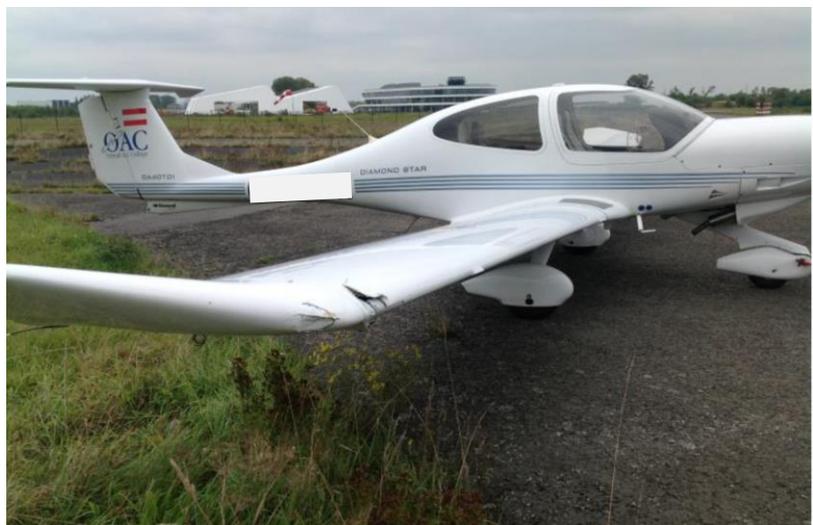
His statement: “I taxied from the apron to the runway. Once arrived at the fence, I reduced speed and checked the clearance along both wings. I turned towards the run-up area when suddenly the aircraft came to a halt. At first I didn't know what had happened, as I had checked both sides. I stopped the engine immediately and stepped out to have a look. Apparently I had hit the side of the gate with the right wingtip.”

Figure 8: damage to the right hand wing

However, still a third accident happened in October. This was somewhat different from the other two as the aircraft approached the gate and fence from the other side and was taxiing from the parking spot towards the runway. So the (student) pilot knew the situation as he already passed the gate that day when arriving at EBST. He also declared that he did pay attention to pass the gate but yet still touched it when turning towards the run-up area. This area is some 50 meters behind the gate (see Figure 6), so it wasn't needed to turn at that location. Should he have followed the taxi line, nothing would have happened. The event was probably due to his low experience and some stress involved with such operations (solo training flight).
