Safety Investigation Report

Ref. AAIU-2020-01-31-01
Issue date: 19 November 2021
Status: Final

Classification:	Incident	Occurrence category:	SCF-NP
Level of investigation:	Standard	Type of operation:	Non-commercial other-than- complex - NCO
Date and time¹:	31 January 2020 11:30	Phase:	Initial climb
Location:	51,235624°N 04,437490°E	Operator:	Arendair Ltd
Aircraft:	Partenavia P68B	Aircraft damage:	Minor
Aircraft category:	Fixed wing - Small aeroplane (MTOW <5700kg)	Injuries:	None

During a local flight after maintenance, when the aircraft was climbing at 1000 ft, the emergency door fell out. The door landed at short distance of a car.

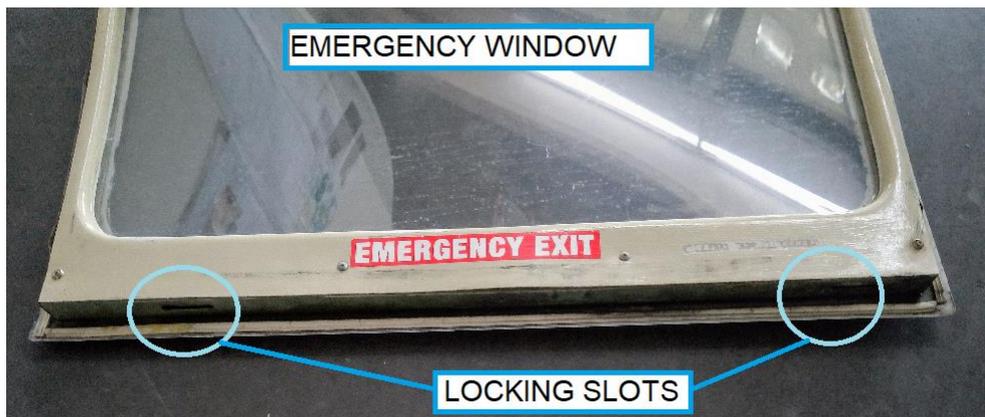
The window is held in position by two metal strips sliding into locking slots solidarizing the bottom part of the window with the aircraft structure. The top part of the window is inserted in a U-shaped angle profile.

Figure 3: Emergency window

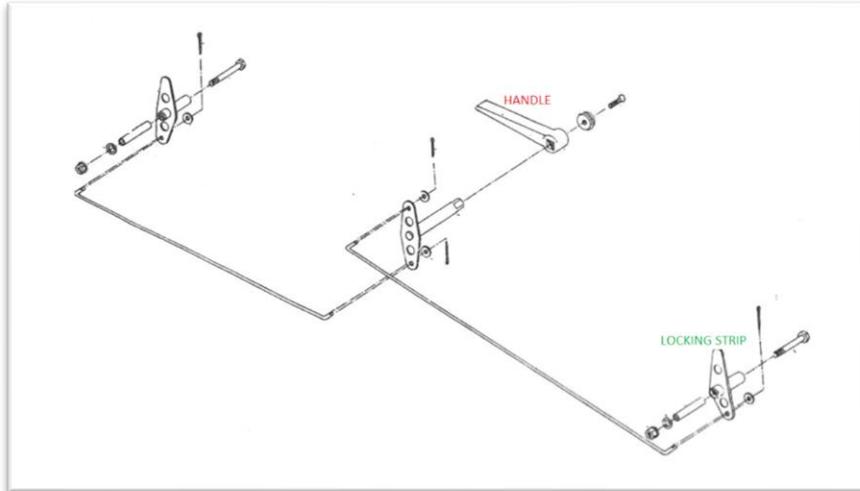
A picture taken after the event shows the locking metal strip stowed (window release position)

Figure 4:Emergency window operating mechanism

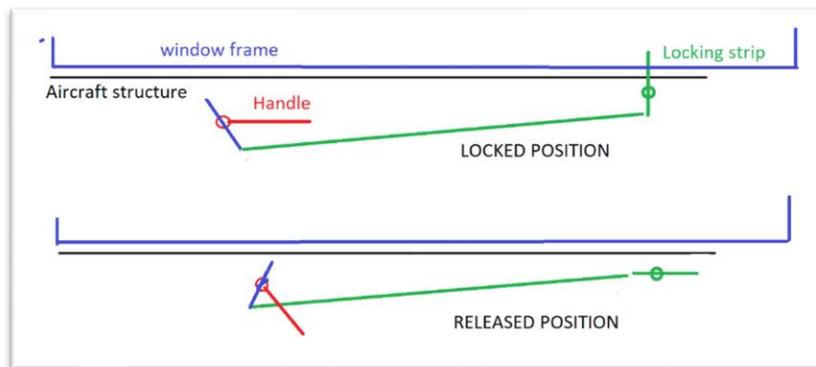
The handle can be put in two extreme positions;

- Upwards (window locked)
- Downwards (window released)

Figure 5: Emergency Window handle operation

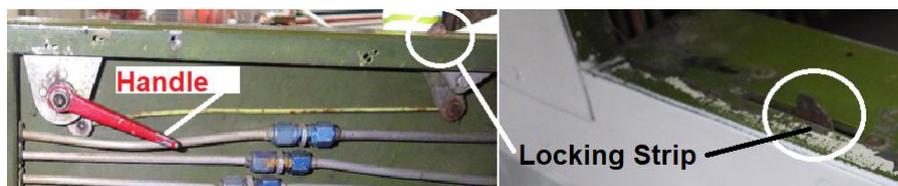
Figure 6: Handle in the 'closed 'position

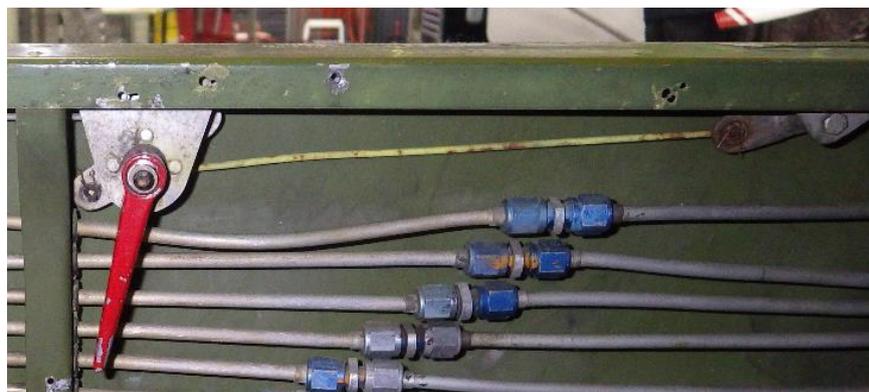
Figure 7: Handle in the 'release' position

- The release of the emergency window was most probably due to the operating handle unintentionally left in the “window release” position after maintenance and this condition was not detected during pre-flight check.

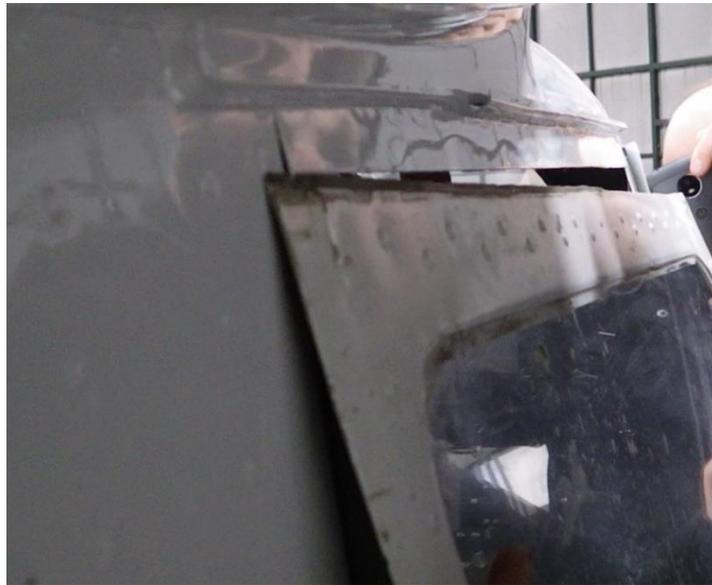
Figure 8: Emergency window topside installation

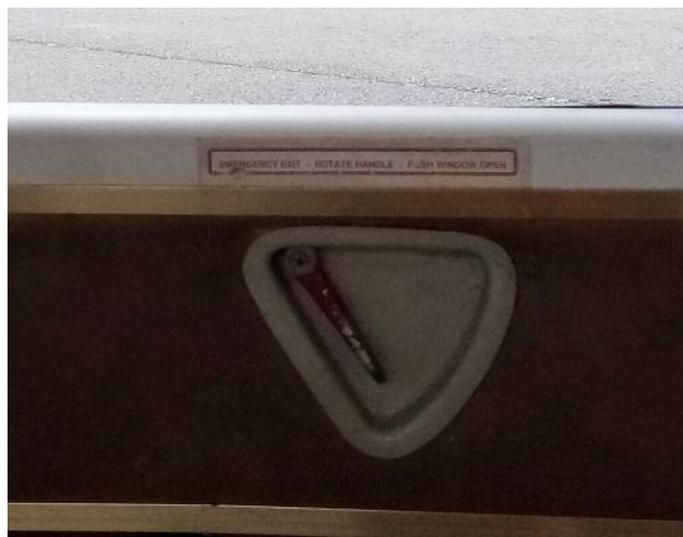
The POH makes no reference to markings of the handle positions (window locked / released). The aircraft was not equipped with such marking. Another aircraft of the same type and age present in the hangar during the inspection showed the same situation.

The absence of indication makes it difficult for anyone to determine whether the handle is in the correct position, as required during pre-flight check.

Figure 9: Emergency window unlocking handle

- improves the Partenavia P68B equipped with the operating system of the emergency window similar to the one of the incident aircraft as to clarify the status (closed – release) of the emergency window
- prevents its unintentional release and
- includes the check in the aircraft POH.

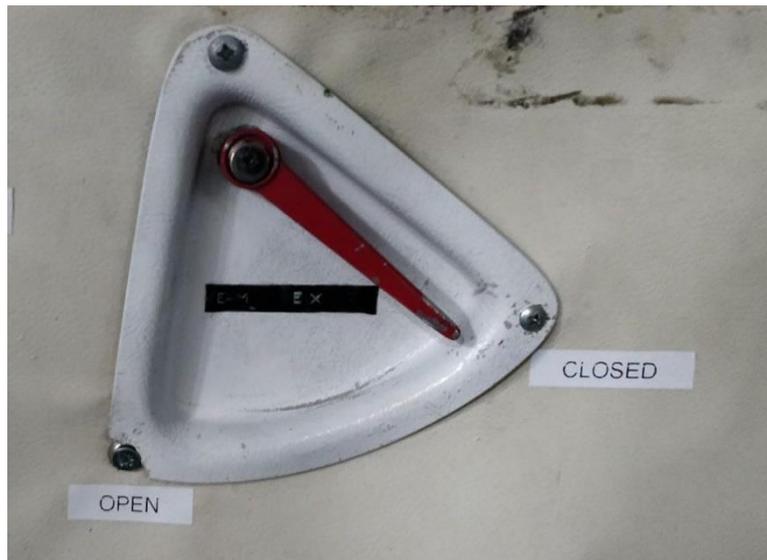
Figure 10: Safety action; marking of the handle position

The maintenance organisation took the initiative to mark the extreme positions of the emergency window opening handle.
