Safety Investigation Report

Ref. AAIU-2020-02-16-01

Synopsis:

During disembarkation, a passenger fell on the airstairs when exiting the aircraft.

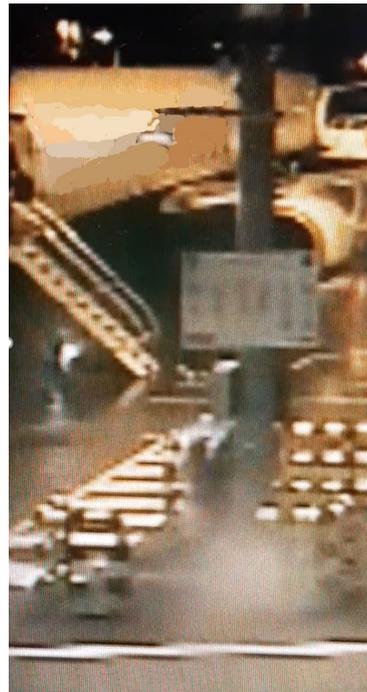
Figure 2: aircraft and surroundings from EBCI CCTV

The event occurred at night, with low lighting of the surroundings. The wind speed was high, although within the prescribed limits for the operation of the airstairs and it was raining. These conditions are known to increase the risk of falling from stairways.

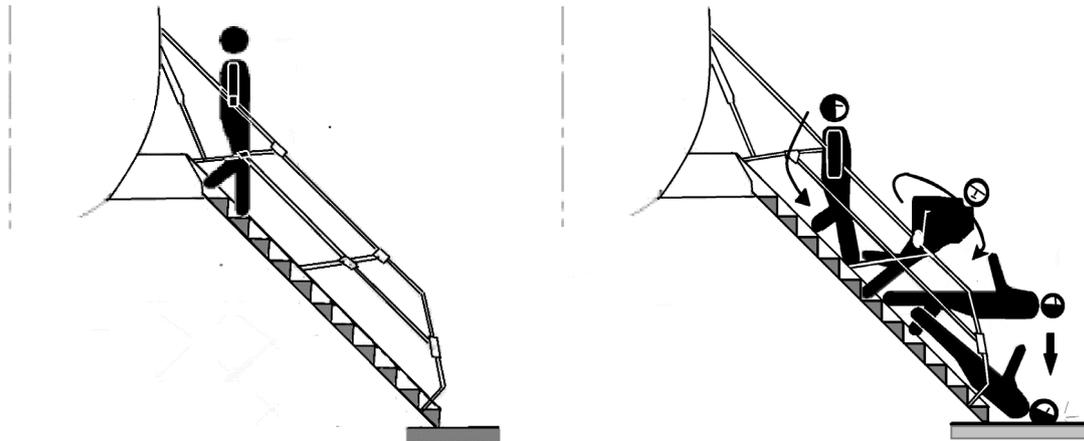
Figure 3: Fall sequence

At 21:39, after a male passenger exited the airplane and was climbing down the airstairs, he slipped, tumbled down the stairs, seemed to grab the railing on one hand, causing him to spin around and continue the fall on his back, eventually landing head first backwards.

The passenger carried a small bag in one hand and appears on the video to hold the safety railing with the right hand before the fall. He was not the first to exit the airplane.

The passenger suffered a severe concussion and a head wound that required stitching. He was evacuated to the hospital.

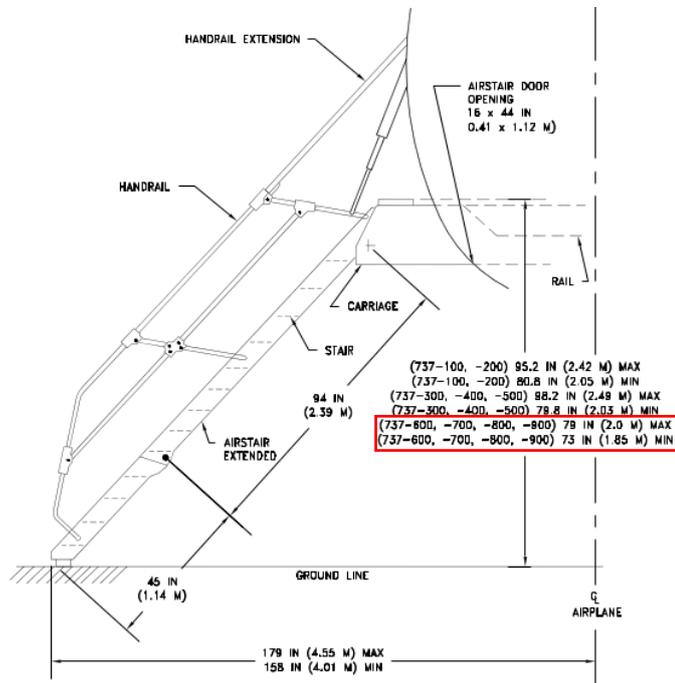
Figure 4: B737 airstairs

This aircraft is fitted with a set of retractable airstairs at the forward left cabin door, to allow the boarding and disembarkation of passengers without the need for additional ground support equipment. The airstairs include an integral two-rung handrail on either side.

The airstairs of the B737 are not more safe than any ordinary stairway, industrial or domestic but have, for the -800 model, a maximum height of 2 meters (see Figure 4). This height already reduces the risk for permanent injuries.

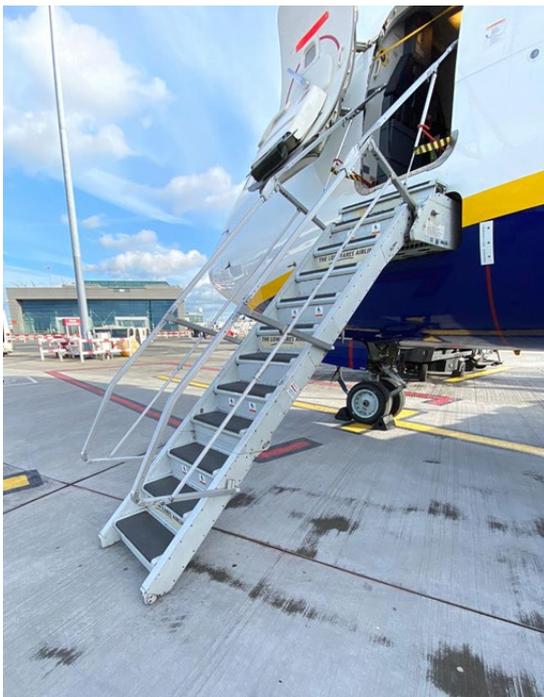
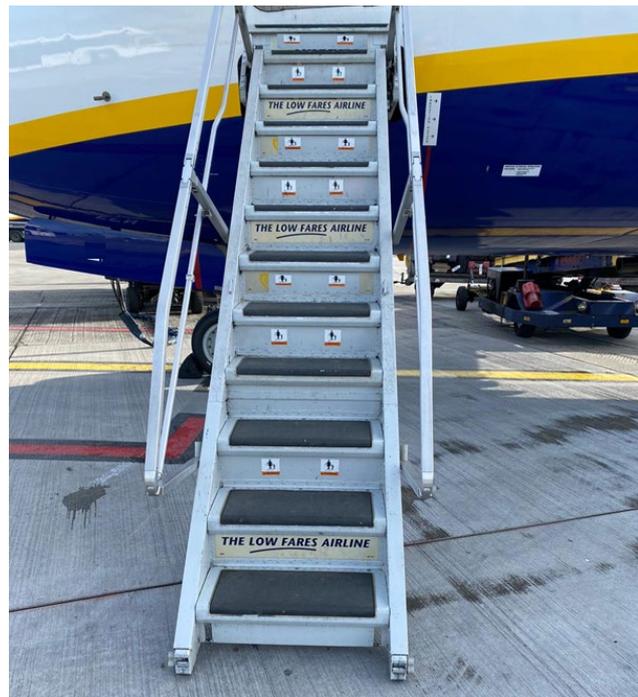
Figure 5 : side view of the Boeing 737-800 airstairs

As seen on Figure 5 and Figure 6, the anti-skid layer was present on the top platform as well as on the other stairs on the involved aircraft and appeared in good shape.
