# Safety Investigation Progress Report

Ref. AAIU-2020-08-29-01  
Issue date: 01 September 2021  
Status: Progress

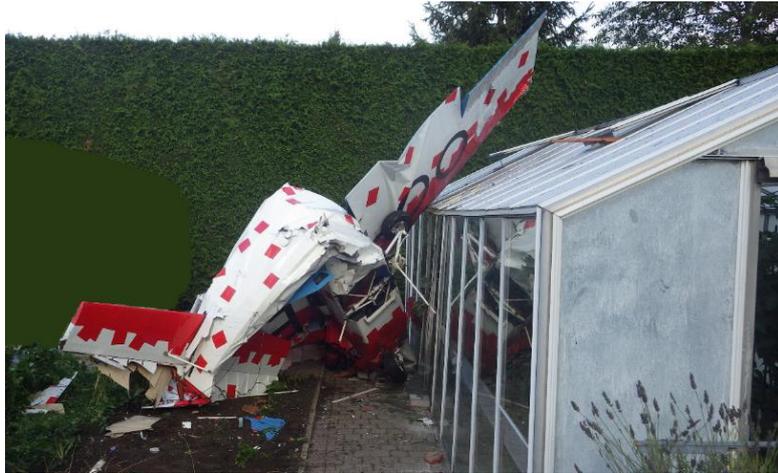
During the climb, beyond the end of the runway, at an estimated height of 300 to 400 ft AGL, the aeroplane was seen making a sharp turn to the left, attempting to return to the airfield in a rather steep descent.

The airplane hit the roof of a house, crashed in the garden, and came to rest next to a greenhouse. The aircraft's nose was oriented to the East, opposite to the direction of the take-off. The crash site was on the left side (south) of runway 27, approximately 230 m southwest of the end of the runway.

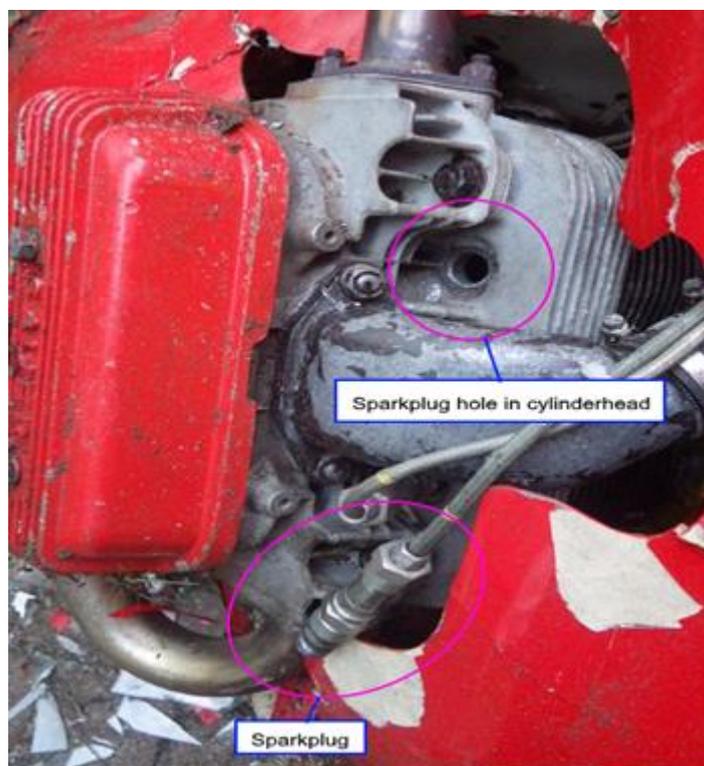
At first inspection of the wreckage, a sparkplug was found out of its hole in the cylinder head.
