# Safety Investigation Report

Ref. AAIU-2017-14

<b>Classification:</b>	Accident	<b>Type of operation:</b>	Specialized Operations – Photography (filming)
<b>Level of investigation:</b>	Standard	<b>Phase:</b>	Taxi
<b>Date and time:</b>	31 March 2017 at 17:00 UTC	<b>Operator:</b>	Heli Service Belgium
<b>Location:</b>	Heliport Sint-Pieters- Leeuw - EBSW	<b>Persons on board:</b>	1
<b>Aircraft:</b>	Eurocopter AS355F2 msn 5187	<b>Aircraft damage:</b>	Substantially
<b>Occurrence category:</b>	Ground collision	<b>Injuries:</b>	None

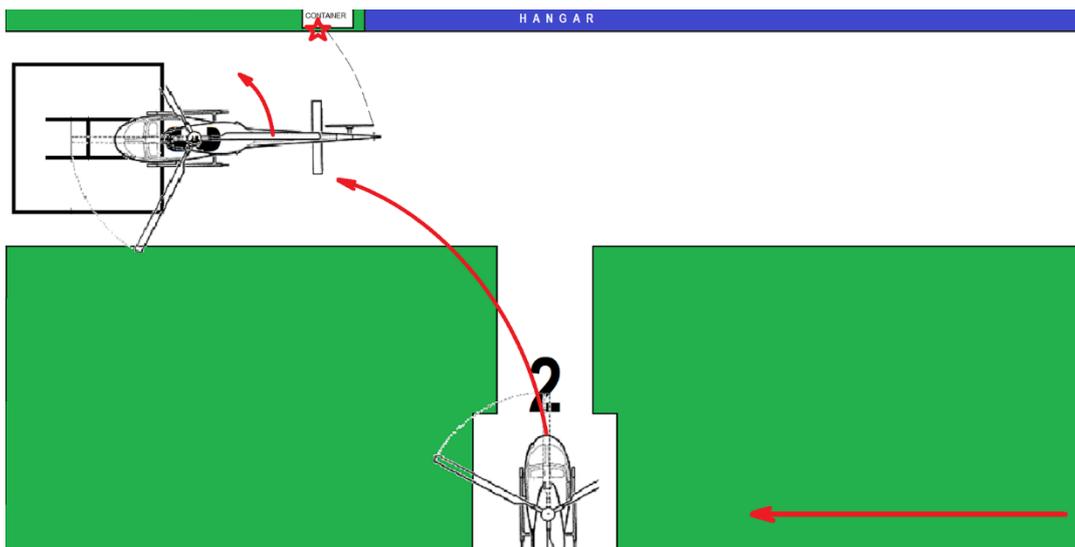
Figure 1: sketch of the last moments of the flight path

The pilot brought the helicopter to a hover, moved laterally towards the helicopter stand 2, then moved to the helicopter stand 3. Arrived at helicopter stand 3, not realising the helicopter was not centered above the stand marking, he wanted to position the helicopter into the wind and initiated a counter-clockwise rotation.

The pilot suddenly felt that the tail hit an obstacle, the helicopter turned to the right somewhat, then violently to the left, as the tail rotor failed. The pilot reaction was to lower the collective controls and land immediately.

The tailskid hit a container standing on the side of the hangar. The tail rotor strike the roof of the container as well.

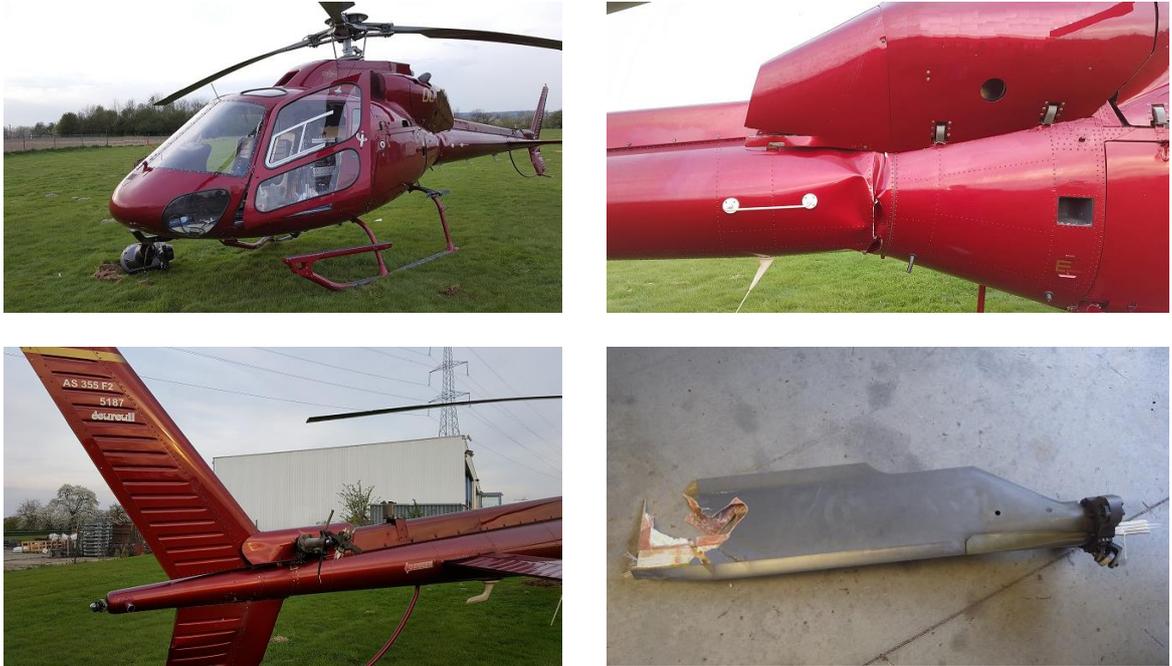
Figure 2: Damage to helicopter

The helicopter landed on the grass behind stand 3 and did not roll over. The tail boom was damaged, the tail rotor blades were severed, the right skid was broken as well as the camera installation installed on the helicopter for filming. There was no injury.

The tail rotor blades were severed, the vertical fin is deformed, the tail boom is deformed. The yellow main rotor blade is damaged by impact with a tail rotor blade.

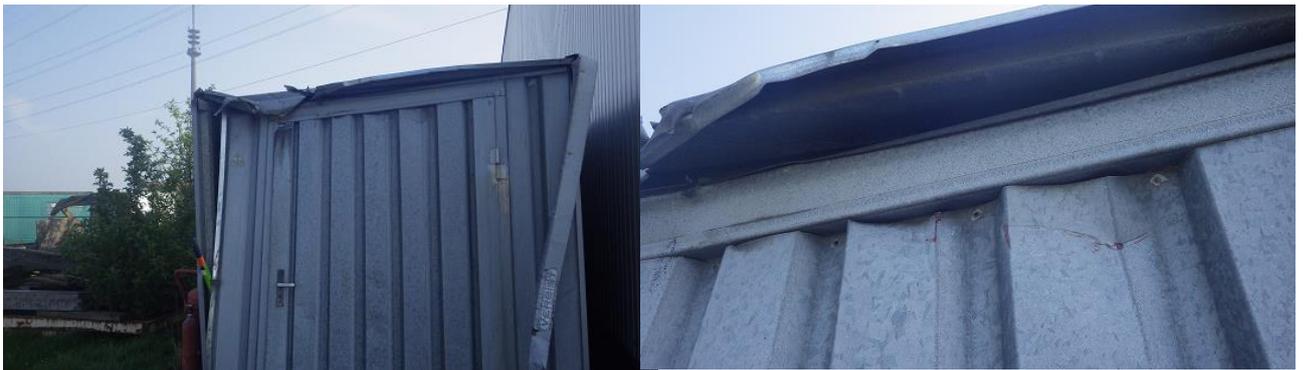
Figure 3: Damage to the container

The container was already there for many years and was well known from the pilot.

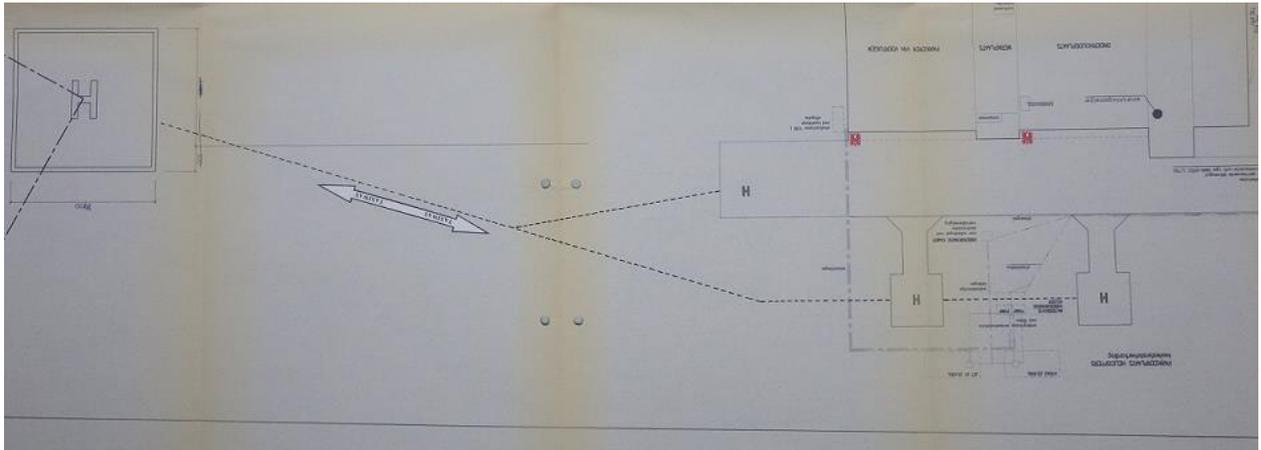
Figure 6: FATO-TLOF and helicopter stand

However the handbook does not describe procedure related to the taxi of helicopters from the FATO to the parking area.

An old (1999) drawing defines the taxiway from the FATO to the helicopter stand places 1, 2 and 3.

In the heliport handbook, there is little or no information available on the heliport lay-out, the air taxiway from the FATO-TLOF and the helicopter stands, each pilot selects the most adequate way to move the helicopter in the parking area, either with a cart or with hover taxi.

The heliport handbook does not identify whether helicopters are allowed to turn above the helicopter stands.

- Include clear instructions related to taxi operations from the FATO/TLOF to helicopter stands and between helicopter stands.
- Adapt the marking of the helicopter stands to give a clear and visible reference to the pilot in order to ensure an adequate clearance with respect to the surroundings buildings and obstacles. The prescriptions of ICAO Annex 14 give adequate indications. Nevertheless, the markings must be compliant with CIR-GDF-02-P.

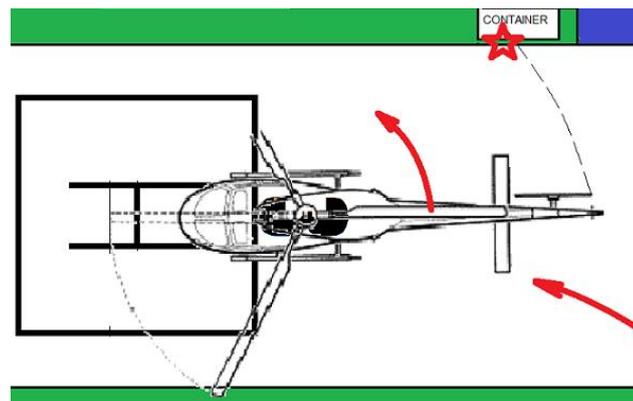
Figure 12: initial position of the helicopter

The helicopter was above an air taxiway but not centered above the ground reference of the parking stand when it started to turn around. The requirement for air taxiway width is to be 2 times the width of the landing gear of the helicopter for which it's intended to serve. There is no requirement to be able to turn the helicopter around its axis on an air taxiway, whereas such a requirement does exist for a parking stand.

The ground reference of the helicopter stand, indicated by a white painted square with a center "H" was visible during the day, but the white paint was somewhat faded. The ground reference is important in this event, as it would give the pilot a crucial information about the position of the helicopter at the moment of turning the helicopter into position.

During a surveillance audit performed in November 2015, the BCAA notified that the parking markings needed to be brought in conformity with the prevailing regulation (CIR-GDF02P). This would eventually require the painting of new ground markings. No action was performed by the company since the audit finding.
