Safety Investigation Report

Ref. AAIU-2011-ULM-10
Issue date: 01 October 2018
Status: Final

Classification:	Accident	Occurrence category:	Fuel starvation
Level of investigation:	Desk	Type of operation:	Non-commercial – Ultralight - Training
Date and time:	24 September 2011 at 17:15 UTC	Phase:	Cruise
Location:	In a field located between two streets Kluisstraat and Beugelstraat, at Zottegem. 24.6 km NE of EBAM	Aircraft damage:	Visible limited damage on engine, NLG, wing and rudder. Airplane was written off.
Aircraft:	AirLony Skylane msn: 31	Operator:	Private
Departure airport:	Aerodrome of Amougies (EBAM)	Persons on board:	2
Destination airport	EBAM	Injuries:	None

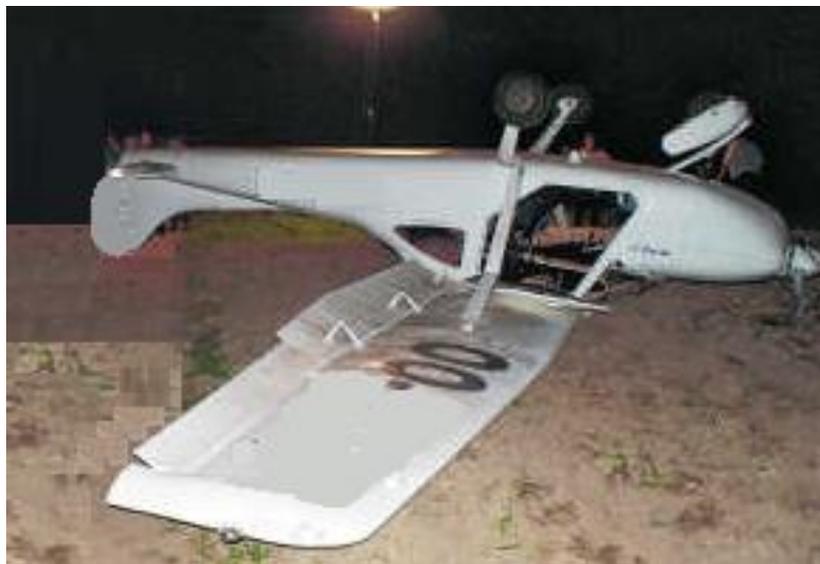
Figure 1

When the nose wheel contacted the ground, it sunk in the soft ground, causing the airplane to tip over.

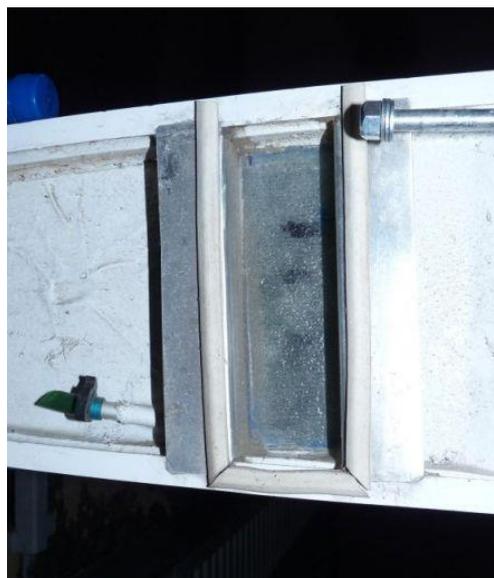
Figure 3

The fuel quantity indication occurs by direct reading of the remaining quantity through a translucent material in the side of each tank, visible in the cockpit. The indicators were not graduated.

The pilots stated that during briefing, they checked the fuel quantity and there were “two fingers height” of fuel visible through the indicator.

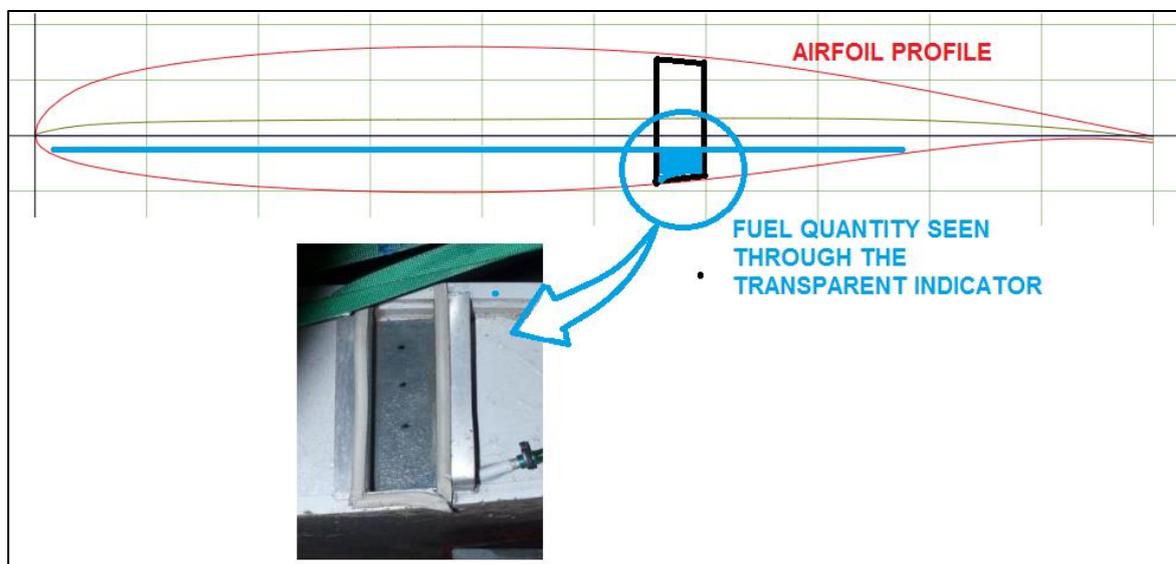
However, due to the wing profile, the wing dihedral, the location of the fuel line port in the tank and the airplane attitude on the ground, the indication of fuel level seen through the looking glass is not linearly proportional to the actual quantity available in the tank.

Figure 4: The fuel quantity indication on the LH wing

The available fuel quantity in the aircraft was not sufficient for the intended flight. The engine experienced problems due to fuel starvation. When the crew switched to the RH tank, the fuel line ran empty and the engine stopped.

The accident is caused by fuel starvation, due to the unreliability of the fuel quantity indicators.

- Inform the manufacturer of the AirLony Skylane UL about the event and the suspected cause, being the unreliability of the fuel quantity indicators.
- Perform the calibration of the fuel quantity indicator on each of his aircraft and all aircraft being imported in Belgium, involving;
 - Determination of the unusable fuel quantity by running the engine on the ground until it stops, making the fuel level by a red line and adequately shading the area below.
 - Graduating the indicator by a line for each addition of 5 liters fuel in the tank.
- Revise the flight manual to outline the meaning of the added graduation on the indicators. A note will be include to stress the importance of the red line.
- Issue a bulletin to inform all other Belgian owners of AirLony Skylane about the procedure to follow in order to calibrate the fuel quantity indicator.
