# Safety Investigation Report

Ref. AAIU-2014-AII-08  
Issue date: 18 April 2016  
Status: Final

<b>Classification:</b>	Accident
<b>Level of investigation:</b>	Standard
<b>Date and time:</b>	25 May 2014 at 08:40 UTC
<b>Aeroplane:</b>	Ultra-light aeroplane Alpi Aviation, model Pioneer 200 (SN: 170) put into service on 19 November 2007. The aeroplane was registered in France and held a 'Carte d'identification ULM' validated up to 19 April 2016 by another document called 'Accuse réception de la déclaration d'aptitude au vol d'un ULM'.
<b>Owner:</b>	Private
<b>Total flight time:</b>	1200 FH
<b>Type of engine:</b>	One Rotax 912UL SN: 4408720
<b>Accident location:</b>	Off EBSG airfield
<b>Type of flight:</b>	General aviation - Local
<b>Phase:</b>	Take-off
<b>Persons on board:</b>	One
<b>Injuries:</b>	None

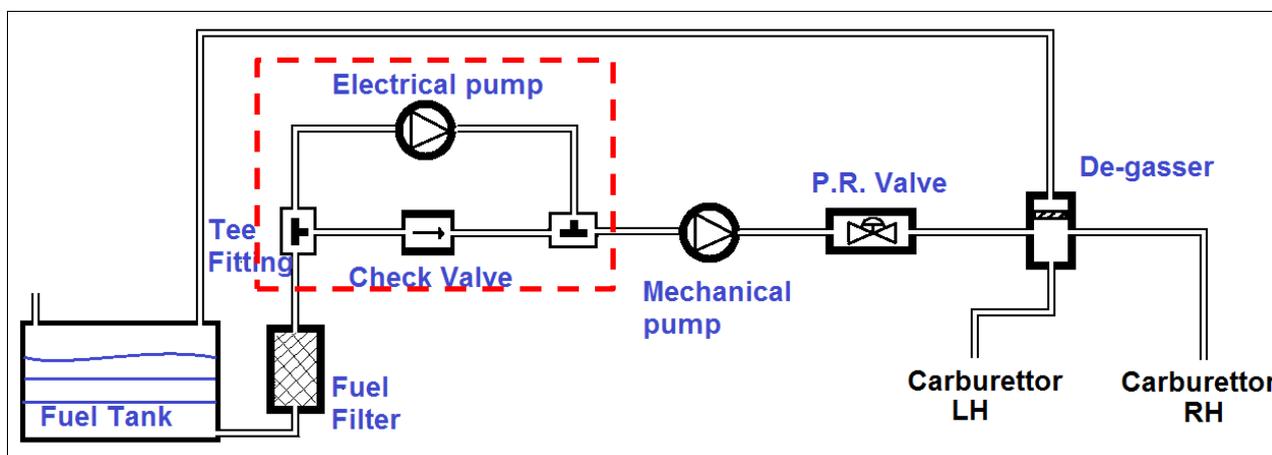
Figure 4: Fuel system after modification

If not properly designed and/or installed, each connection (10) needed for the installation of the back-up fuel pump has the potential to leak or cause an air intake, which raises the question of the actual added value of the modification (the best is sometimes the enemy of the good).

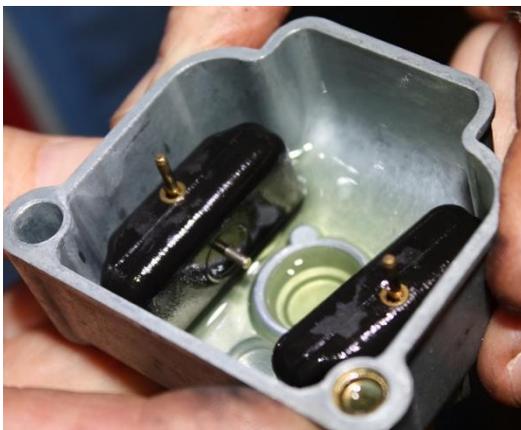
Thereafter, the bowl of each carburettor was carefully removed paying particular attention to avoiding fuel spillage. The fuel quantity in the left hand carburettor bowl was abnormally low and the right hand carburettor fuel level was worse, showing a much lower fuel level. The extremely low fuel level in both carburettor bowls could explain the engine stoppage. No other anomaly was found in the carburettors.

Figure 5: low fuel level

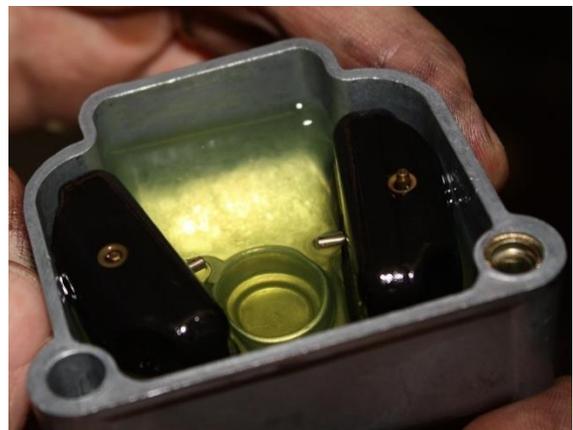
Then, the carburettors and their fuel lines were reassembled and the electrical fuel pump was operated for 1 minute. Reopening of both carburettor bowls could determine that the level of fuel was significantly higher than previously observed, each carburettor showing an identical fuel level. This could conclude that the engine loss of power was due to an insufficient fuel feeding of the carburettors.

Figure 6: normal fuel level, after feeding

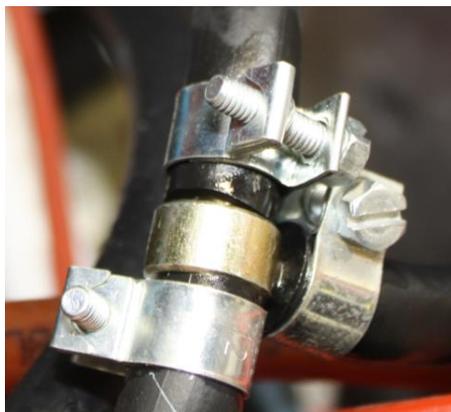
Just after the above test of the electrical fuel pump, a thorough inspection of all fuel lines and fuel line connections found a fuel leak indication (sweating) at the tee connection located before the electrical fuel pump.

Figure 7: tee fitting connection showing a sweaty leak

A lack of sealing in the suction side of the fuel system will cause the fuel pumps to pump air, or a mixture of air and fuel, instead of liquid, reducing the fuel flow capacity of the system.

Further palpation of the 3 fuel pipes and clamps at the tee fitting increased the fuel leak and found that the leaking rubber pipe clamp was not properly tightened.

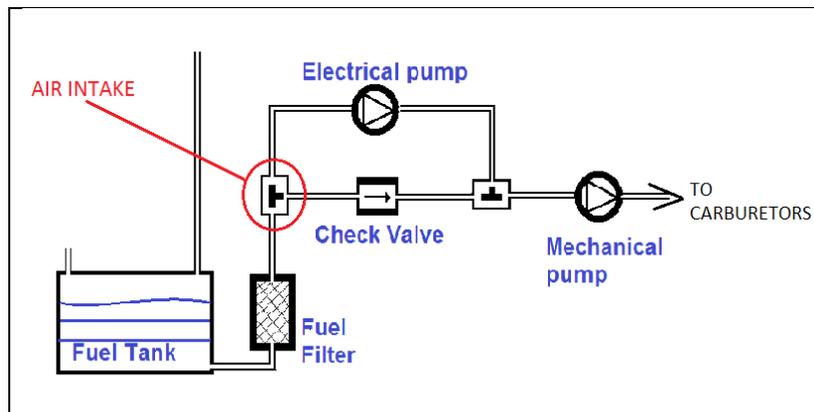
Figure 8: Position of the leaking tee fitting connection

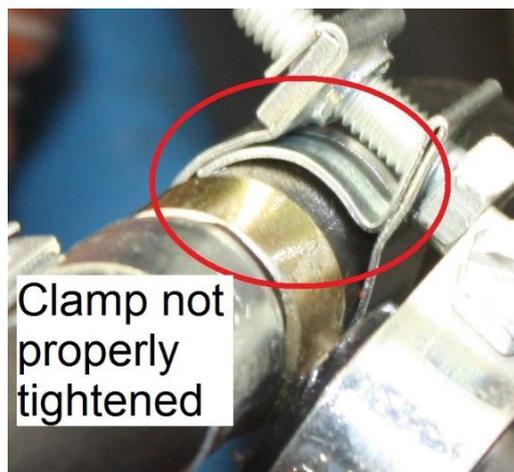
After removal of the clamp, a closer examination of the rubber pipe where the clamp was located showed no obvious sign of clamping in the rubber material (not any deformation of the rubber).

Examination of the two other clamps of the same tee fitting found the same anomaly. This suggests that the clamps had not been properly tightened during initial installation and subsequent inspections failed to identify the situation

Figure 9: gap between the clamp and the rubber pipe.

The cause of the accident is an engine stoppage resulting from a fuel starvation due to a false air intake at a tee fitting connector located at the suction side of the fuel system. The air intake occurred as a consequence of a fuel pipe clamp not being properly tightened.

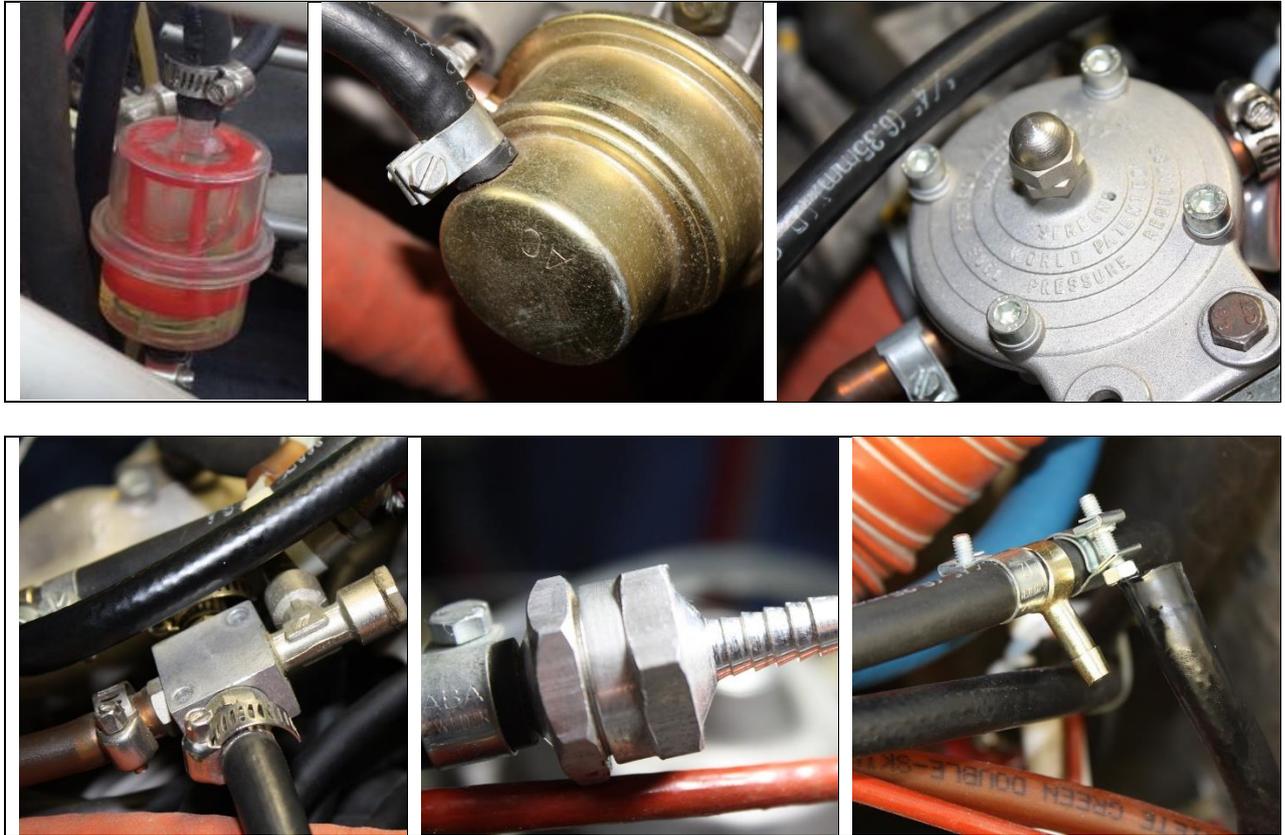
Examination of the fuel system showed that there was no standardisation in the fuel connectors showing different shapes and diameters and in the hose clamps.

Figure 10: pictures showing different clamp and connection types.

The use of a large variety of clamps and connectors may be conducive to a possible inadequacy between the different connectors and the pipe used and prone to maintenance errors in particular regarding the size of the clamps and the way to tighten it.

The measurement of the fuel lines and their connectors showed several discrepancies owing to a mismatch of metric and English units (inner diameter of the rubber line is 6.35mm while the outer diameter of the mechanical fuel pump connection is only 6mm ...).

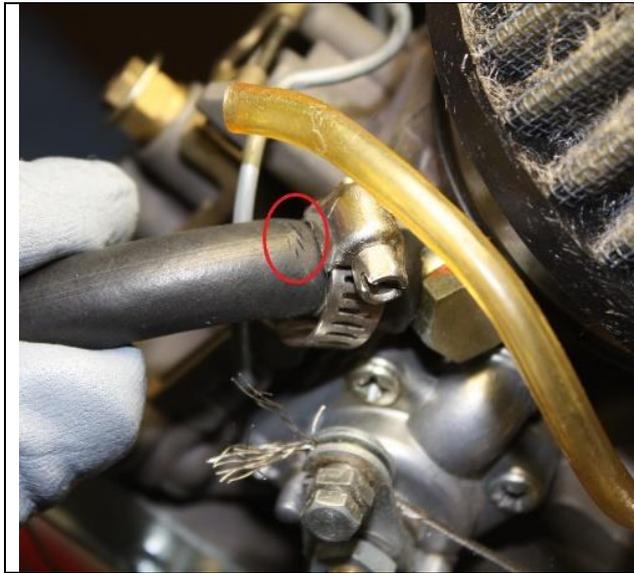
The identification markings printed on some rubber lines show the cure date 6 September 2007, the inner diameter 1/4" (6.35mm) and a reference to the SAE standard 30R7-KX. According to ULM maintenance organizations renowned for their competence, it is common (good) practice to renew the rubber lines every 3 or 4 years depending on the material quality and the condition of use. Actually, the installed rubber lines were already 7 years old and showed ageing cracks in some places.

Figure 11: cracks in a rubber line

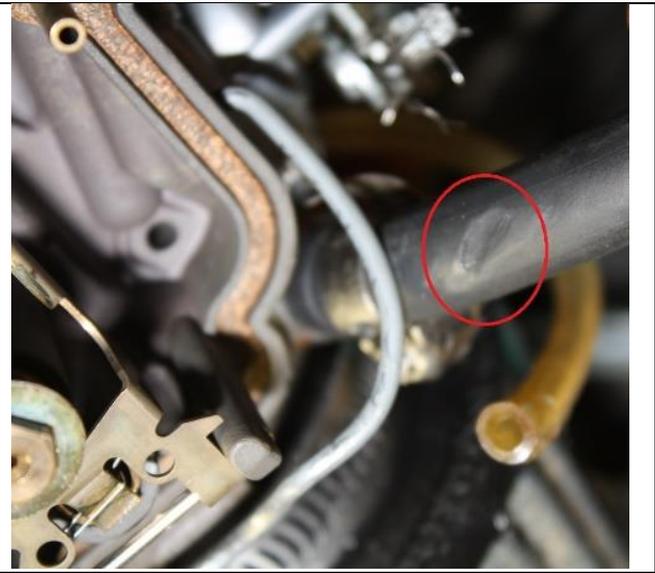
Defects such as traces of fraying in the rubber material were also found in a few places.

Figure 12: traces of fraying in a rubber line
