Safety Investigation Report

Ref. AAIU-2015-10
Issue date: 22 March 2016
Status: Final

Aircraft: Cameron Balloons Ltd, model Z-210, msn 11265. The balloon is registered in Belgium and holds a Certificate of Airworthiness, delivered by BCAA, Belgium and an Airworthiness Review Certificate (ARC), valid until 03 June 2016.

Abstract:

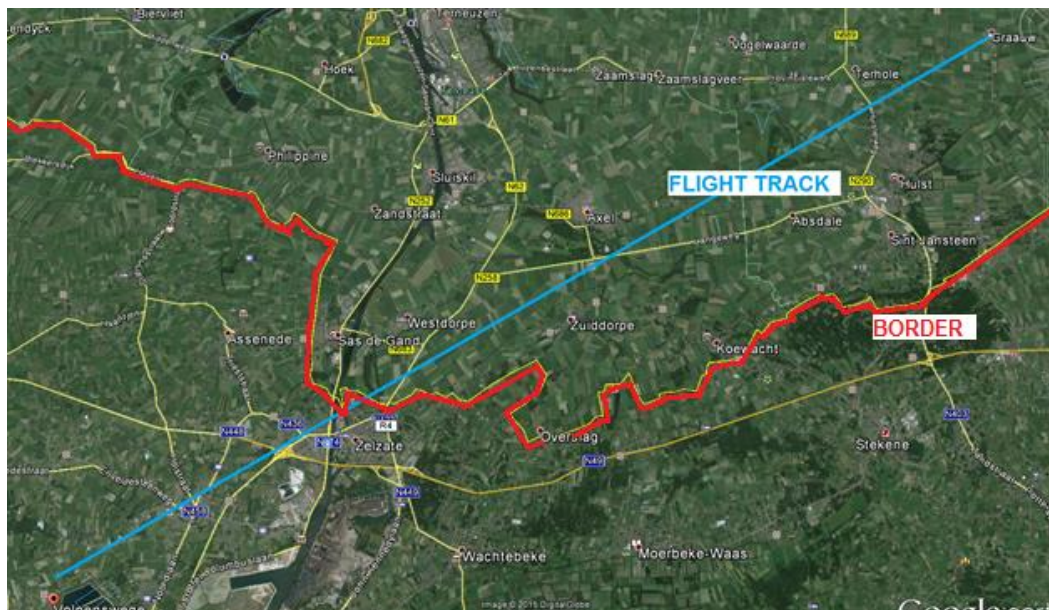
Figure 1: Flighttrack

During the flight, the wind speed was higher than originally planned and the pilot decided to cross the canal Gent – Terneuzen. After the crossing, the pilot decided to look for a landing area, and decreased the altitude. In Sleidinge, Belgium, the pilot found an area suitable for landing.

The pilot stated “he did not want to miss the chosen landing place and, after crossing an electrical line on the northern side of the field, decreased rapidly the altitude.

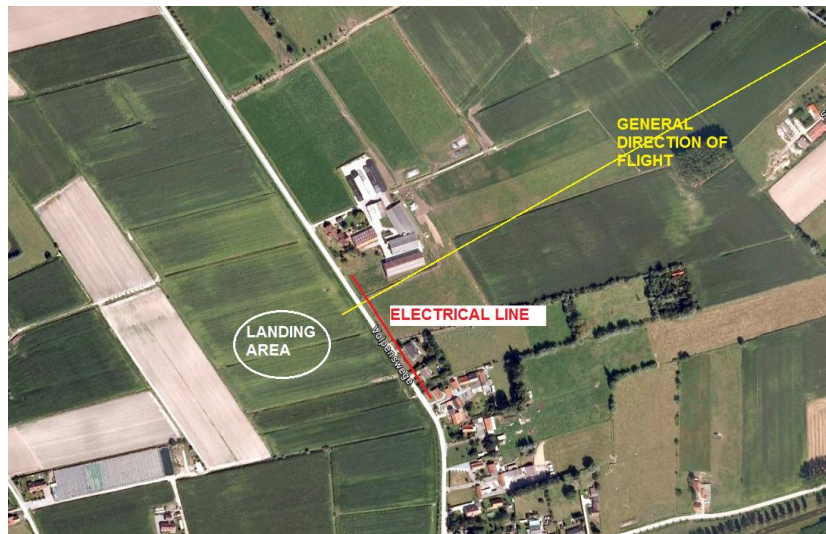
Figure 2: Crash area

The contact with the ground was hard, the pilot lost his balance and fell forward. The basket tilted and the pilot got partially caught under the basket.

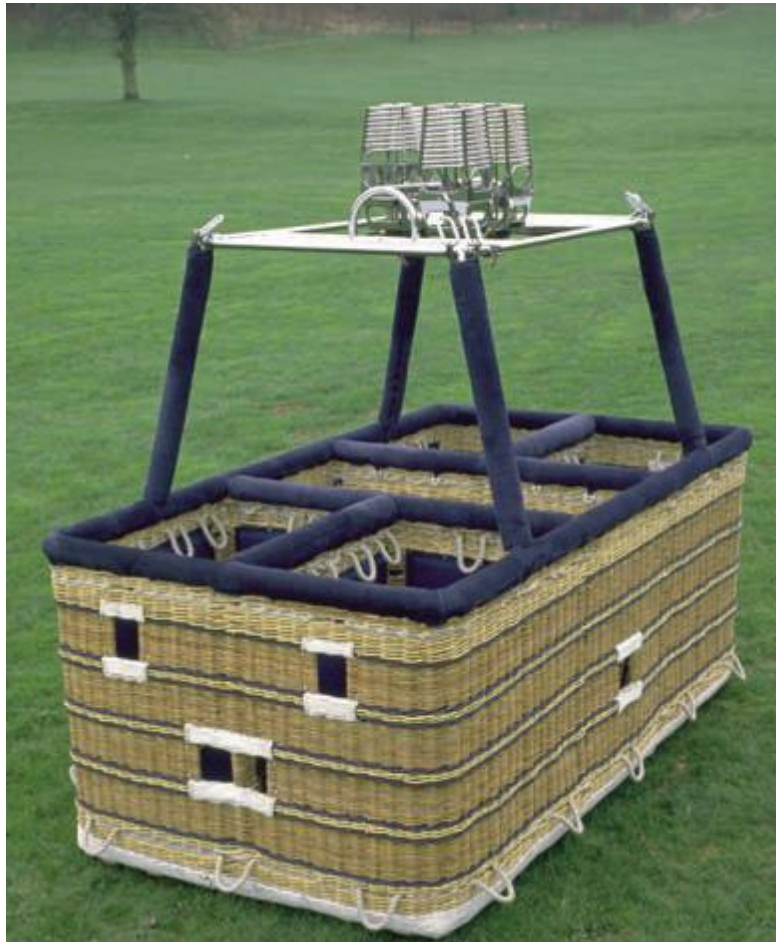
Figure 4: Basket

The pilot wore the restraint harness, as prescribed by Cameron (combination of CB-0929-5001 strap and CB-0929-5002 belt) but not secured at the correct place. The harness was clipped to an anchor point located upwards (instead of an anchor point fitted on or near the floor of the basket).

Although he was wearing a restraint system, it was not secured at the correct place. The harness was clipped to an anchor point located upwards (instead of an anchor point fitted on or near the floor of the basket. This didn't prevent him to be thrown outside the basket.

During landing, the pilot had the harness attached to the sides of the basket, instead of having it secured to the bottom of the basket. This caused the pilot to be ejected outside of the basket during a hard landing.

The balloon operator took immediate corrective action recommending to all their pilots to use the pilot restraint harness and to secure it to an anchor point at the bottom of the basket. This in order to restrict the vertical movement of the pilots and lower the risk to have him ejected from the basket during landing.

It is recommended that the Balloon Federation of Belgium addresses a note to all Balloon pilots to advise them of the good practice to use the pilot restraint harness correctly during flight and in particular during landing, securing the harness to an anchor point at the bottom of the basket. This in order to restrict the movement of the pilots and lower the risk to have him ejected from the basket during landing.

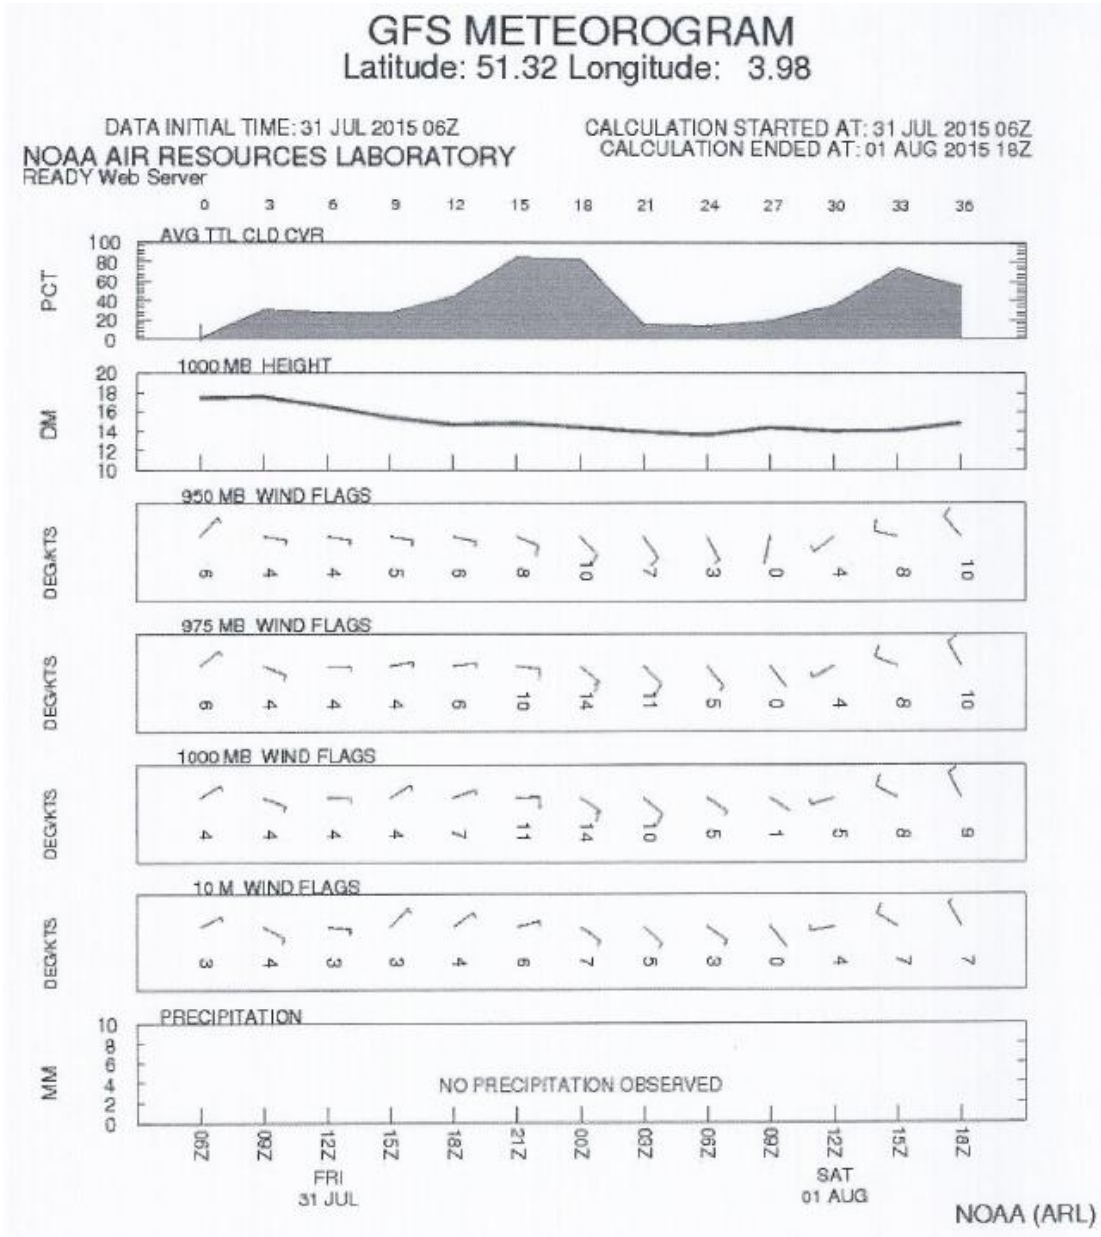
Figure 5: Meteogram

060 degrees during the flight

020 degrees during the landing.
