# Safety Investigation Report

Ref. AAIU-2015-14  
Issue date: 20 August 2016  
Status: Final

<b>Classification:</b>	Accident
<b>Level of investigation:</b>	Desk investigation
<b>Date and time:</b>	20 August 2015 – 10:05 UTC
<b>Aircraft:</b>	Cessna 172M msn 17265655. The airplane is registered in the Netherlands
<b>Owner:</b>	Private
<b>Accident location:</b>	On a taxi track on the airfield of Brasschaat (EBBT)
<b>Type of flight:</b>	General aviation – Cross country (international)
<b>Phase:</b>	Take-off
<b>Persons on board:</b>	One pilot, one pax
<b>Injuries:</b>	None

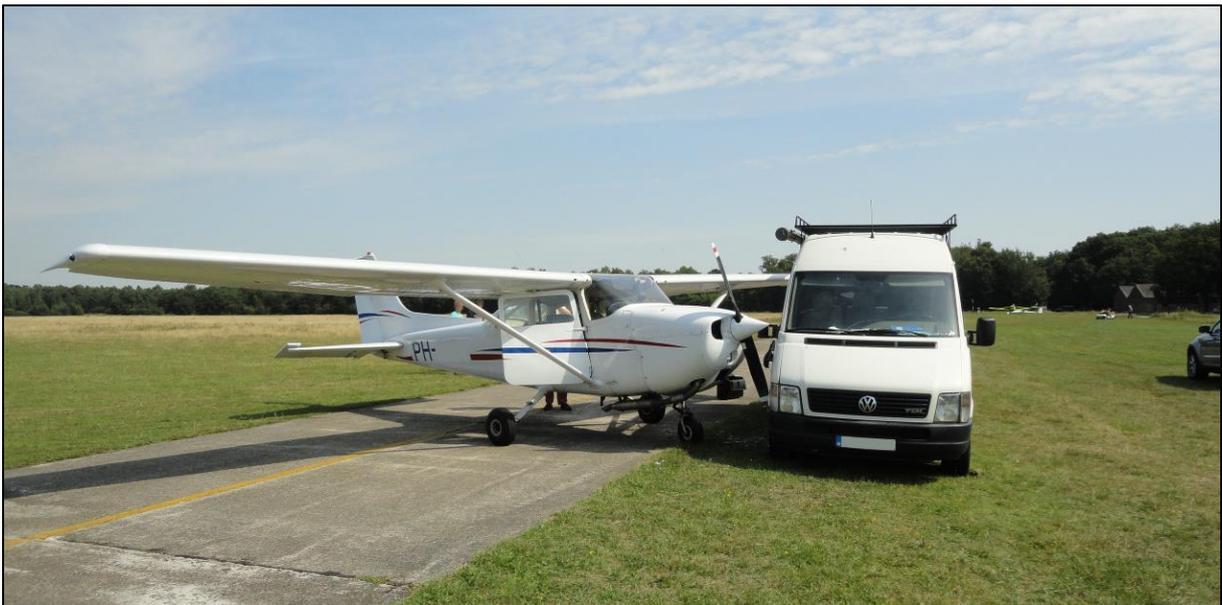
The pilot did not spot another van standing at 1 m from the left edge of the taxiway. The left wing tip of the aeroplane hit the van, swivelling the aeroplane to the left. The propeller hit the right flank of the van. Nobody got hurt.

Figure 1: The situation just after the collision

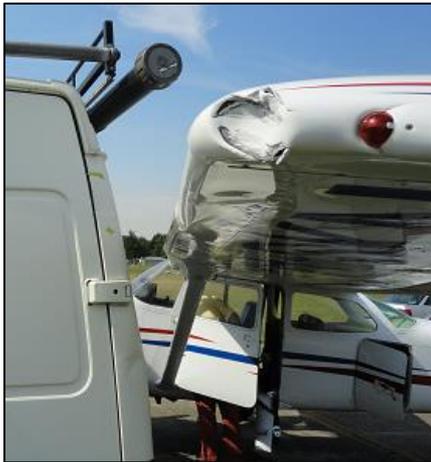
Impact damage to the left wing tip and leading edge, and subsequent deformation damage to the rear spar.

Figure 2: damaged wingtip

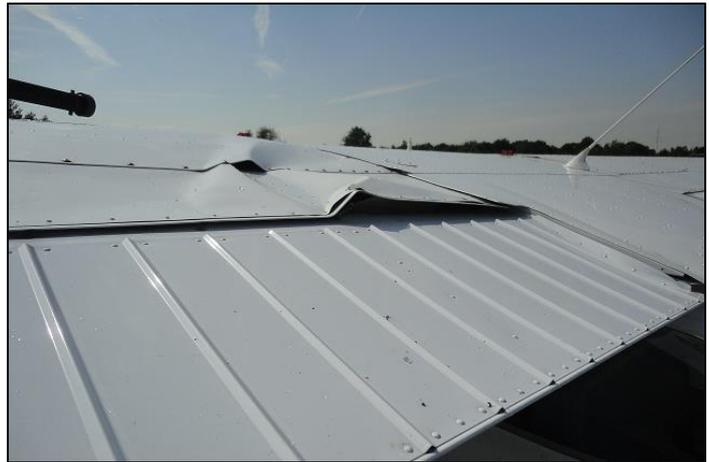
Figure 3: damaged upper skin and structure

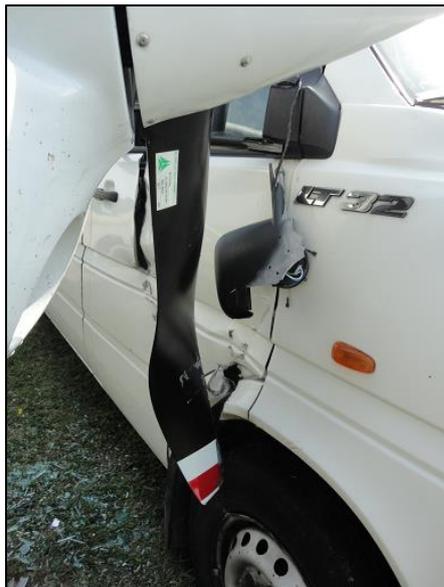
The propeller was also damaged.

The main damage of the van is on the right side; the propeller cut in the right door and the rear view mirror.

Figure 4: Damage to propeller and the van

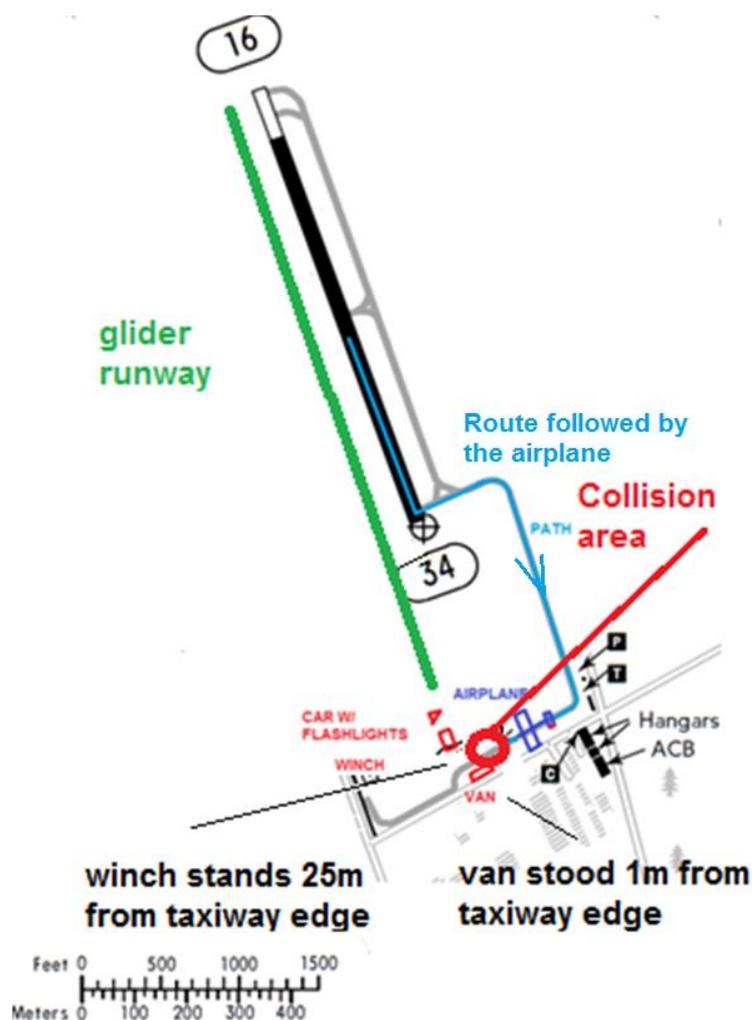
Figure 5: Situational sketch

The aeroplane taxied further, in what is known as “the reserved glider” area and where vehicles and gliders are positioned, with no particular attention to the taxiway, “as no aeroplane goes that far”.

The attention of the pilot was distracted by the activity around the winch, located 25m from the edge of the runway, on the aeroplane’s right. A van stood closer to the taxiway edge, on the left, and the pilot did not see it.

The BCAA (Belgian Civil Aviation Authority) issued circular GDF 04 *Private aerodromes* in which amongst others is stated that no fixed installations may be placed within 15 m from the centerline of taxiways. It would be a good and safe practice by the users of the airfield to also follow this rule for mobile and/or temporary obstacles.

It is recommended the Aeroclub Brasschaat improves the signalization of the EBBT taxiway in order to prevent uncontrolled access of airplanes in the zone dedicated to gliders.

It is recommended the Aeroclub Brasschaat issues instructions to the airfield users aimed to ensure that the taxiway remains clear of obstacles.
