Safety Investigation Report

Ref. AAIU-2016-04

Classification:	Accident
Level of investigation:	Standard
Date and time:	07 May 2016 at 18:16 UTC
Aircraft:	Sailplane Alexander Schleicher ASK-13 SN: 13244.
Owner:	Private
Accident location:	Saint-Hubert Airfield (EBSH)
Type of flight:	General aviation – Flight training – Local solo
Phase:	Landing
Occurrence type:	Abnormal runway contact (ARC)
Persons on board:	One pilot
Injuries:	Pilot seriously injured

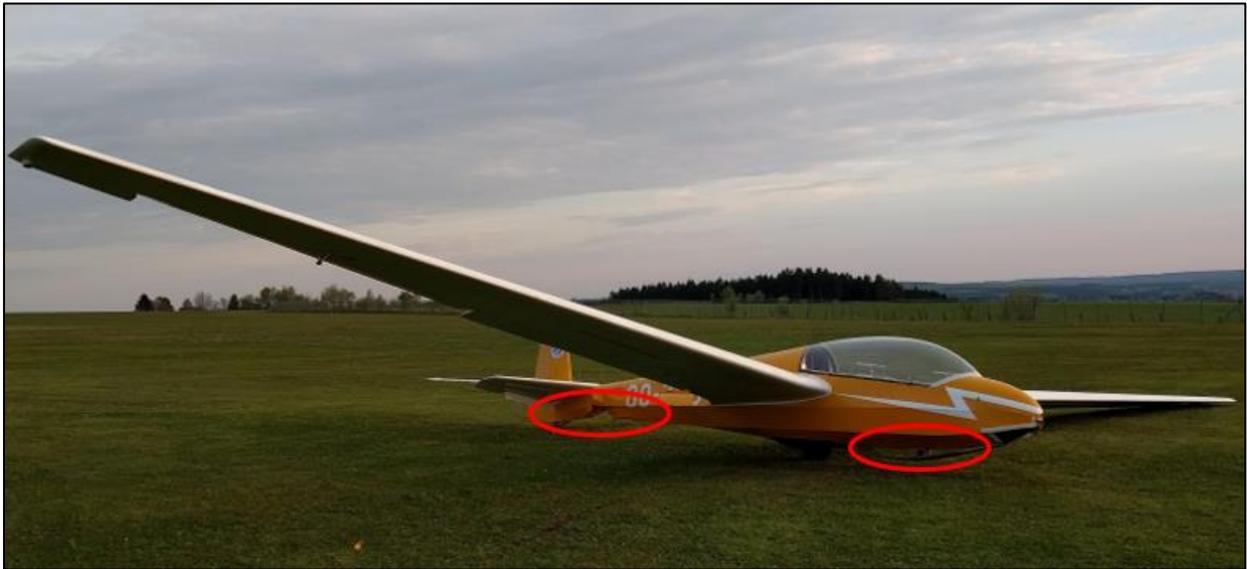
The structure of the sailplane was substantially damaged at the front underside of the fuselage and at the rear underside of the fuselage where the welded steel tube structure was severely deformed.

Figure 1: areas showing visible structural damages

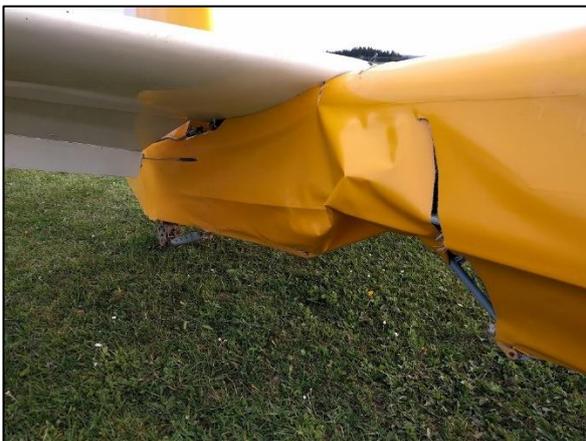
Figure 2: rear underside of the fuselage

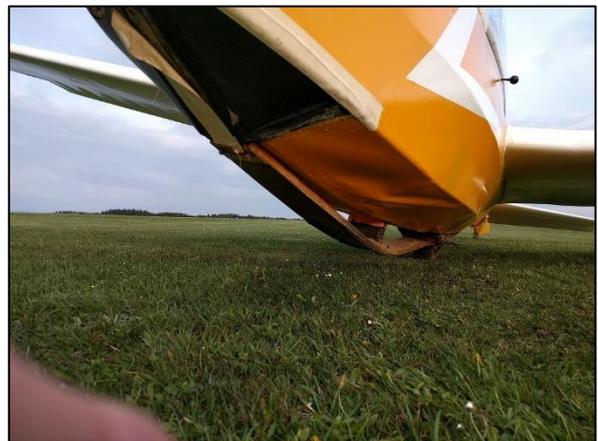
Figure 3: front underside of the fuselage

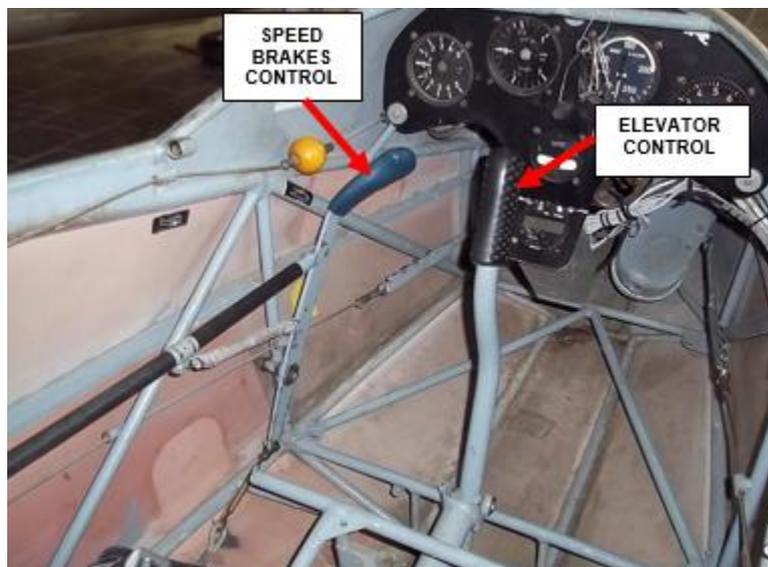
To extend the airbrakes, the control has to be pulled backwards; to retract, the control has to be pushed forwards, but no placard is available to show in which direction it works.

Figure 7: Elevator and airbrakes controls

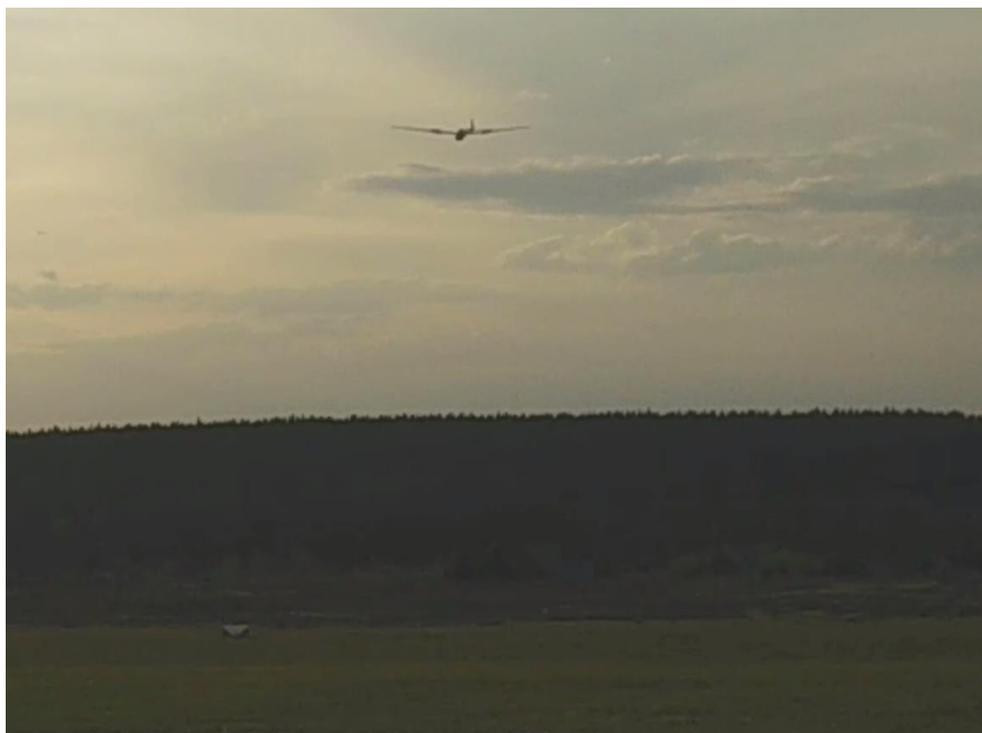
Figure 8: After 10 seconds, the airbrakes are clearly visible. They seem to be partially deployed.

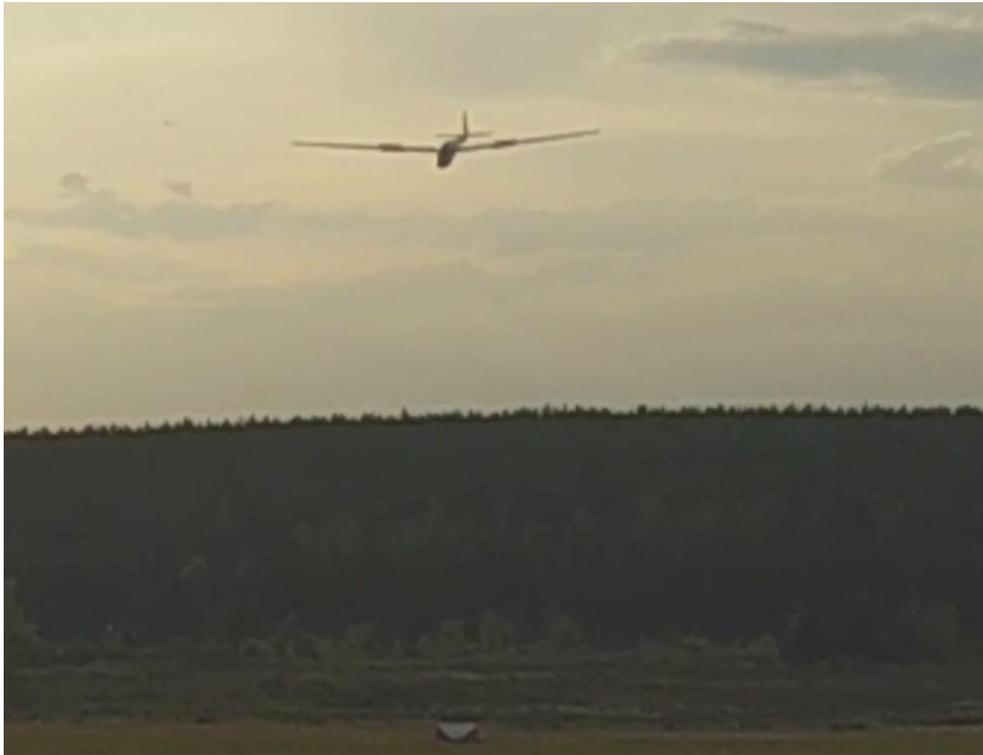
Figure 9: After 19 seconds, the nose down attitude is noticeably increased. No visible modification of the airbrakes' position.

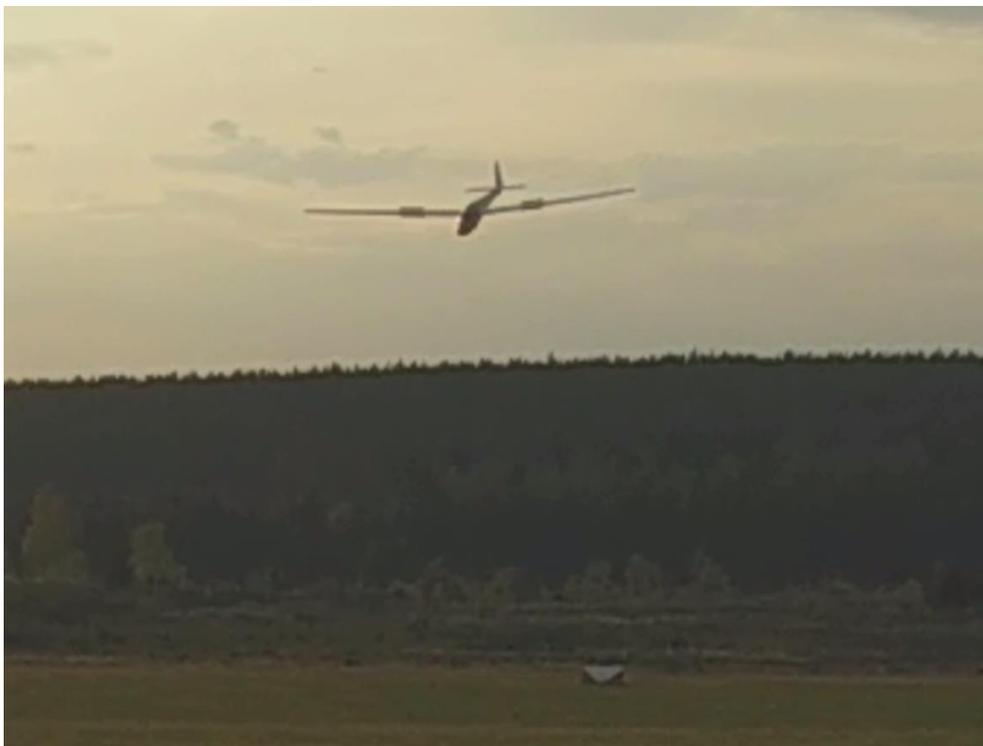
Figure 10: One second later (time 20), when flying at approximately 20 – 30 metres AGL the air brakes are more deployed.

Immediately after, the rate of descent increases, suggesting that the pilot tries to recover the correct approach glide path and/or airspeed. He likely modified the glide path first by pushing forward on the elevator control and one second later, at time 20, by extending the airbrakes further.

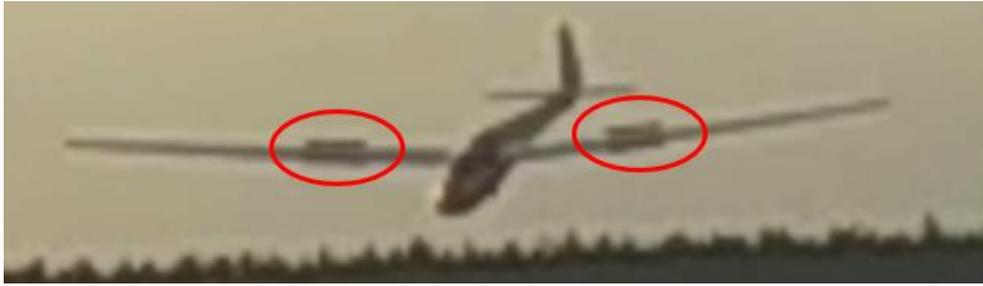
Figure 11: After 21 seconds, an enlargement of the picture allows a light grey line to be seen between the upper skin and the top airbrakes, indicating a full deployment.

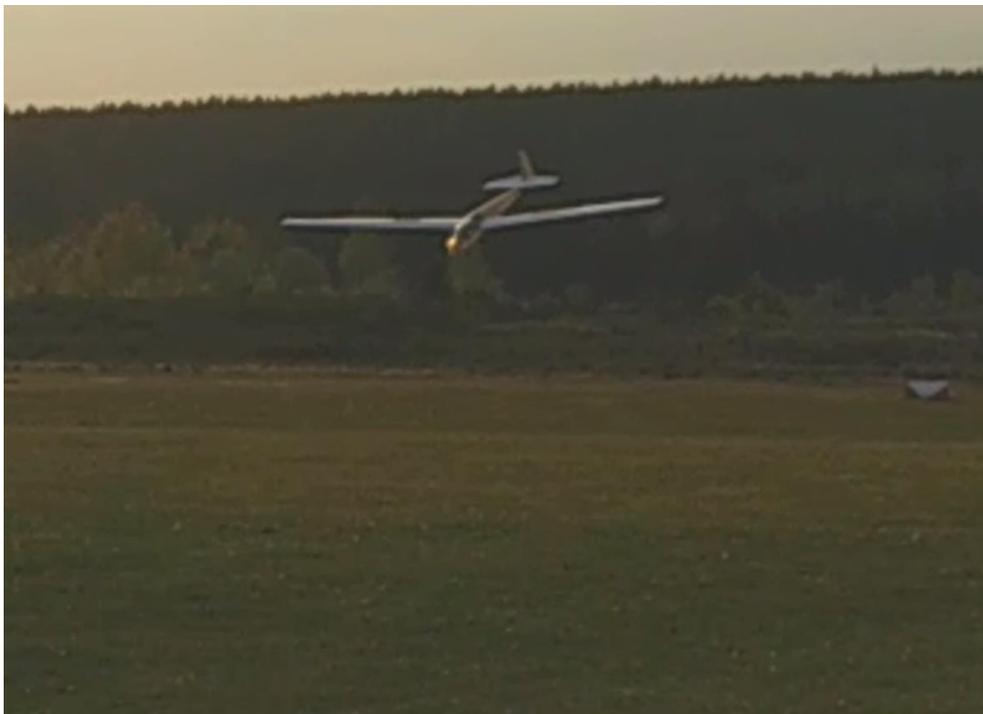
Figure 12: After 22 seconds, last useable picture in flight: the pitch down attitude seems to be again increased for a fraction of a second just before impact. No visible attempt to flare.

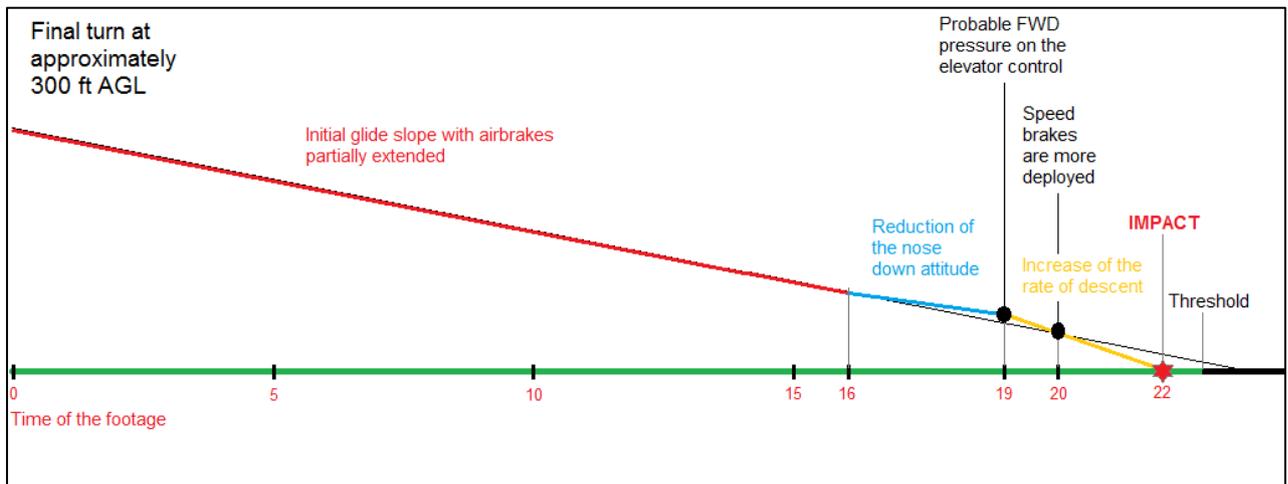
Figure 13: Approximate (not on scale) view of the glide path

The instructor stated that following his observation made from the ground, the entire flight, including the major part of the final leg, had been very well performed by the student pilot. He also stated that the initial glide path, in red on the above figure, was adequate to land a little further than the threshold, at the typical place where the students are trained to touch down. It is only in very short final that the flight started to go wrong.

At the end of the final, the footage shows a reduction of the nose down attitude between time 16 and 19 (in blue on the graph). The investigation could not determine whether the pilot slightly pulled back on the elevator control, maybe in order to land a little further on the runway or whether it was due to another phenomenon (pilot action on the elevator trim, meteorological etc.).
