Safety Investigation Report

Ref. AAIU-2016-25
Issue date: 20 June 2018
Status: Final

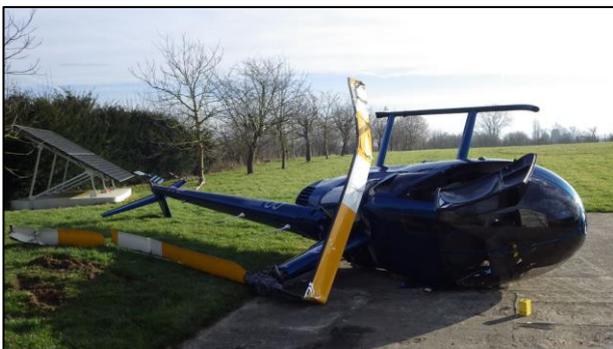
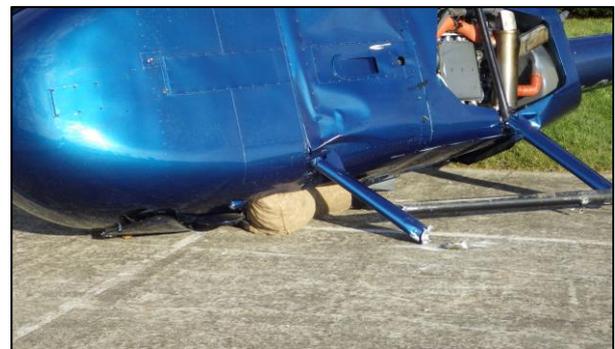
Figure 1: pictures showing damage to the helicopter and the burlap bag involved

The accident was caused by a loss of control at low altitude, further to a heavy bag, not adequately secured, falling on the cyclic column and impeding its movement.

Safety restraint systems which have to a certain degree freedom of extension and movement should never be used to secure cargo, in particular when they could interfere with the flight and engine controls. If cargo is to be transported on a regular basis, the aircraft manufacturer should be contacted to seek for advice.
