Safety Investigation Report

Ref. AAIU-2017-AII-05
Issue date: 9 November 2017
Status: Final

Classification:	Accident
Level of investigation:	Standard
Date and time:	8 April 2017 at 11:50 UTC
Aircraft:	JODEL D 92 "Bébé" homebuilt aeroplane
Owner:	Private
Accident location:	Airfield of Tournai / Maubray - EBTY
Type of flight:	General aviation - Local
Phase:	Take-off
Occurrence type:	Loss of control - inflight (LOC-I)
Persons on board:	One pilot – Not injured

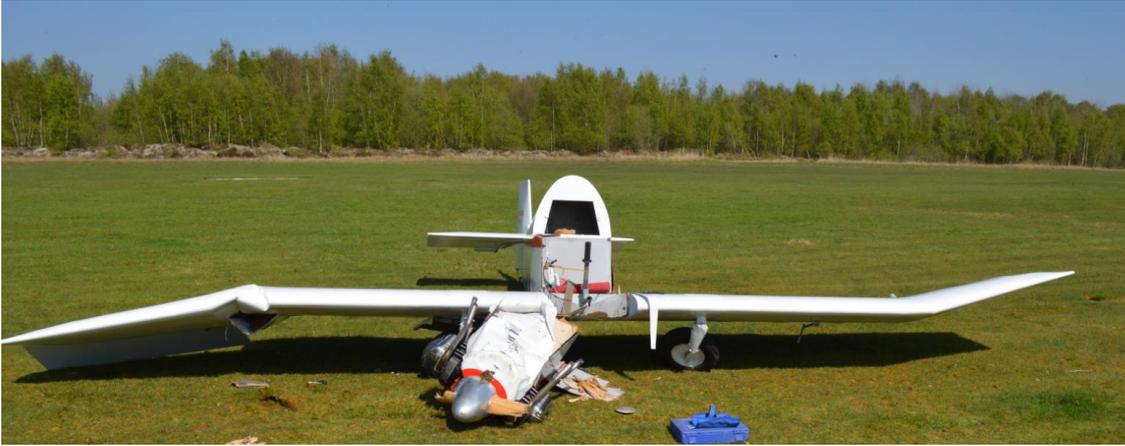
Figure 1

The aeroplane stalled in a right turn movement and violently hit the ground at about 200 m from the threshold of the runway. The right-hand wing tip hit the ground first, followed by the main landing gear and finally the engine and propeller. On the ground, the aeroplane rotated to the right with respect to its flight direction and came to a stop about 20 m from the initial ground contact. Due to the shock, the front section of the fuselage, including the engine, the firewall and the fuel tank separated from the fuselage. There was no fire.

Damage

The aeroplane was significantly damaged.

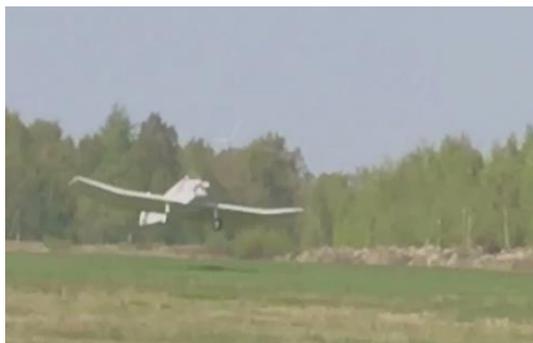
Figure 2:
00:00 - normal pitch up attitude

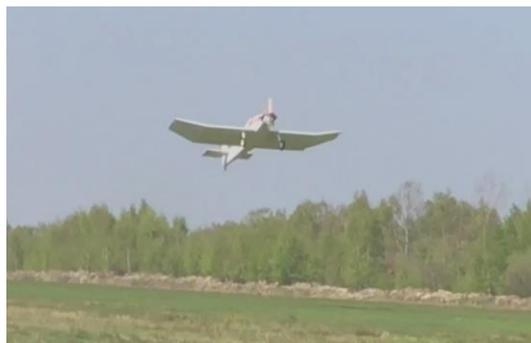
This situation was clearly initiated by an excessive angle of attack during the first phase of the climb. The airplane did not reach the required best rate of climb speed after lift-off and remained at low airspeed close to the stall speed.

Figure 3:
00:02 - excessive pitch up attitude

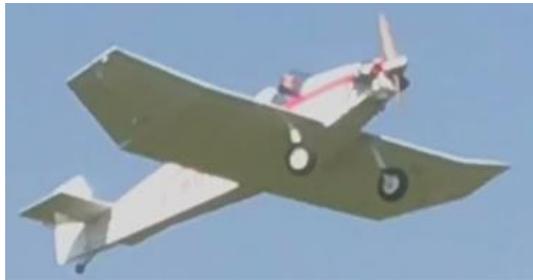
Figure 4
00:06 - The aeroplane is flying at a height between 10 to 20 metres. Last moment of high nose up attitude. No visible elevator deflection

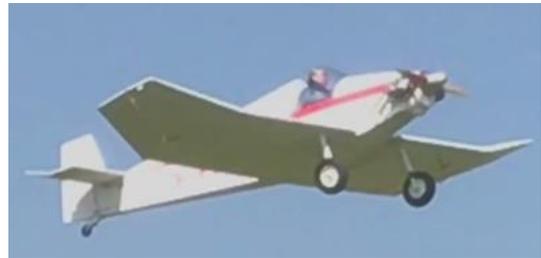
From that time, the pitch up attitude decreased, the aeroplane entered in a stall and rapidly lost height. The observation of the video shows that the pilot's reaction was to pull on the elevator control. Immediately after, the aeroplane entered into a nose down right turn, likely being the incipient phase of a spin. The pilot fully deflected the ailerons to counteract the right turn in an attempt to recover a horizontal attitude. His reflex exacerbated the situation by amplifying the asymmetric stall, inducing a spin. The aeroplane was totally out of control.

Figure 5:
00:06: Begin of the stall: the pitch up attitude is decreasing, prompting the pilot to pull on the elevator control.
The aeroplane develops a sink rate.

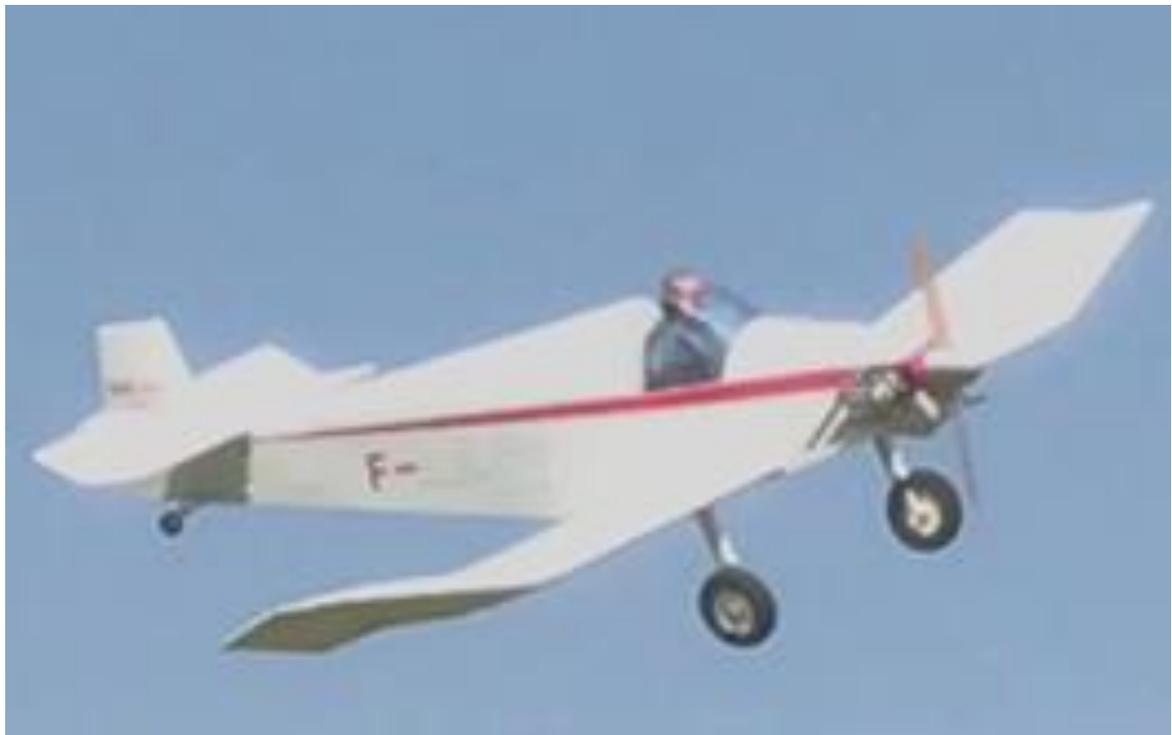
Figure 6
00:08: Full nose up action on the elevator control. The aeroplane begins a right turn stall. The ailerons are fully deflected in a reflex to attempt recovering a horizontal attitude.
