Interim Statement

Ref. AAIU-2017-04

Date and time:	5 February 2017 – 09:48 UTC
Aircraft:	Airbus A330-343 msn284
Date of Manufacture:	Oct 1999
Type of engine:	2 x RR Trent 772B-60
Event location:	Brussels Airport (EBBR)
Type of flight:	Commercial - Passenger
Phase:	Take-off
Injuries:	None
Occurrence type:	System/Component Failure or Malfunction (Non-Powerplant) (SCF-NP)

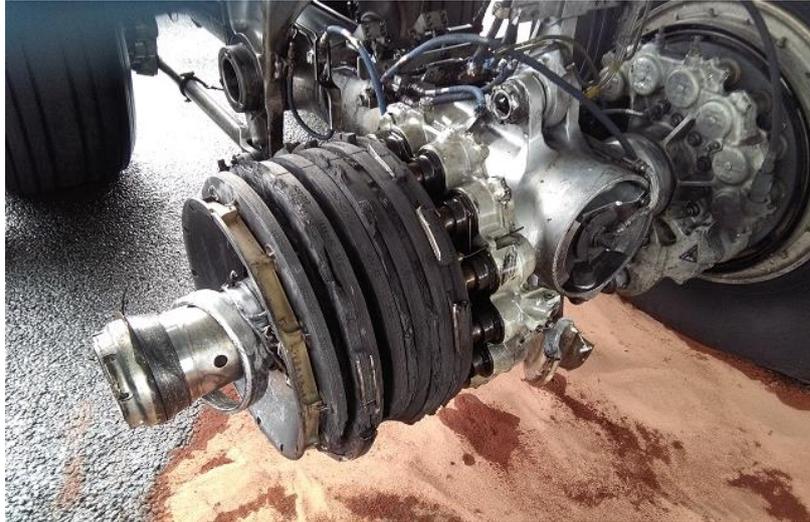
The forward right wheel of the RH Main landing gear was missing, remained only the axle and the brake. A separated half of a half wheel rim was still present. The hydraulic lines were cut, and fluid was leaking.

Figure 2: Damage on the RH bogie

The failure of the outboard roller bearing of wheel #4

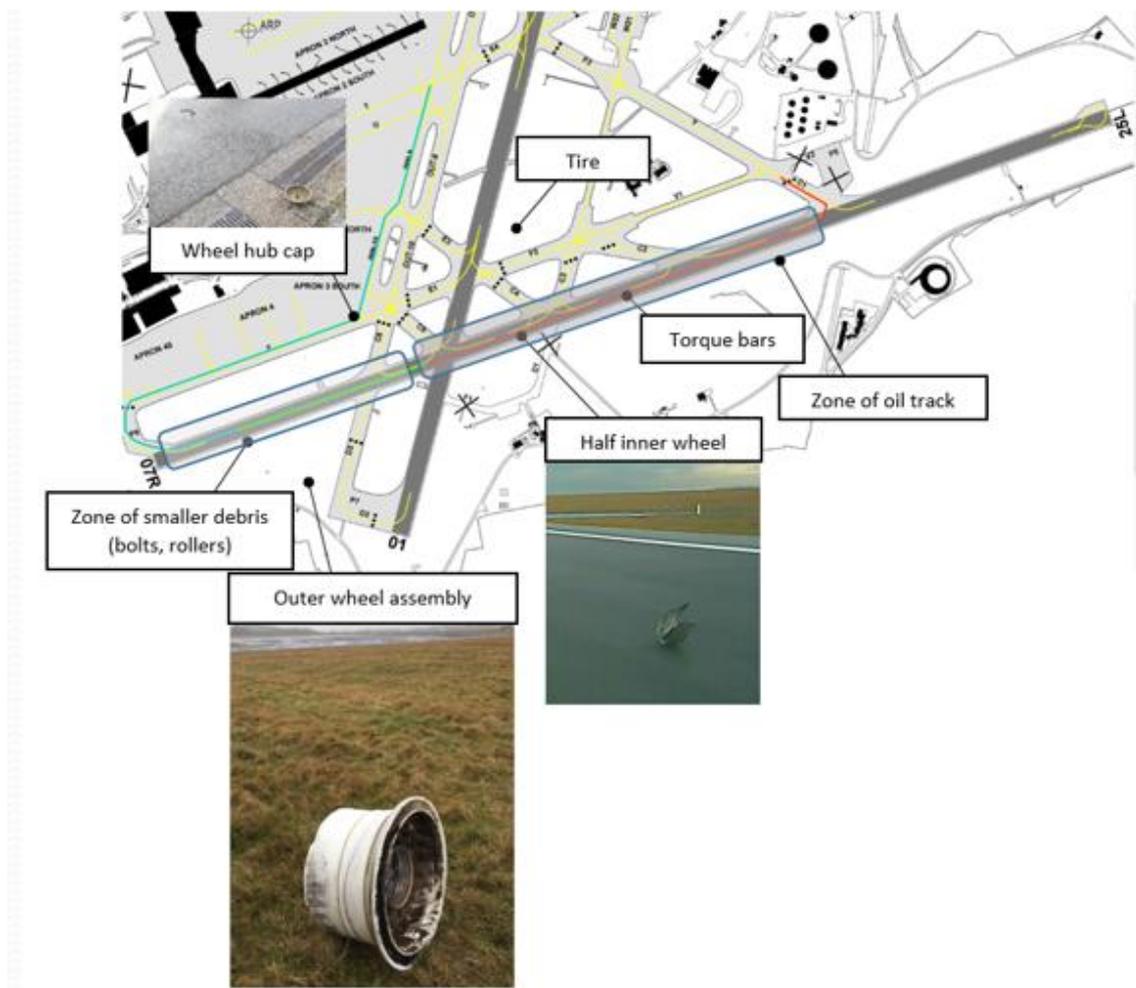
The first part found on the ground was the axle cover. It was found on taxiway Zulu, more or less at the same point the airplane was taxiing when smoke was first spotted. (turn between OUT 10 and Zoulou).

Small parts, including some coming from the bearing (rollers,..) were found on Runway 07R, from the start of the runway up to H. From that point, further towards the half length of the runway, bigger parts were found, including a half wheel rim between intersection C3 and C2.

The tyre was found nearly intact in the grass located right side of runway 01 north of F2.

Figure 3: Location of the wheel debris
