Interim Safety Investigation Report

Ref. AAIU-2015-12

Aircraft: Diamond Aircraft Industries DA-42 msn 42-252. The aircraft was registered in France and held a Certificate of Airworthiness, delivered by DGAC, France on 03 September 2010 and a valid Airworthiness Review Certificate (ARC), valid until 03 September 2015

At the end of a navigation flight, the airplane with one instructor and a student on-board, was performing a go-around, followed by a one-engine out exercise. When landing on runway 24 of EBCI, the crew realised the landing gear was not extended. The airplane landed on its belly.

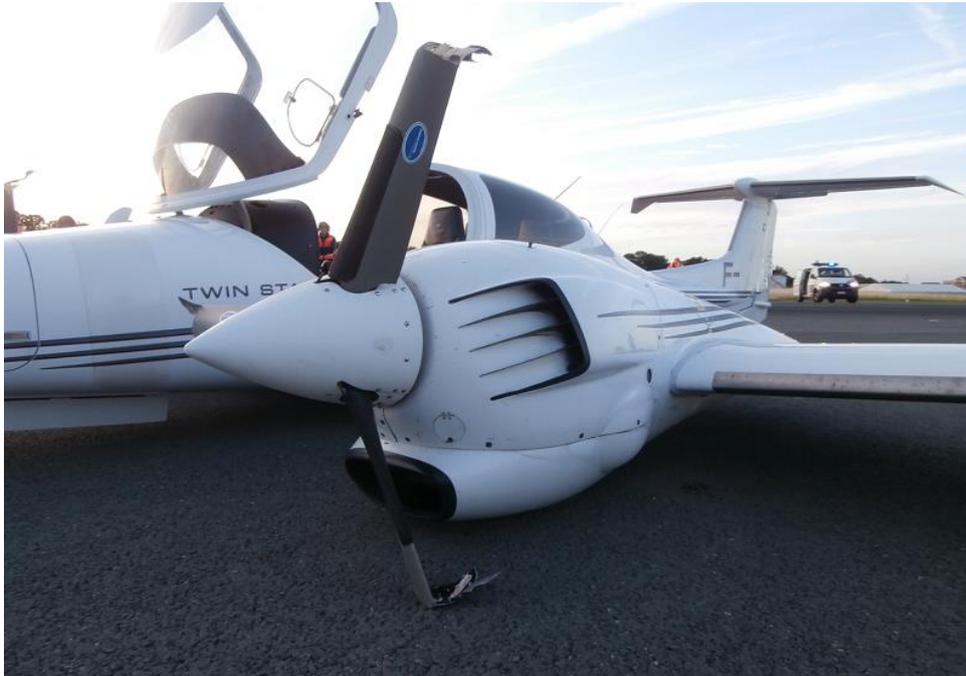
- Damaged left engine propeller blades:
 - o All blades fractured from the original 78cm length, the remaining length of the blades were respectively: 54, 51 and 51 cm.

- o All three propeller’s rubber boots were still attached.
- Damaged right engine propeller blades:
 - o All blades fractured from the original 78cm length, the remaining length of the blades were respectively: 52, 51 and 50 cm.

- o All three propeller’s rubber boots were still attached.
- No obvious trace of friction wear on the lower external surface of the engine cowling.
- Worn out damage on the exhaust pipe of the left and right engine.

- Deformation due to overheat of the lower external cowling in the immediate vicinity of the exhaust pipes (both engines)
- Worn out damage on the left foot step. The step itself was separated and found on the runway.

- No damage on the landing gear doors
- Lower central Com antenna was undamaged
- Friction grit on the tail skid.

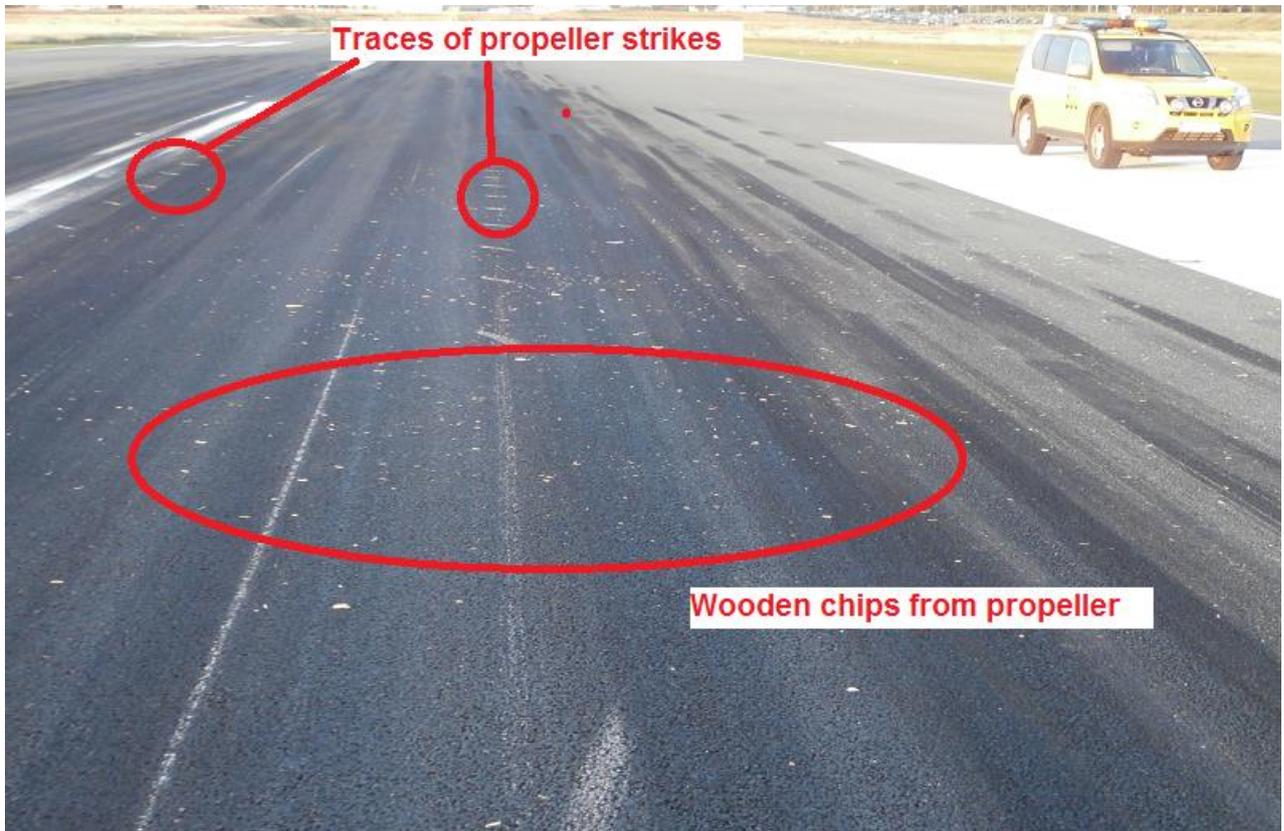
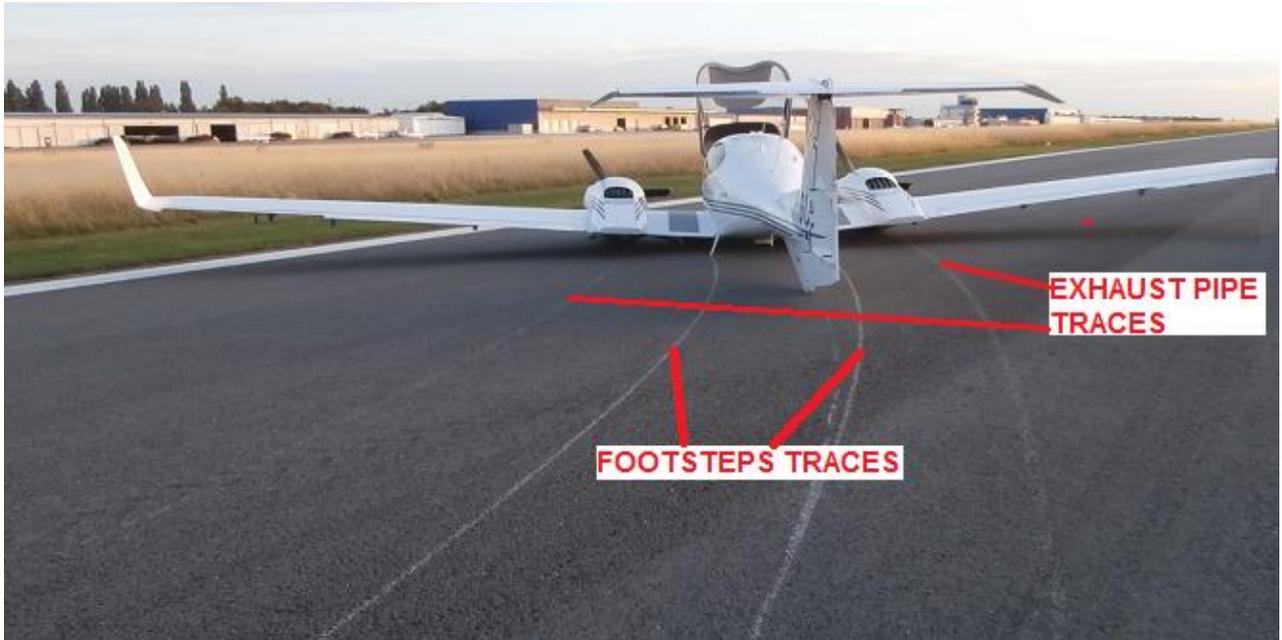
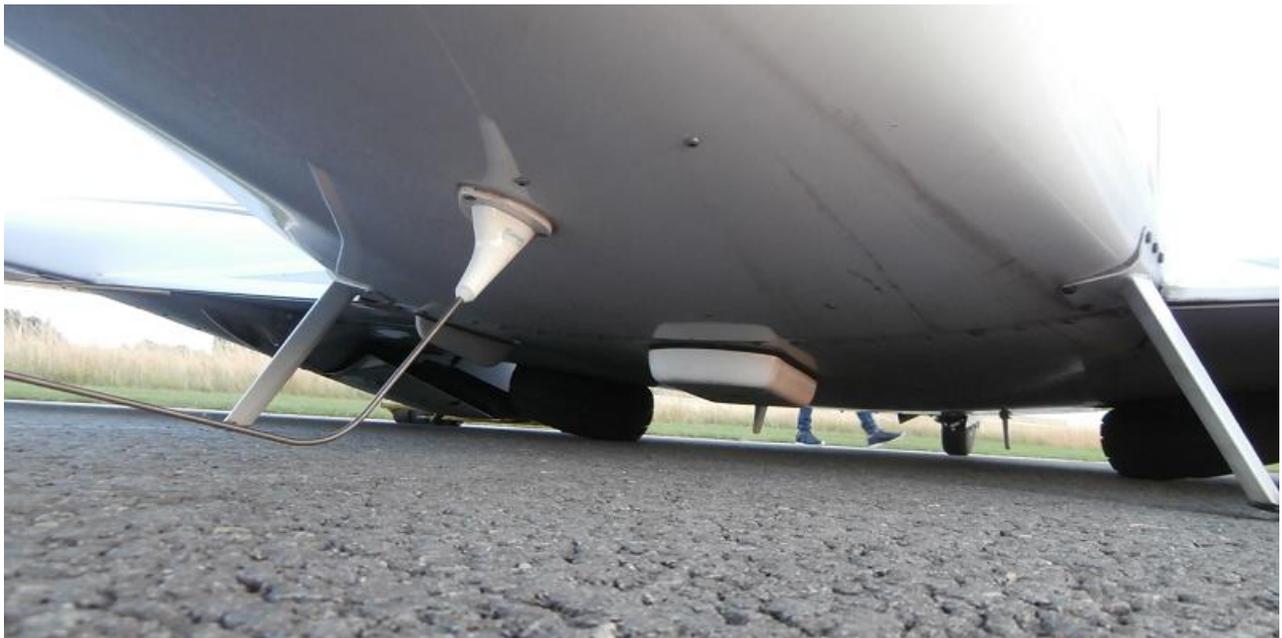
Impact information

The crew reported that the belly landing was remarkably smooth. The airplane skidded on the two footsteps, the two engine exhaust and the tail pad. It stopped after 300-400m.

The wooden propeller blades of the two engines were grated.
