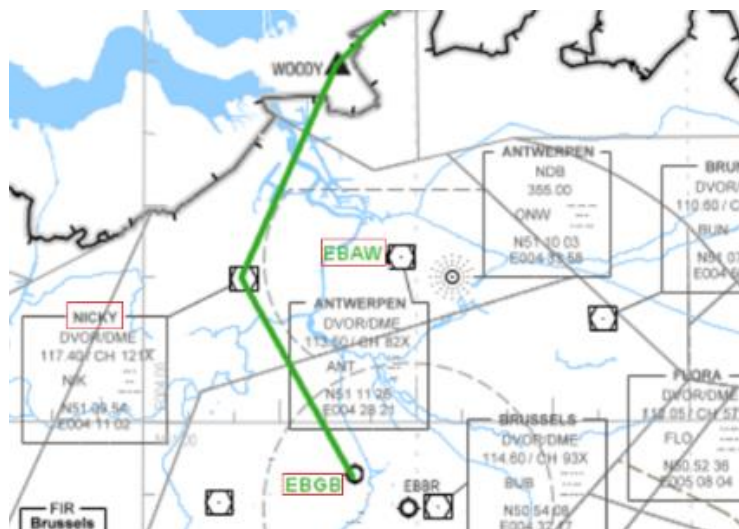
Figure 1

departure. The pilots were told that due to the intermittent instrument meteorological conditions (IMC), EBGB was closed and that it was highly probable that it would remain closed that day. The aerodrome forecast (TAF) at Brussels (EBBR) predicted a visibility of 6 km and a ceiling of 1400 ft for the 30 hour period starting from 12:00 UTC, with a temporary deterioration to a visibility of 3 km (thus IMC) and ceiling of 600 ft in the period between 12:00 UTC and 21:00 UTC. Nevertheless, they departed at 13:45 UTC from EHGG for a two-hour flight, with EBAW as a destination alternate in case the weather wouldn't improve. Flying inbound VOR NICKY, still under IFR, the pilots listened to the ATIS recordings of EBAW which stated that RWY11 was the active runway. Reportedly, it was approximately at the same time that the pilots noticed that the DME display (distance measuring equipment) was inoperative. Because the Instrument Approach Chart (IAC) for RWY11 states that DME is required, the pilots determined that landing in EBAW was neither possible nor safe (as the vicinity of the built-up area of Antwerp) and that continuing to EBGB was the best option. According to them, the weather was slightly improving (although still IMC).
