# Landing in IMC on an uncontrolled aerodrome

Issued by the Air Accident Investigation Unit of Belgium, section of the FPS Mobility and Transport

Issue 1 / June 2018 – Original version

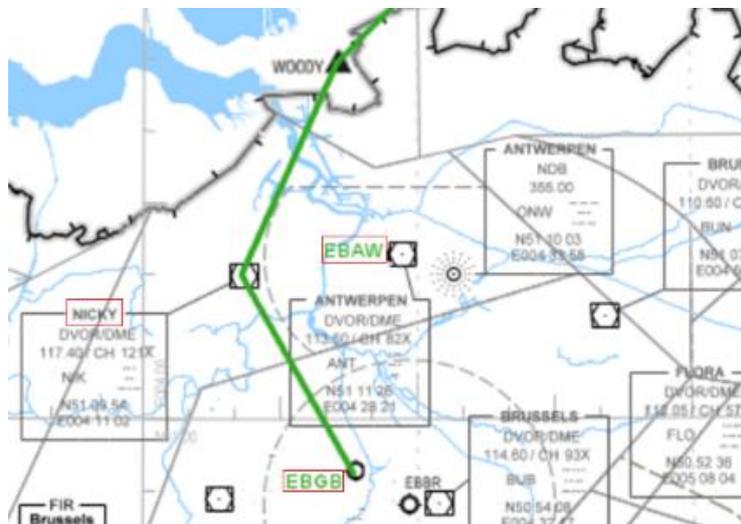
Figure 1

Outbound NICKY, they were asked by 'Brussels Control' to report when they wanted to cancel the IFR flight. About one minute later the crew made a 'PAN PAN' call with as reason an 'erratic instrument' and they stated their intention to land at EBGB. They got the instruction to leave the frequency and to contact 'Grimbergen Radio'. According to the pilots, the last leg from LONDI to the aerodrome of EBGB was flown lower than normal (normally 900 ft AMSL) but both the vertical and horizontal visibility were good. The landing was uneventful.

Reportedly, the failure of the DME display was intermittent and already known by both the operator (club) and the pilot flying the aircraft that day.
