Report on the investigation into the
Marine Casualty
on board the LPG Carrier mts “EUPEN”

with the loss of life of a crew member, at
PORT KHALIFA, ABU DABI on
12 February 2015

Independent Unit

September 2016

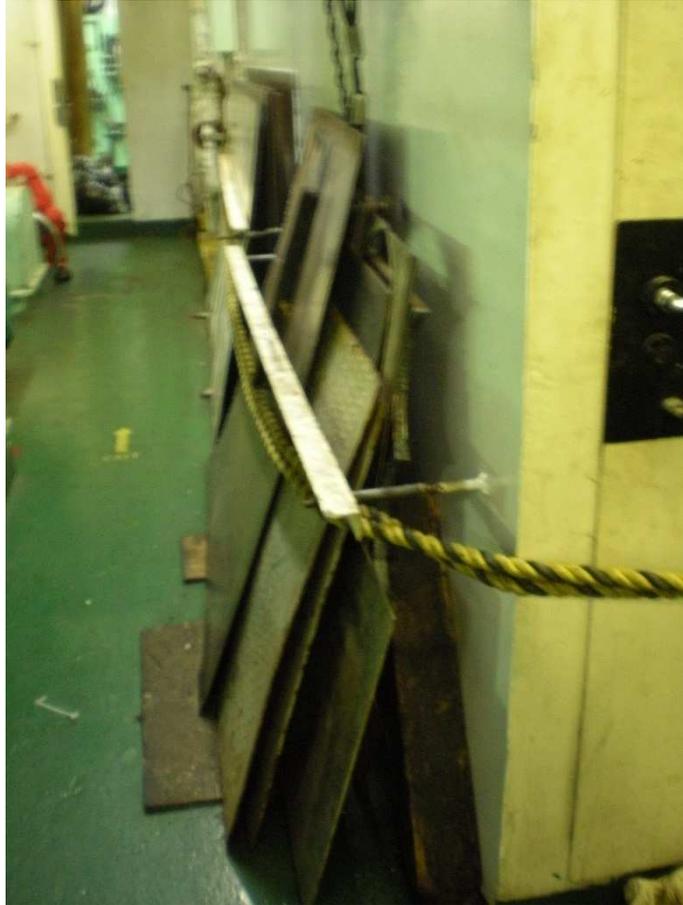
Figure 1 - Normal stowage position of steel plates in engine room

One crew member was tasked to release the angle bar, that was used to secure the metal plates in position, so that the metal plates could be stored with the rest of the metal plates already in place. The crewmember tasked with releasing the angle bar, proceeded alone to the stowage location and, removed the nuts holding the angle bar in position, as seen in Figure 1 on page 6.

A crewmember started to remove a bolted angle bar which is used to keep metal plates secured in place, as seen in Figure 1 on page 6.

The angle bar is secured by means of two threaded rods welded to the bulkhead onto which the angle was slid through two holes, one at each end of the angle bar. Threaded nuts were used to bolt and secure the angle bar tight to the metal plates.

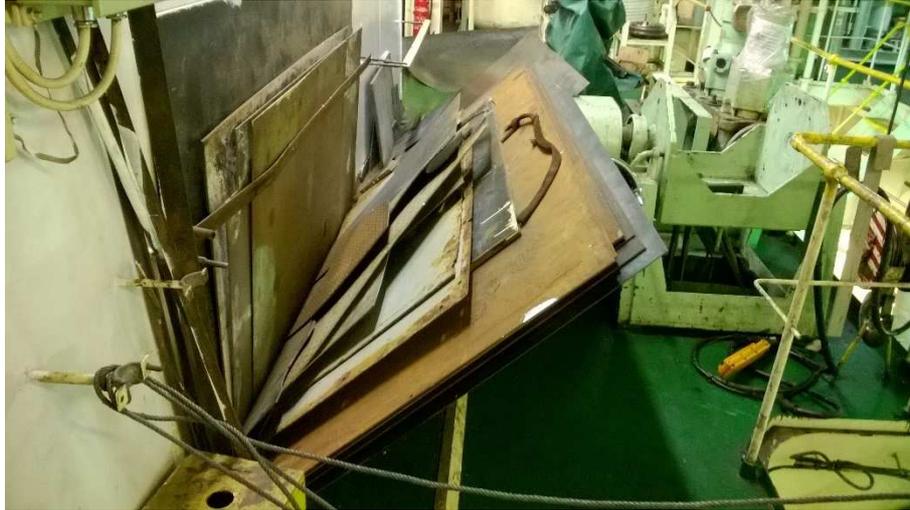
Soon after the securing had been removed the plates fell towards the crewmember.

Figure 2 - Fallen metal plates after securing nuts had been removed

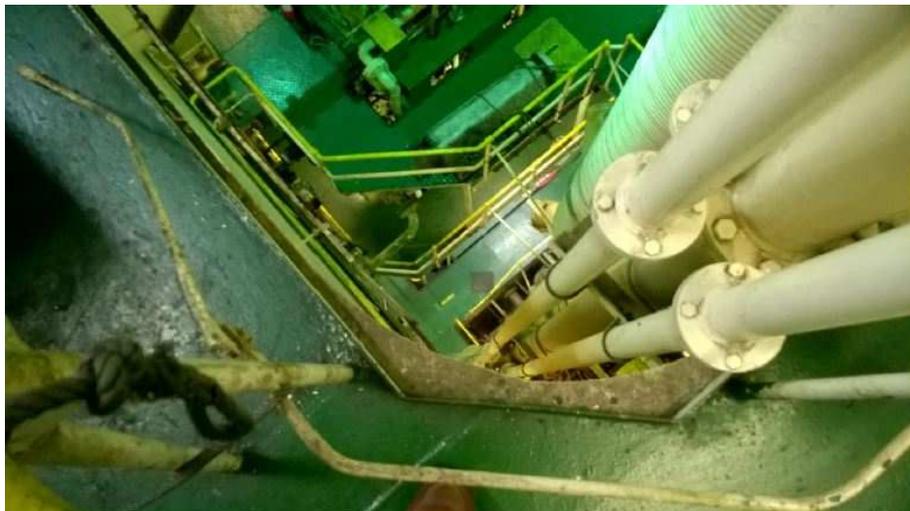
Figure 3 - Downward view of engine from platform

where crewmember fell off

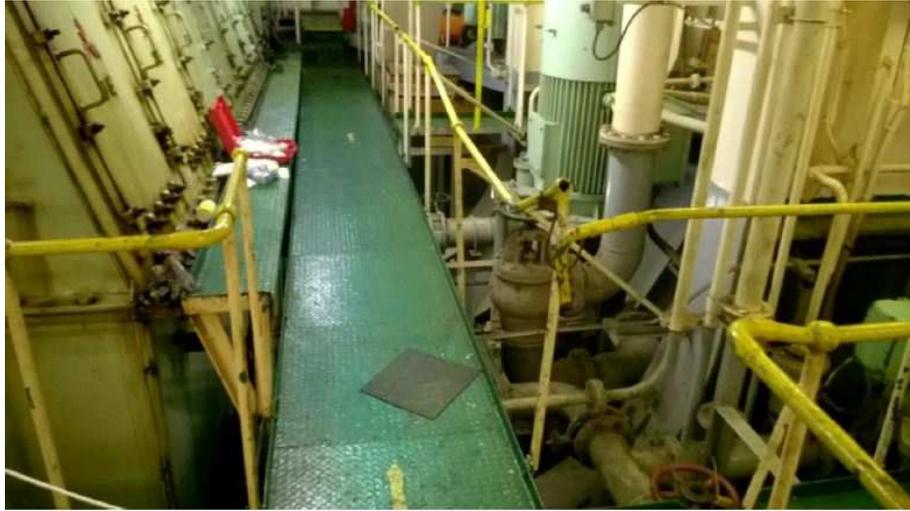
The dismantlable part of the railing gave way and the crewmember fell down into the lower part of the engine room of the mts "EUPEN", onto a railing surrounding a lower platform in the engine room of the mts "EUPEN", some 10 metres below as seen in Figure 4 on page 8.

Figure 4 - Area in lower part of engine room where crewmember fell onto

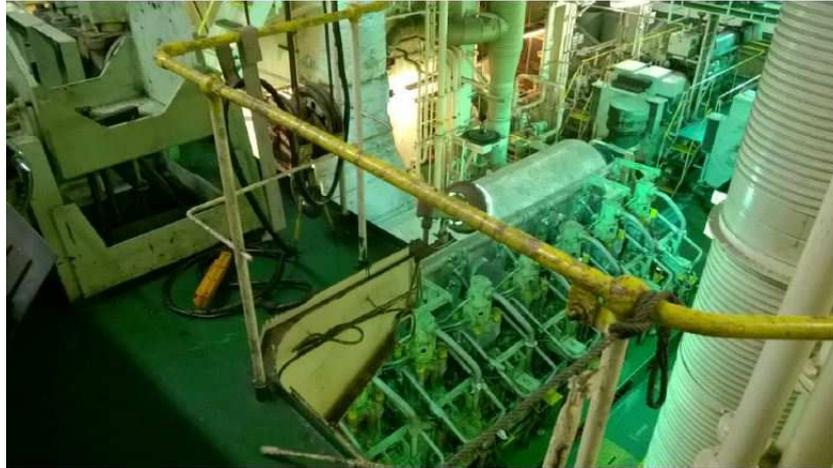
Figure 6 - Lower part of railing (loose) where crewmember fell onto

The lower section of the railing gave way under the impact from the crewmember's motion, and consequently the crew member fell onto a railing in the lower section of the engine room some 10 metres below the place of initial impact onto the dismountable railing.

- EXMAR Shipmanagement had issued a safety bulletin to have the integrity of the railings in the engine room of their managed ships assessed and where necessary repaired or brought back to their initial condition to prevent railings from giving way under the weight of a crewmember, i.e. accidental opening under.
- EXMAR Shipmanagement had the ways of stowing metal plates, on board their managed vessels, re-assessed and had necessary measures taken to prevent metal plates from falling over when being handled, considering the number of stowed plates, the size of the stowed plates, the location where metal plates are stowed and considering the orientation of the stowed plates and means of stowage

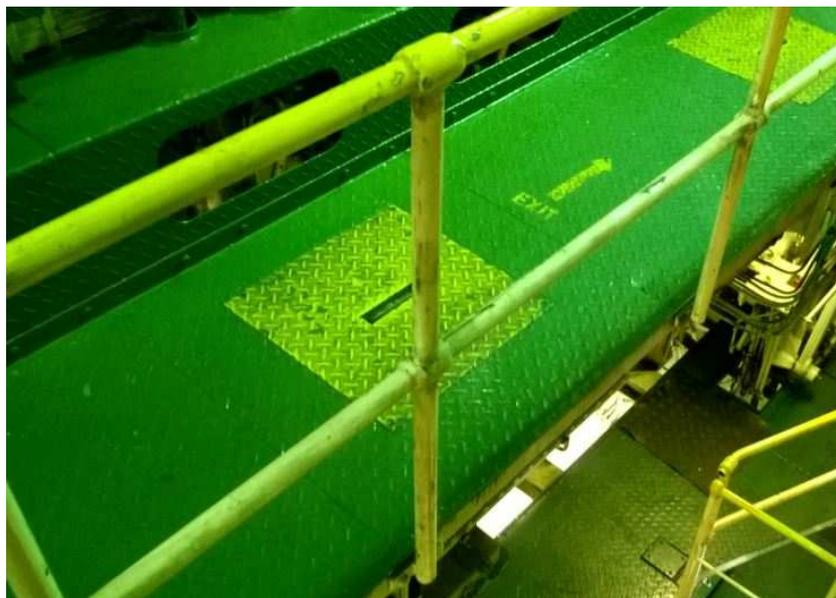
The fixed railings on the various platforms of the engine room of the mts “EUPEN” were all of similar construction. The fixed railing was built up with stanchions and two parallel rails. The top rail at the place of the incident consisted of a metal hollow tube of about 1 inch in diameter.

Both rails passed through holes in the various stanchions and were welded to the stanchions at said locations as seen on Figure 7 on page 6.

Figure 7 - Typical section of fixed railing in engine room of the mts “EUPEN”

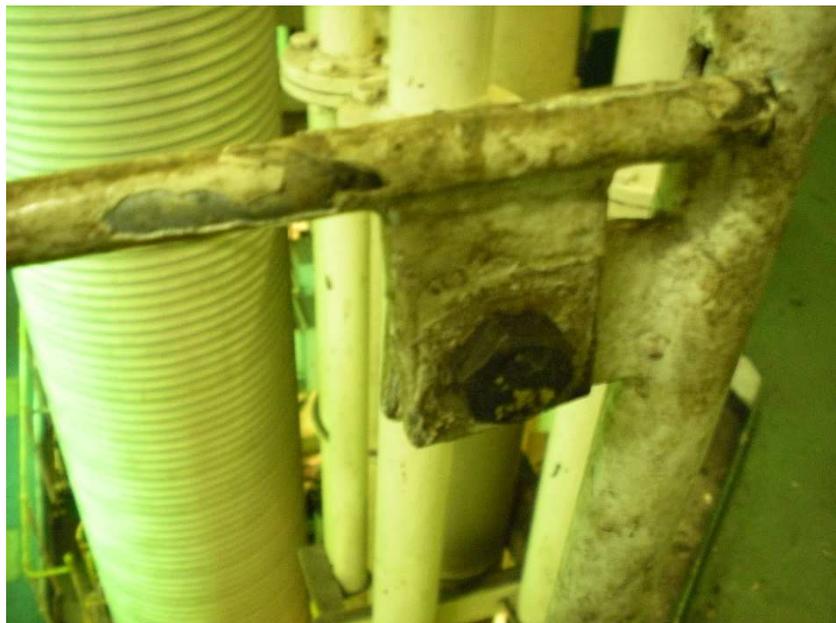
At the location the crew member fell onto the railing, an undersized bolt was being used as spigot for the hinge of the bottom part of the railing, allowing for the bottom part of the railing to move horizontally while being secured. Reportedly the bolt used as spigot was 5 mm undersize in diameter allowing for a consequential movement of 5 mm in the vertical plane.

Figure 8 - Bolt used as spigot for section of railing

The bolt used as spigot for the a section of the railing in way of the place where the metal plates were stowed was undersized, allowing movement of the railing.

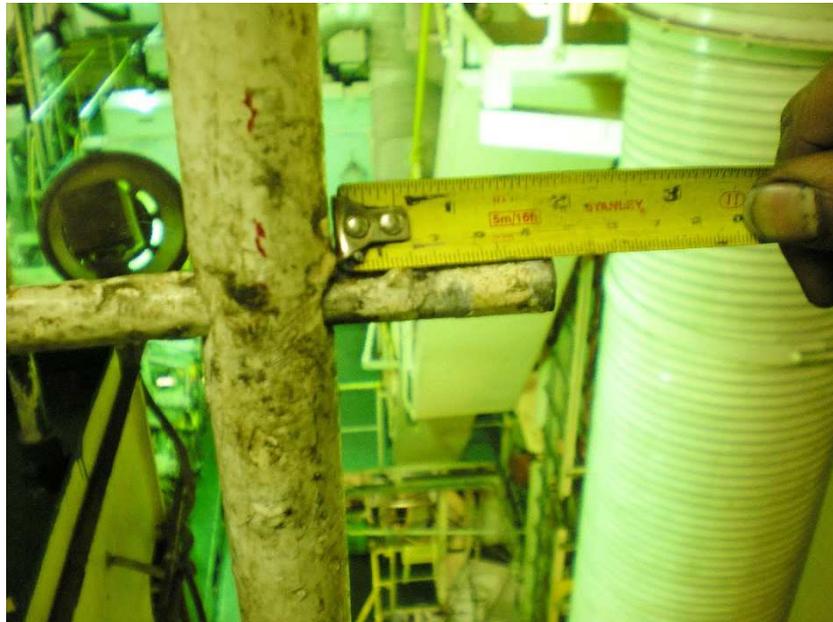
The tack weld, keeping the bottom rail in position had come loose, allowing for the bottom rail to move horizontally through the hole in the stangion over a distance of +/- 3,00 centimetres.

Figure 9 - Broken tack weld allowing for 30 mm horizontal movement

The condition of the railing, i.e. the broken tack weld in way of the removable section of the railing, allowed for excessive movement of the removable section of the railing without same section being loosened for removal.

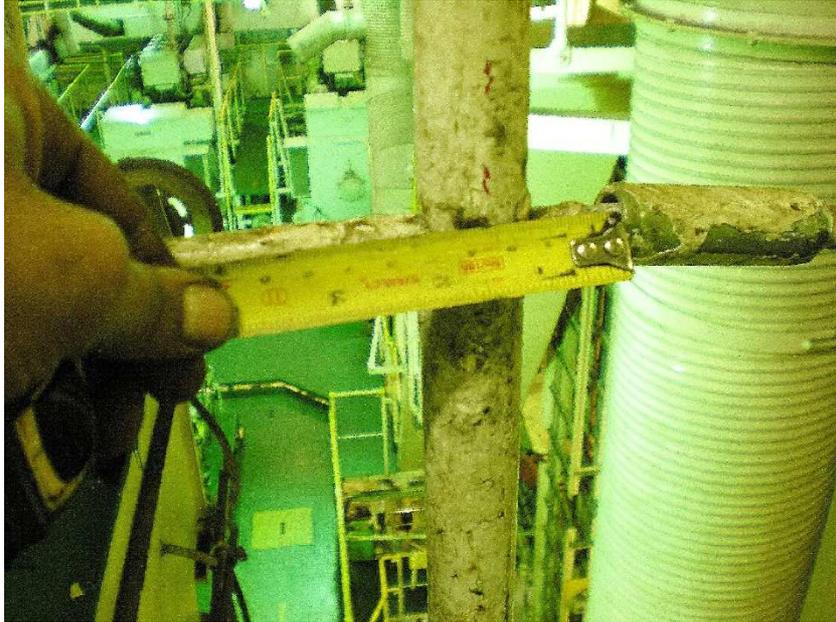
The combination of the usage of an undersized bolt as pivot and the free movement of the lower rod, part of the railing, due to the broken tack weld, allowed for the rod to come out of the male/female connection when the railing was pushed against and the consequential bending of the railing.

Figure 10 - Male/female connection of railing and maximum insert

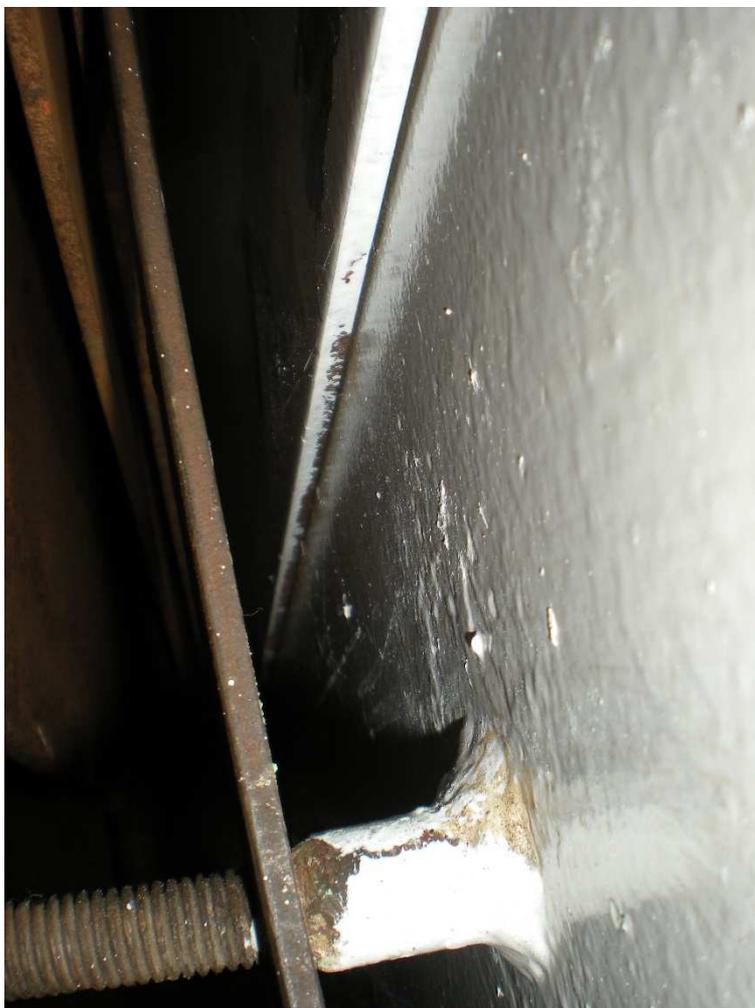
The plates were held in their position by means of an angled steel bar. The steel bar was slid, through two holes, one at each end of the angled steel bar, over two threaded rods that were welded against the bulkhead. The thread, however, did not continue all the way to the bulkhead, as seen on Figure 11 on page 19.

Figure 11 - Threaded rods that holds steel plates in position

Since the threaded rods are not threaded all the way till the bulkhead, in case only a limited amount of steel plates are stowed, to a thickness of less than the unthreaded part of the threaded rods, plates will move, when stowed, when the vessel is pitching, potentially creating a hazardous situation, especially when the angle bar keeping the plates in position is removed during adverse weather conditions.
