Report on the investigation into the fire on board
Z.98 Op Hoop Van Zegen off the coast of
Cherbourg on March 11th, 2019

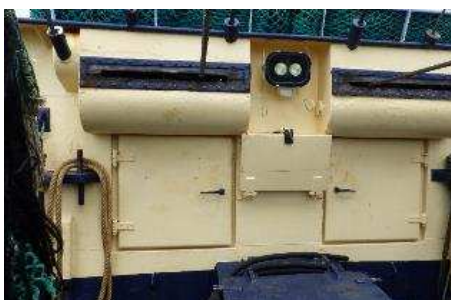
Figure 3 – Access panel to winch room on main deck

On March 11th 2019, around 0400, huge waves came on deck of the fv Z.98 OP HOOP VAN ZEGEN. As the SB access panel of the winch room was not properly closed and secured, the water entered the winch room, through the aforementioned opening.

During the voyage, the starboard access panel was opened. As there was no damage to the clamp or doorframe, it was concluded that the hatch had not been properly secured before leaving port.

There was no tell-tale system installed nor any indication that the hatch was well/not properly secured.

The starboard front panel of the winch room was not properly secured and was opened when overcoming waves smashed onto this panel.

4. BVBA Rederij Aris is recommended to put a barrier in place that limits the consequences if a weathertight access panel is not properly closed and secured, such as:

- a documented procedure with extra controls before sailing; or
 - an auditory or visual indication that the door is not properly closed and secured; or

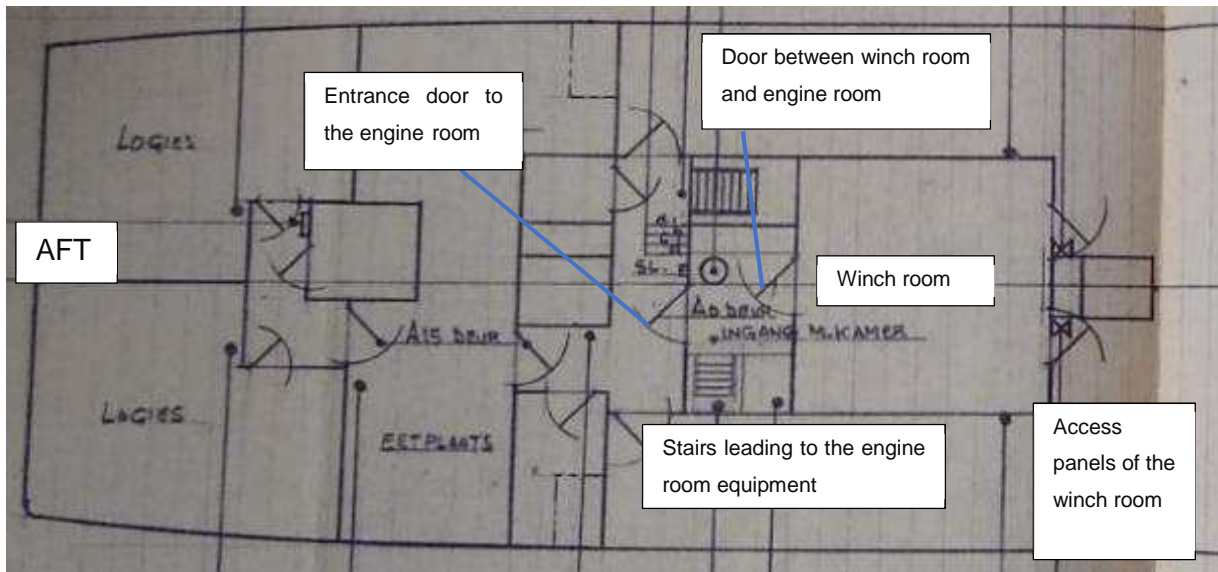
Figure 5- Detailed drawing of main deck

Opposite of the access panels, on the other side of the winch room, there was a door leading to the engine room and a ventilation opening.

The door between the winch room and engine room was kept open most of the time to allow ventilation of the engine room.

With the door between engine room and winch room kept open, water could run freely into the engine room (and fuse box) once inside the winch room.

- an extra physical barrier (a closed door between winch room and engine room) that prevents water ingress into the engine room.

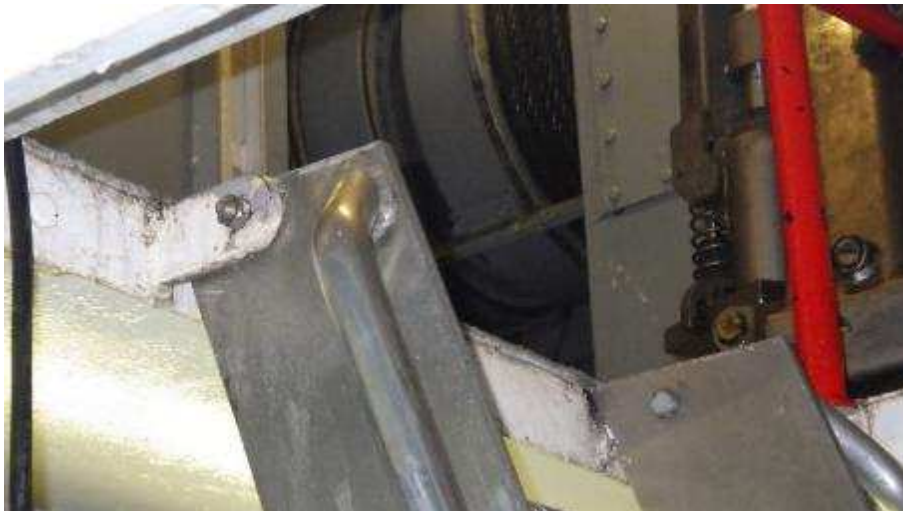
Figure 6– View from the stairs leading to engine room equipment

Inside the engine room, in front of this door, a staircase was leading down to the engine room equipment as shown in Figure 6.

Water ran down in the engine room through the door opening between the winch room and the engine room.

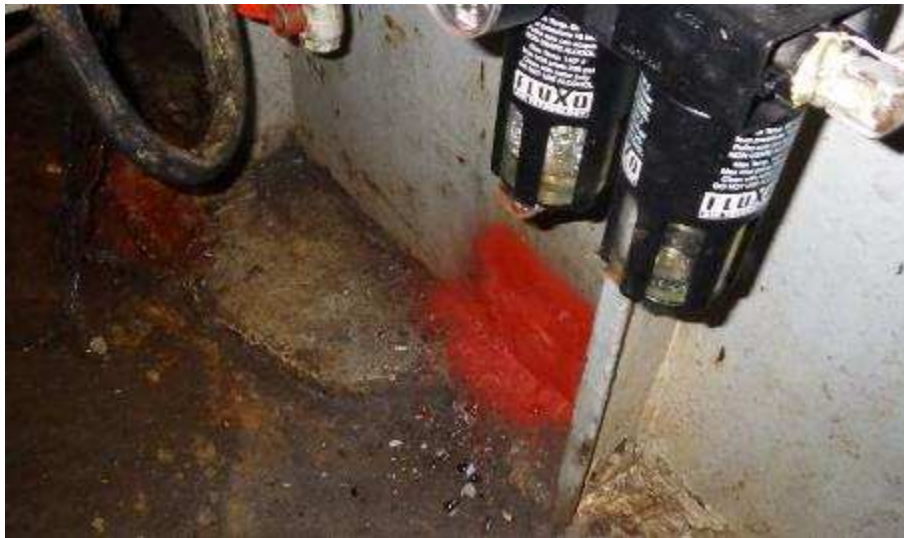
Figure 7- Welded hole from winch room to engine room

The water had also found its way through a hole in the bulkhead between the winch room and the engine room. This hole originated from a removed pipe, as seen in Figure 7. The hole was detected during inspection of the bulkhead after the incident had taken place.

There was also an opening in the bulkhead between the winch room and the engine room, originating from a removed pipe, see Figure 7. Water also found its way through this opening into the engine room.

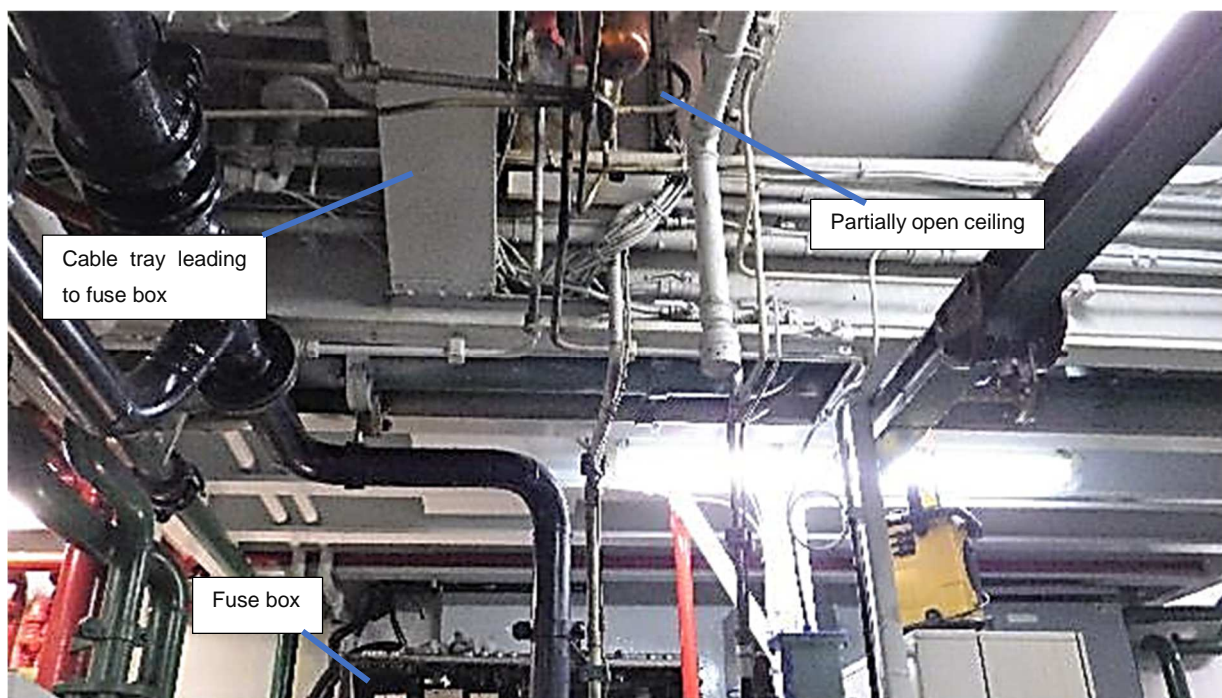
Figure 8 – View from inside the engine room

This water had found its way guided by pipes and a cable tray on the ceiling into the fuse box, as seen in Figure 8.

Inside the fuse box, the water had caused an electrical shortcut leading to a breakdown.

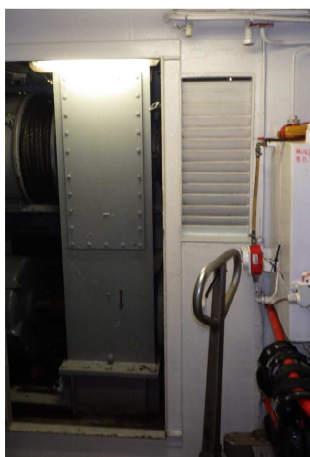
Figure 10- Ventilation opening in front of the engine room

A ventilation opening in the bulkhead between winch room and engine room was kept open, as seen in Figure 10.

As this bulkhead was part of the structural fire protection of the engine room, all openings needed to be able to be closed from outside the engine room in case of fire in the engine room.

As the door between the engine room and the winch room was the only access to the closing-panel of the ventilation opening in front of the engine room as seen in Figure 10 and Figure 11,

it was necessary to cross the engine room to enter the winch room in order to close the ventilation panel.

2. The Belgian Maritime Inspectorate is recommended to compare the actual structural situation on board with the BMI approved drawings.
3. BVBA Rederij Aris is recommended to label doors/access panels/ventilation panels on board to indicate whether or not they need to be closed and/or secured (weathertight for sailing, fire door, fire flap,...) during sea passage or in case of fire.
