**Federal Bureau for the Investigation
of Maritime Accidents**

Report on the investigation into
the accident on board the mv
KNOKKE on Tuesday February
23rd 2021
whereby a crewmember was
severely burnt

Incident name: Severely burnt crewmember on board the mv KNOKKE

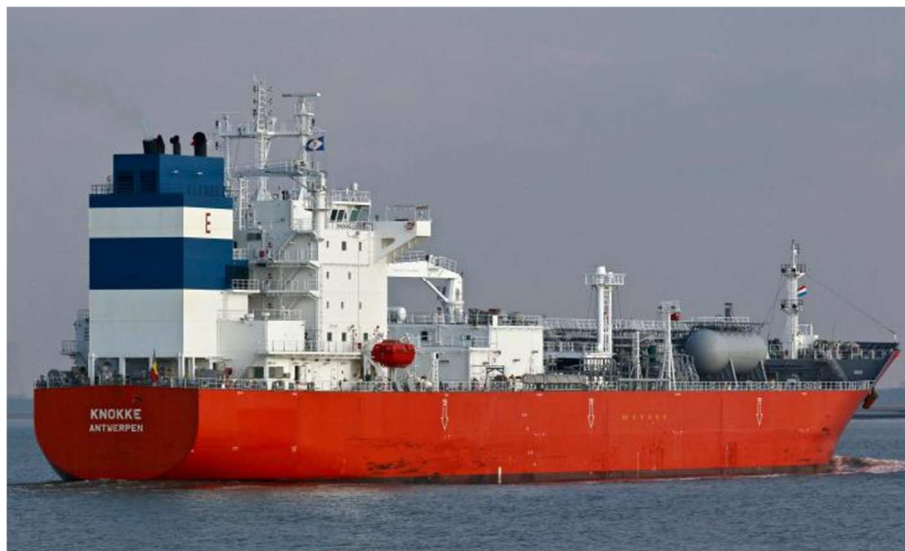
Figure 1 - mv KNOKKE

Ship's Name	Mv KNOKKE
IMO Number	9687497
Call Sign	ONIL
Flag	Belgian
Ship type	LPG Tanker
Gross Tonnage	26.261
Deadweight	29.478 Mt
Date keel laid	01/04/2015
Company Name	Exmar Shipmanagement
Maximum engine power	8.560 KW
Length over all	181.70 m
Length between perpendiculars	171,40 m
Breath	29,43 m
Draught	10,416 m
Hull Material	Steel

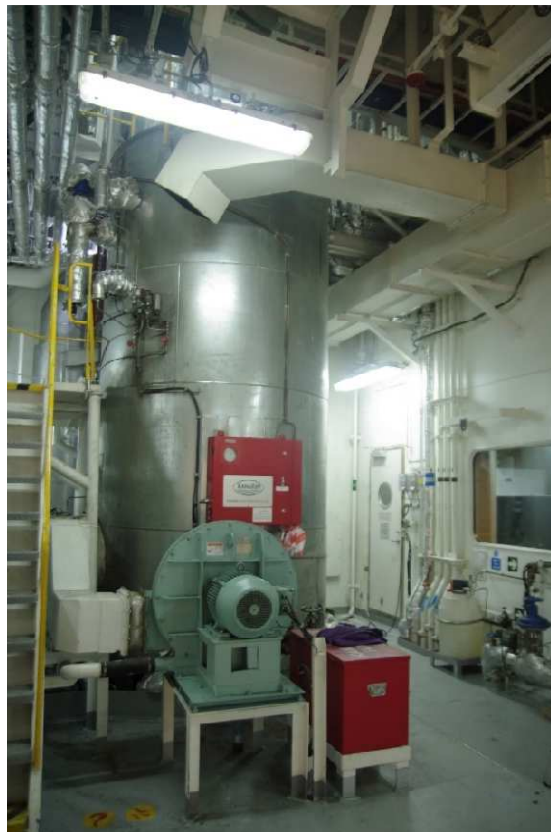
Figure 2 - auxiliary boiler

On February 23rd 2021, at 08:00, during a morning meeting with the engineering staff of the mv KNOKKE and technical staff from the Remontowa Shipyard in Gdansk it was agreed to work the day after on the auxiliary boiler, as seen in Figure 2 on page 10, for survey and service.

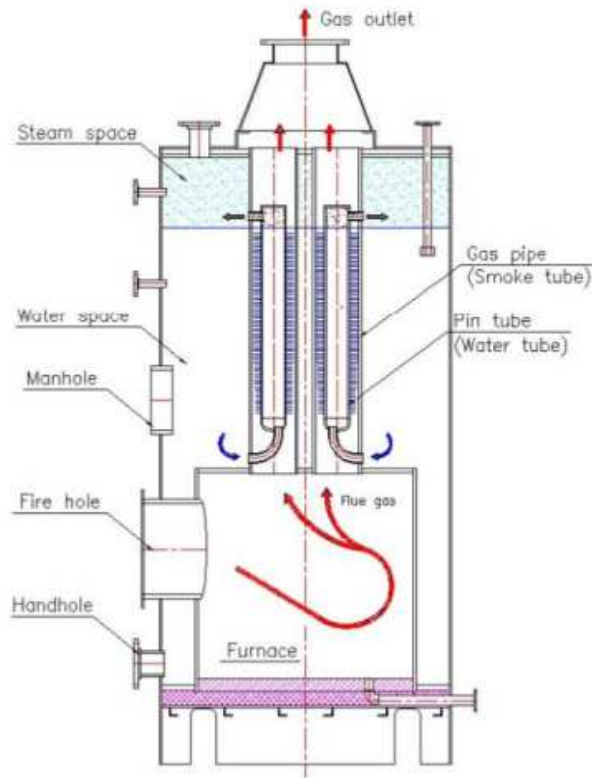
Figure 3 - schematic drawing of auxiliary boiler

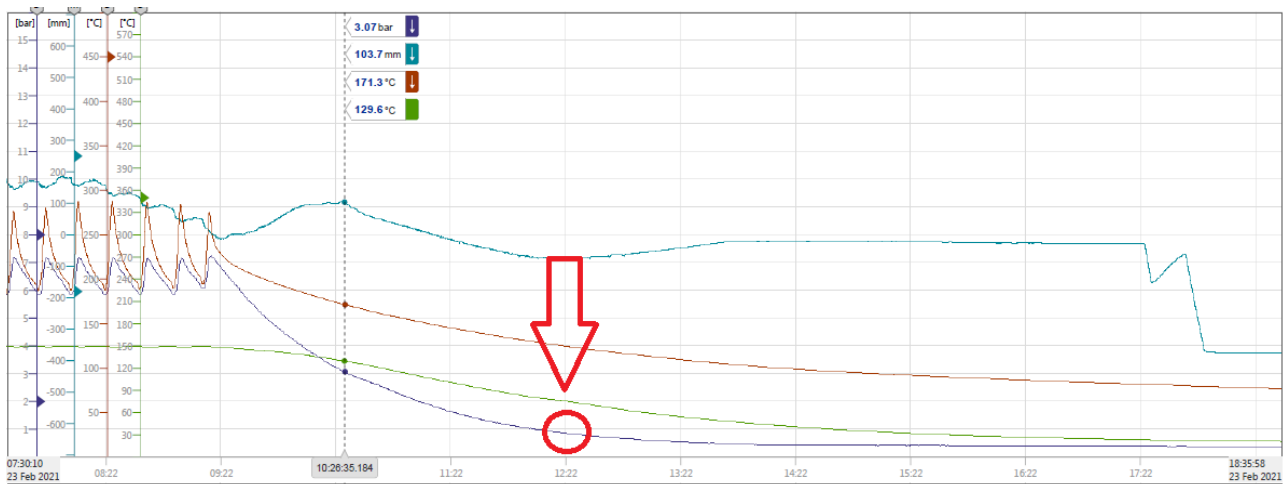
The auxiliary boiler was to be shut down, the pressure inside the boiler brought down to 1 bar, which occurred on February 2021 at 12:22 hours according to the auxiliary boiler pressure, level and temperature monitoring as seen on Figure 4 on page 11 .

Figure 4 - evolution of auxiliary boiler pressure from the remote monitoring device

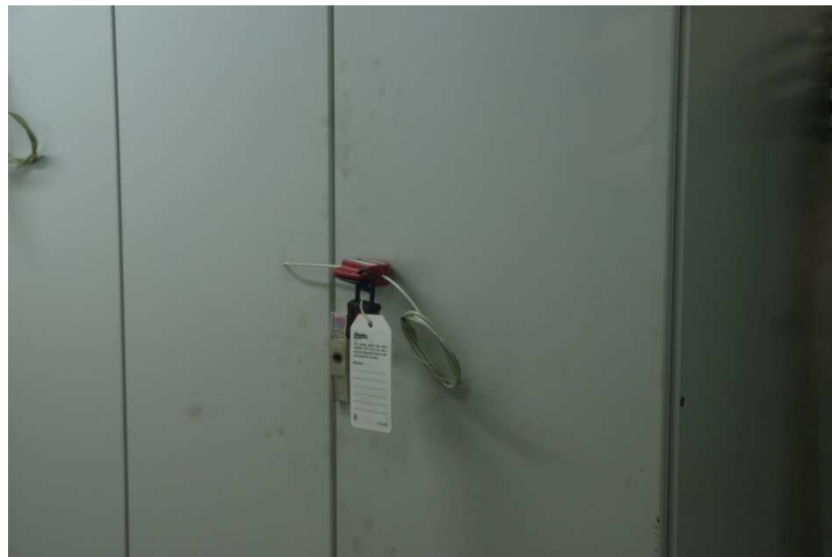
Subsequently the boiler's vent were to be opened, the hand hole was to be opened and a LOTO was to be applied of which an example is shown in Figure 5 on page 12.

Figure 5 - example of a LOTO

Incident Barrier	Performance	Barrier Challenge / Causes	Remarks concerning performance
Open boiler vents			
LOTO not applied	Unreliable		Boiler could be manipulated remotely without the engineer assigned with the task of draining the boiler and opening the hand holes knowing that the boiler is manipulated
	BFA Primary Causes		Boiler could be manipulated remotely while someone else is working on it
Open boiler vents			
stopping and draining the boiler and bring down pressure	Effective		
Open boiler vents			
Open Ventilation Valve	Effective		
	BFA Primary Causes		Omitting to open the ventilation valve can have several negative consequences. If the pressure drops below 1 bar, a vacuum that could structurally damage the boiler is created, and if the pressure is maintained above 1 bar, the opening of the inspection holes can be a dangerous act

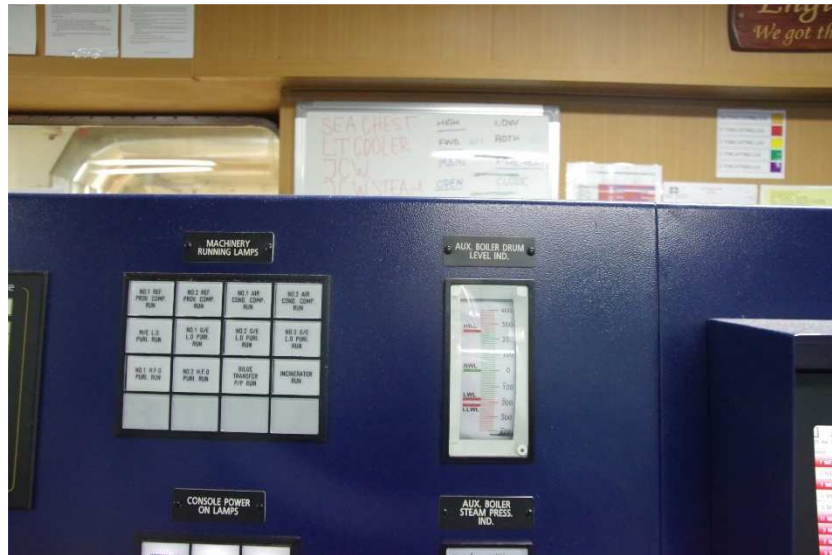
Figure 6 - auxiliary boiler remote water level indicator

It was subsequently noted via the water level indicators as in Figure 6 on page 13 and Figure 7 on page 14 that the water level no longer decreased and that the pressure inside the auxiliary boiler settled at 1 bar.

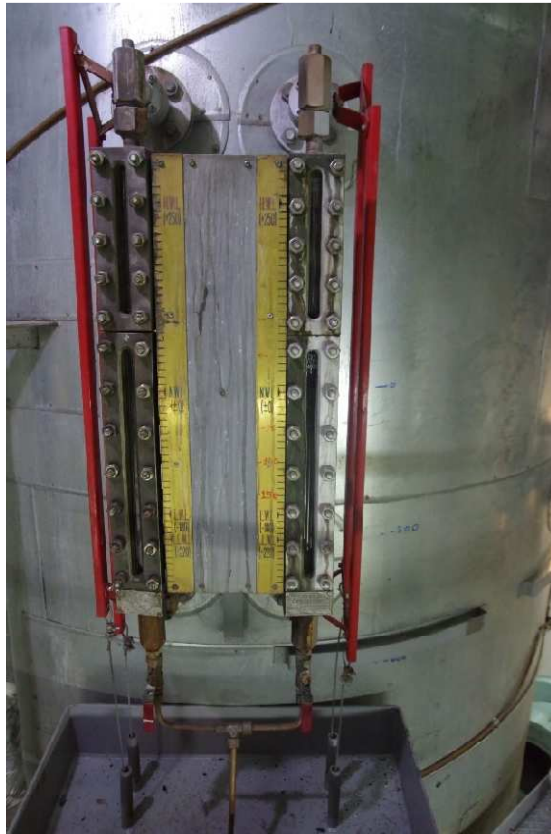
Figure 7 - glass water level indicating gauges

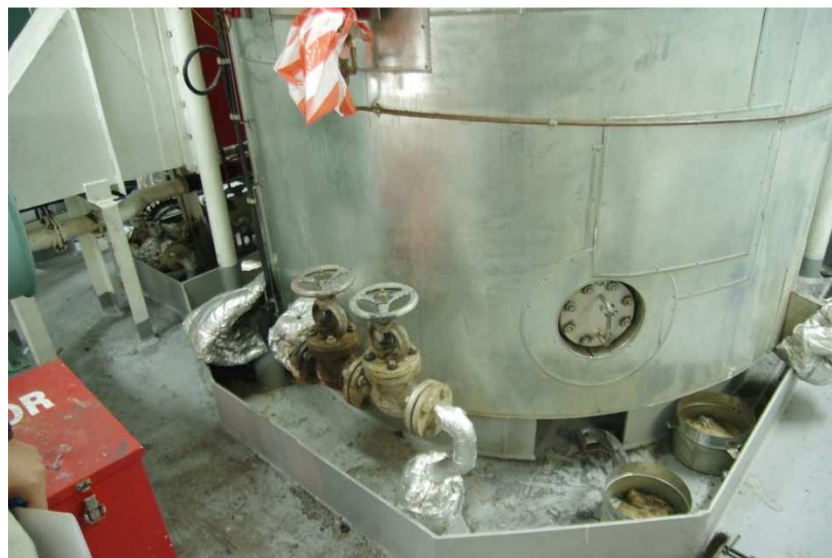
Figure 8 - handhole cover on auxiliary boiler

At 18:05, when removing the lower part of the handhole cover of the auxiliary boiler, the appointed engineer was sprayed over his legs and lower forearms with boiling hot water when a mix of steam and water escaped under pressure from the auxiliary boiler. The appointed engineer consequently started shouting and ran to the vessel's sickbay, where he jumped into a cold shower. Moments later the 2nd officer arrived at the sick bay and assisted the engineer. Soon thereafter the medical intervention team from the shipyard arrived in the sick bay. They called for an ambulance and subsequently removed the injured engineer's T-shirt and socks. After the ambulance had arrived, the victim himself walked to the ambulance and was subsequently transported to the a hospital in Gdansk. At the hospital the victim was administered painkillers. It was subsequently decided to airlift the victim to a specialised trauma centre in Southern Poland.

1. A reminder was sent, to all vessels in the operator's fleet, concerning the importance of tool box meetings on the work floor and the importance of supervision of juniors
2. Ensure that the manual of the boiler clearly states that there is a cool-down period for the boiler after it has been switched off and before the hand and or manholes or being opened

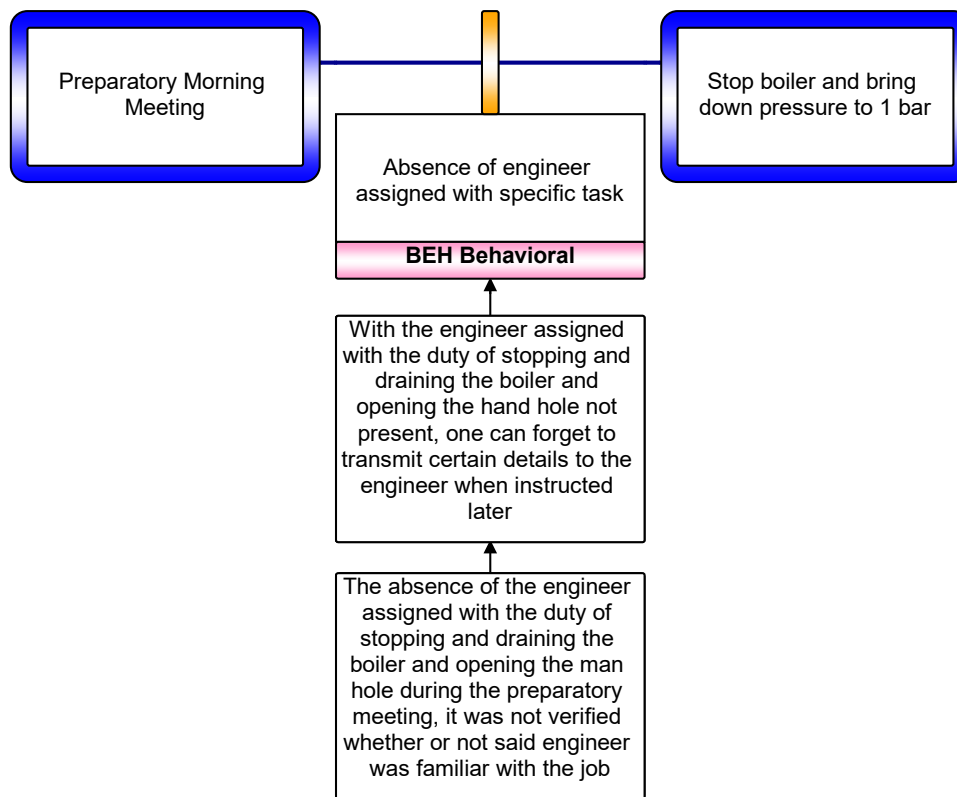
Incident Barrier	Performance	Barrier Challenge / Causes	Remarks concerning performance
Stop boiler and bring down pressure to 1 bar			
Absence of engineer assigned with specific task	Unreliable	The ship's engine room staff should check whether or not an engine room crew member is familiar with the tasks assigned	No checks and balances The engineer assigned with the task was absent and it was not checked whether or not he was familiar with the task
	BFA Primary Causes		With the engineer assigned with the duty of stopping and draining the boiler and opening the hand hole not present, one can forget to transmit certain details to the engineer when instructed later
	BFA Secondary Causes		The absence of the engineer assigned with the duty of stopping and draining the boiler and opening the man hole during the preparatory meeting, it was not verified whether or not said engineer was familiar with the job

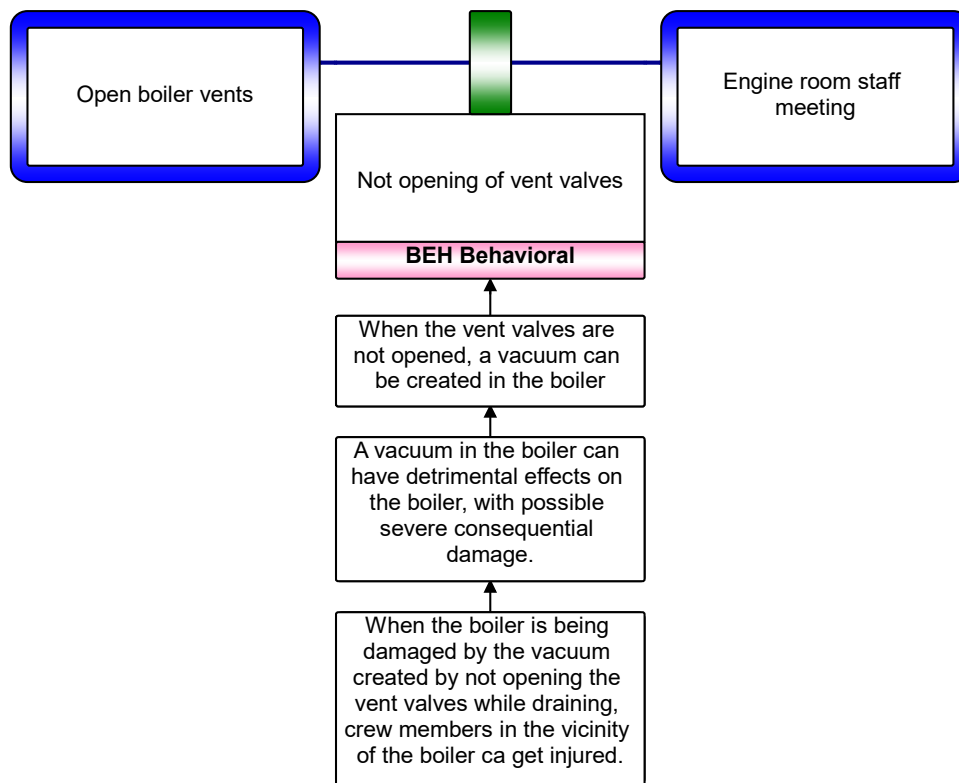
Incident Barrier	Performance	Barrier Challenge / Causes	Remarks concerning performance
Engine room staff meeting			
Not opening of vent valves	Effective		
	BFA Primary Causes		When the vent valves are not opened, a vacuum can be created in the boiler
	BFA Secondary Causes		A vacuum in the boiler can have detrimental effects on the boiler, with possible severe consequential damage.
	BFA Tertiary Causes		When the boiler is being damaged by the vacuum created by not opening the vent valves while draining, crew members in the vicinity of the boiler can get injured.
