# Report on the capsizing of fv O.13 - MORGENSTER on 7 November 2018

## Part I - Investigation Report

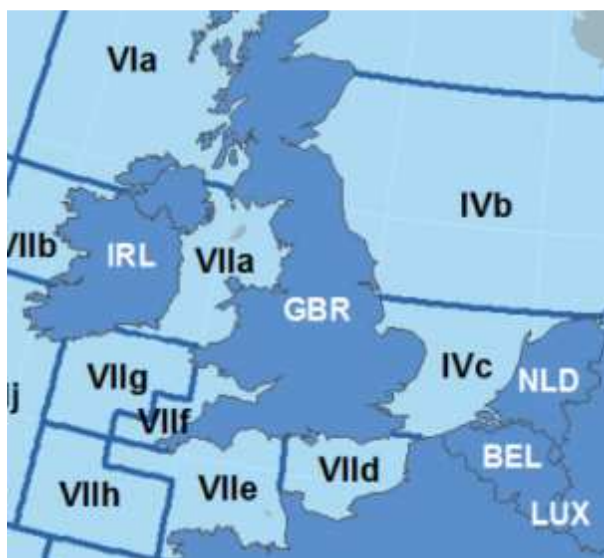
Figure 1- Fishing Divisions

*O.13-MORGENSTER was fishing in division VIId- Eastern English Channel.*

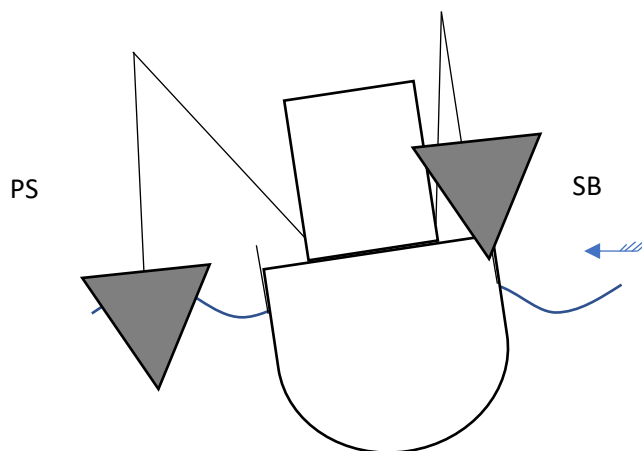
Figure 3 - Schematic drawing of initial condition of the vessel

Both nets were empty, and due to the different elevations of the derricks, there was a slight list over portside, see Figure 3. No manipulation of winches was ongoing.

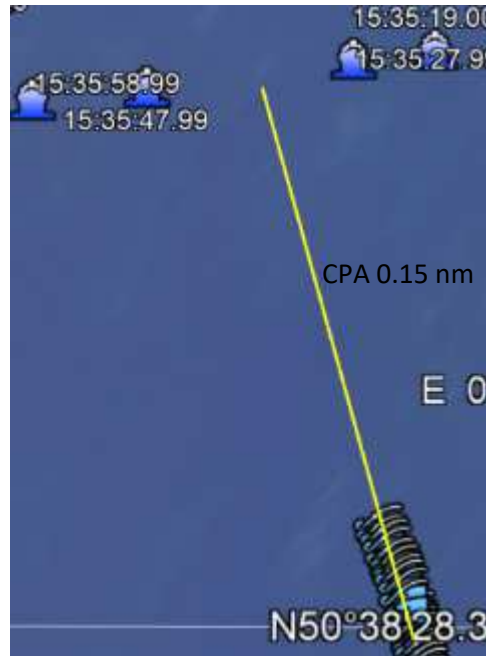
Figure 4 - CPA m/v ARKLOW BREEZE

*CPA between m/v ARKLOW BREEZE (Dark Blue color) and O.13-MORGENSTER is 0.15 nm or 278m, at 1535 UTC. (Source AIS data UK Coastguard)*

At 1535, m/v ARKLOW BREEZE, heading 260° and a speed of 9 knots, crossed fv O.13–MORGENSTER. Fv O.13-MORGENSTER was drifting northwards with a heading of 120°. The closest point of approach (CPA) between both vessels was 0.15nm. Reportedly, radio contact between both vessels had taken place when m/v ARKLOW BREEZE was at a distance of 0.75 nm with an initial CPA of 0.10 nm.

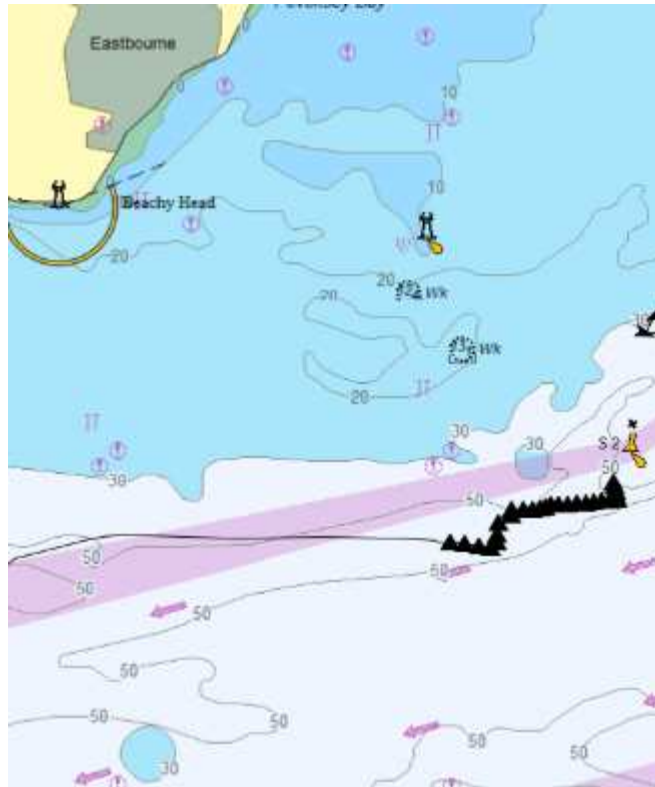
*Figure 5 - Last Position*

*Last available position received by UK Coastguard is N 50°38' 29" E 000° 32' 7 at 15:37:06 UTC.*

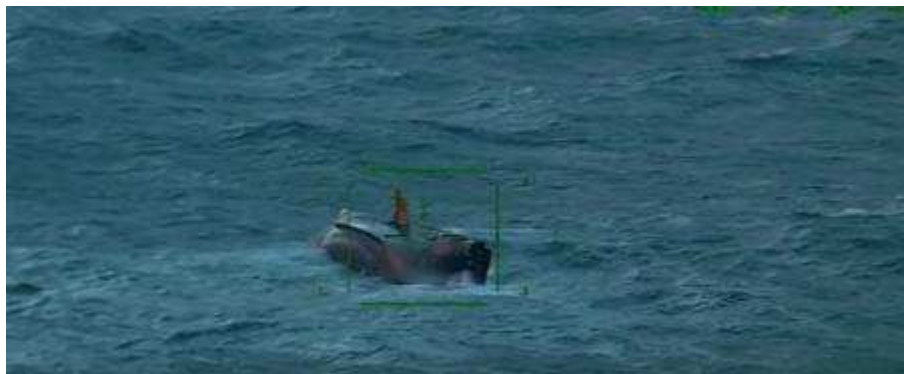
*Figure 6 - Capsized vessel*

*Extract from video by UK Coastguard upon arrival.*

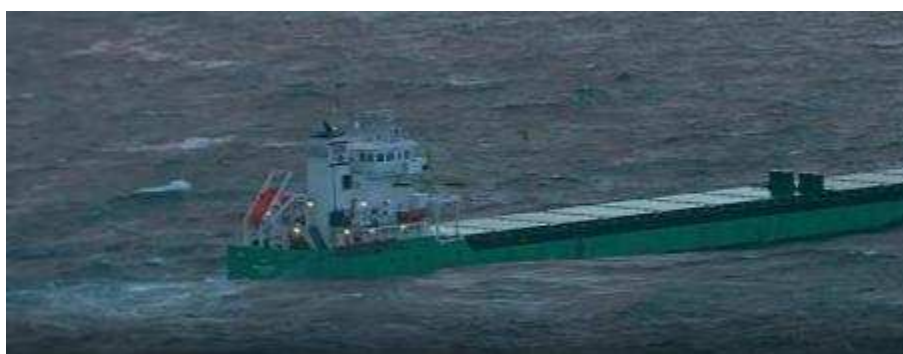
*Figure 7 - M/v ARKLOW BREEZE and state of the sea*

The crew on board the M/v ARKLOW BREEZE witnessed the incident and turned the vessel around in order to pick up the two men from the water.

*Extract from video by UK Coastguard upon arrival.*

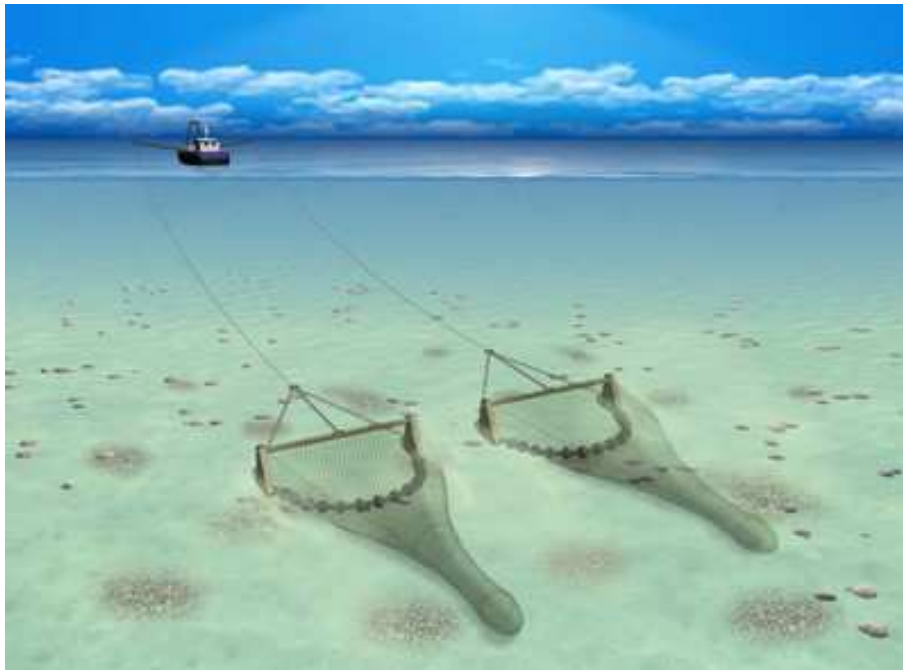
*Figure 9 - Beam trawler*

*Impression of a fishing vessel rigged for beam trawl [www.seafish.org](http://www.seafish.org)*

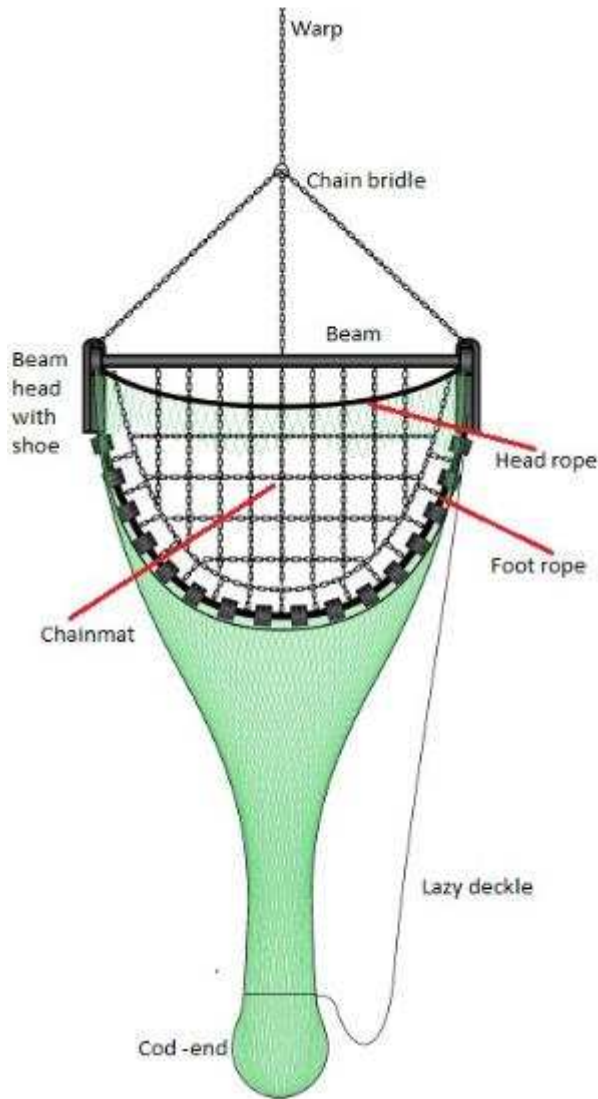
Figure 10 - Trawl Gear

The beam trawl consists of a heavy tubular steel beam supported by beam heads at each end. These beam heads have wide shoes at the bottom which slide over the seabed. The beam and beam heads form a rigid framework that keeps the mouth of the trawl open and supports the net.

The beam is usually towed using a chain bridle arrangement from both shoes and the centre of the beam attached to the end of the trawl warp leading to the vessel.

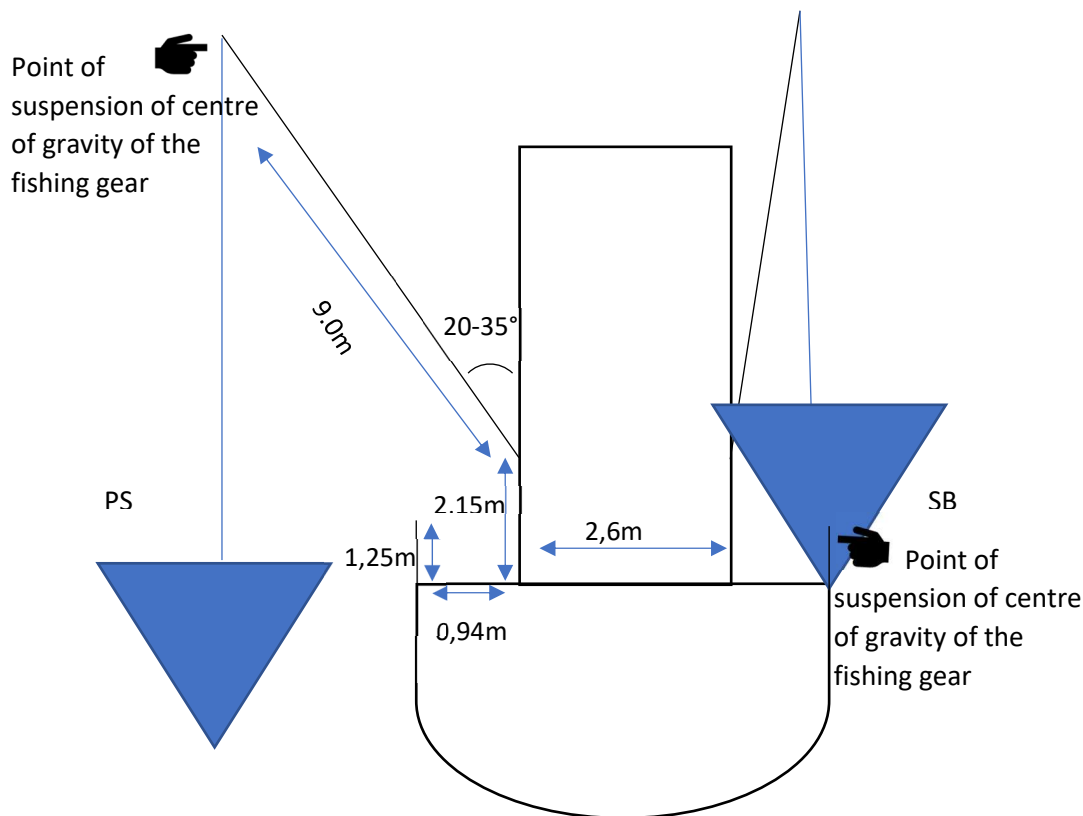
Figure 13 -Dimensions

The portside derrick was at an angle between 20 and 35 degrees (step 1), as shown in Figure 13.

*Schematic view of distances at the time of capsizing*

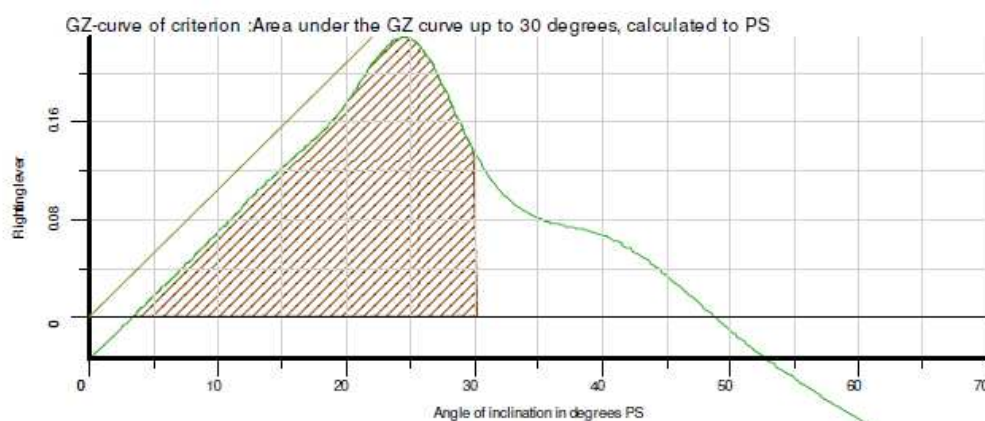
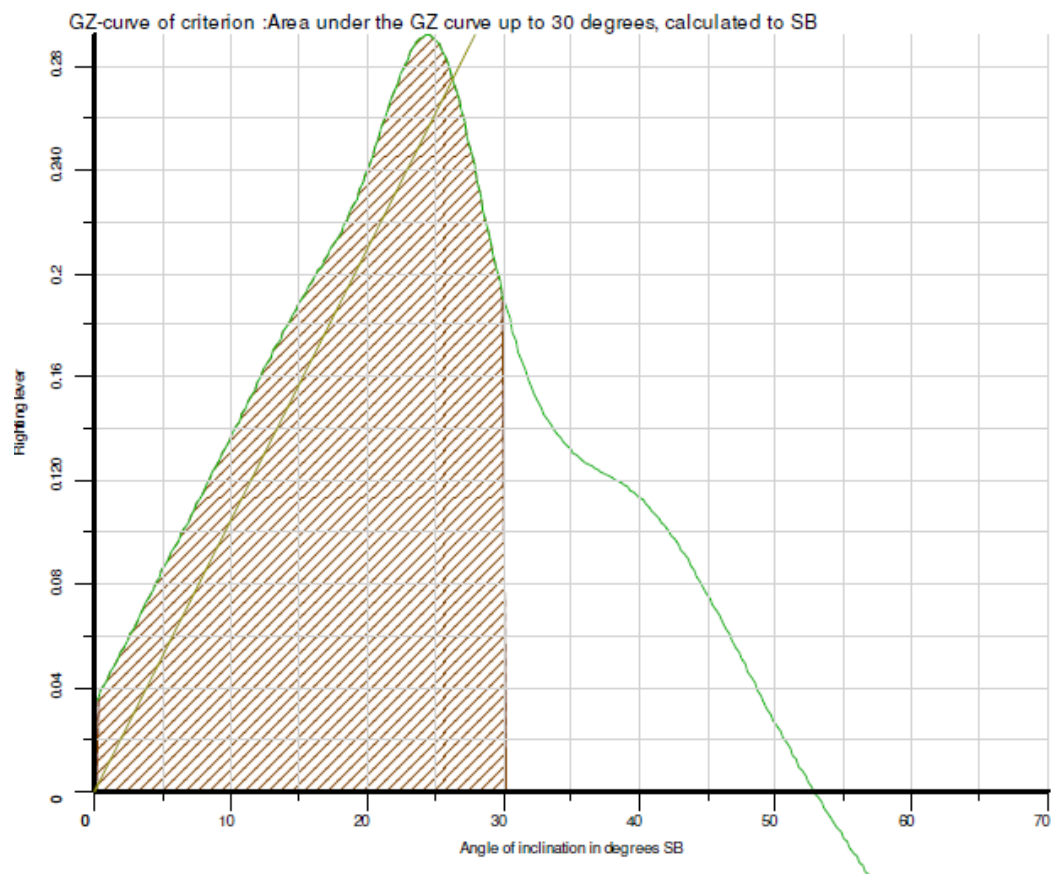
Figure 14 - Initial condition, 20°

Stability values were less than the required values for different loading conditions in Service regulation 15. The vessel had a static angle of heel of almost 3 degrees, but had still a positive range of stability of 48 degrees. No real danger for capsizing existed.

**Loading condition DOES NOT comply with the stated criteria.**

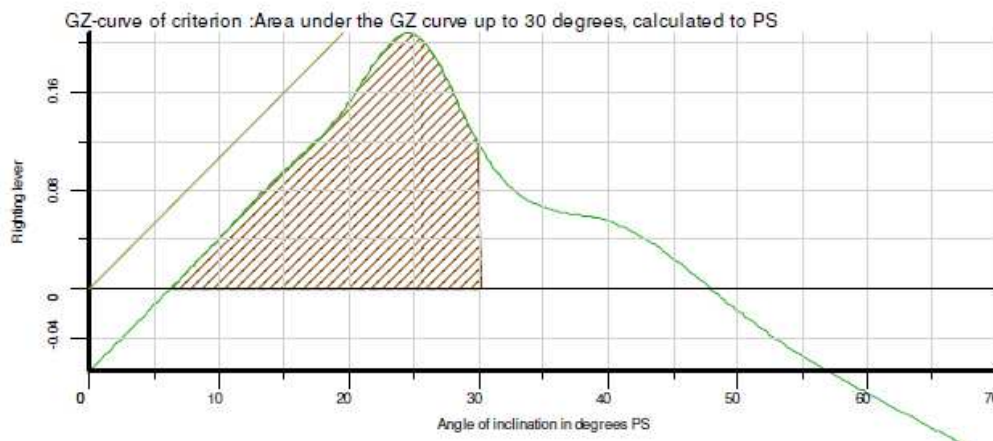
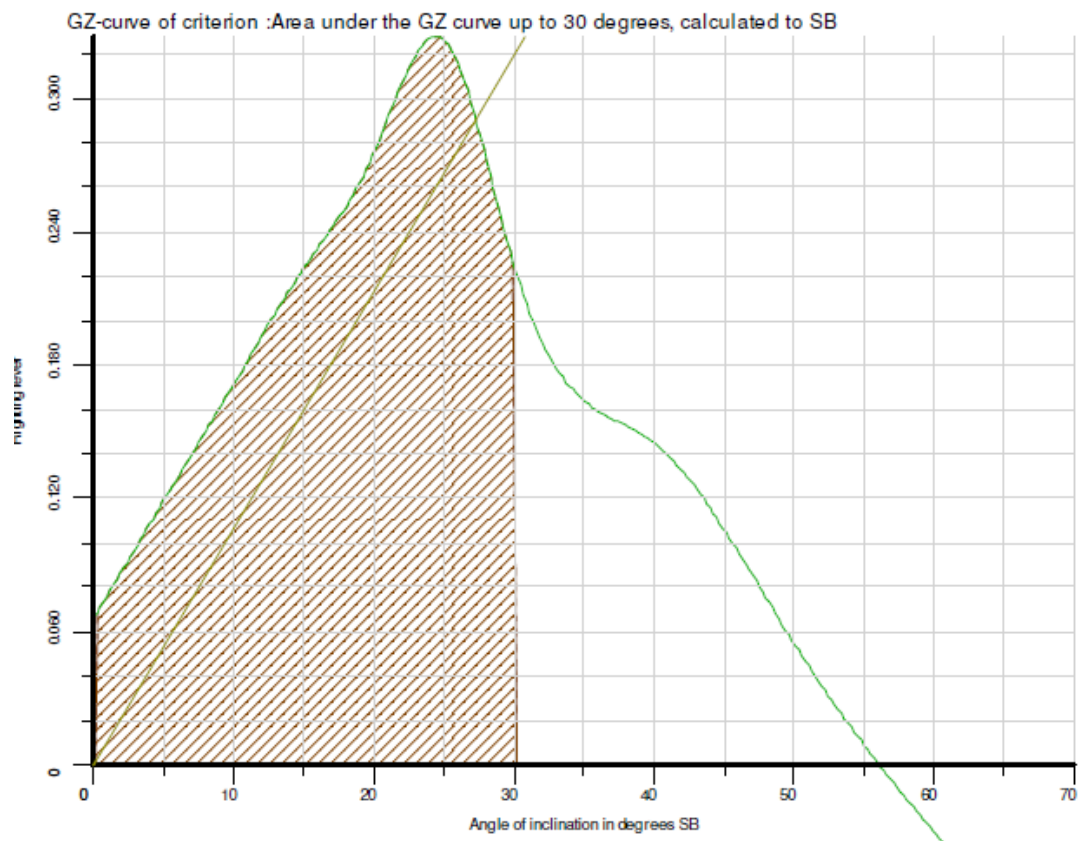
Figure 15 - Initial condition, 35°

Stability values were less than the required values for different loading conditions in Service regulation 15. The vessel had a static angle of heel of 5,5 degrees, but had still a positive range of stability of 44.5 degrees. No real danger for capsizing existed.

**Loading condition DOES NOT comply with the stated criteria.**

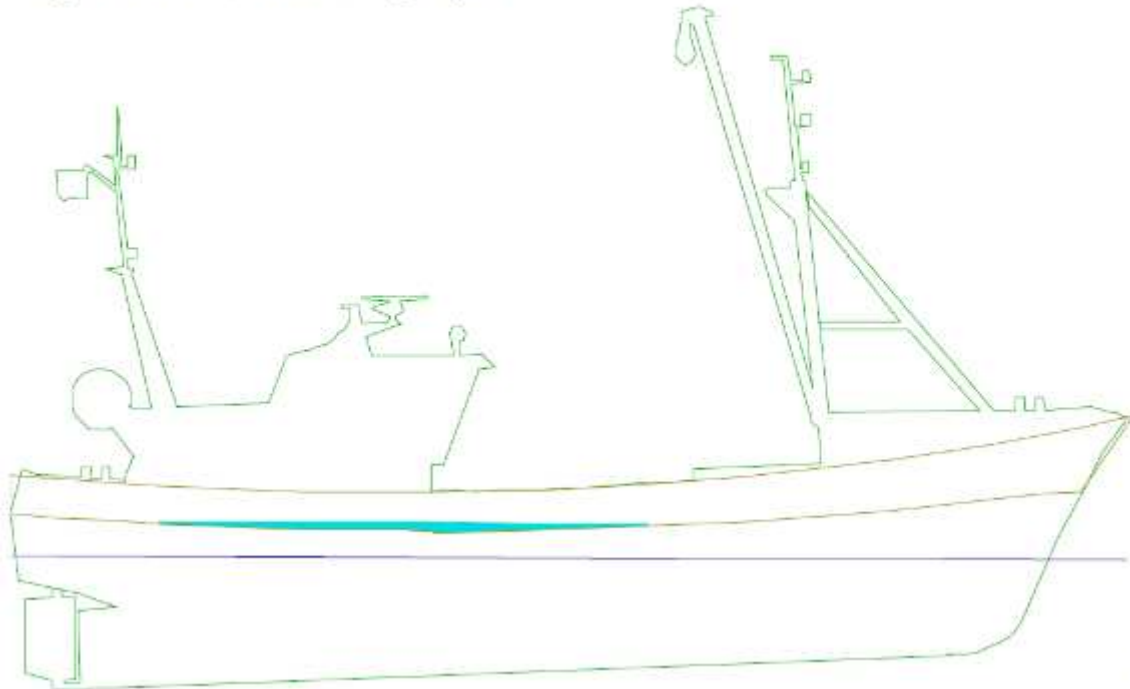
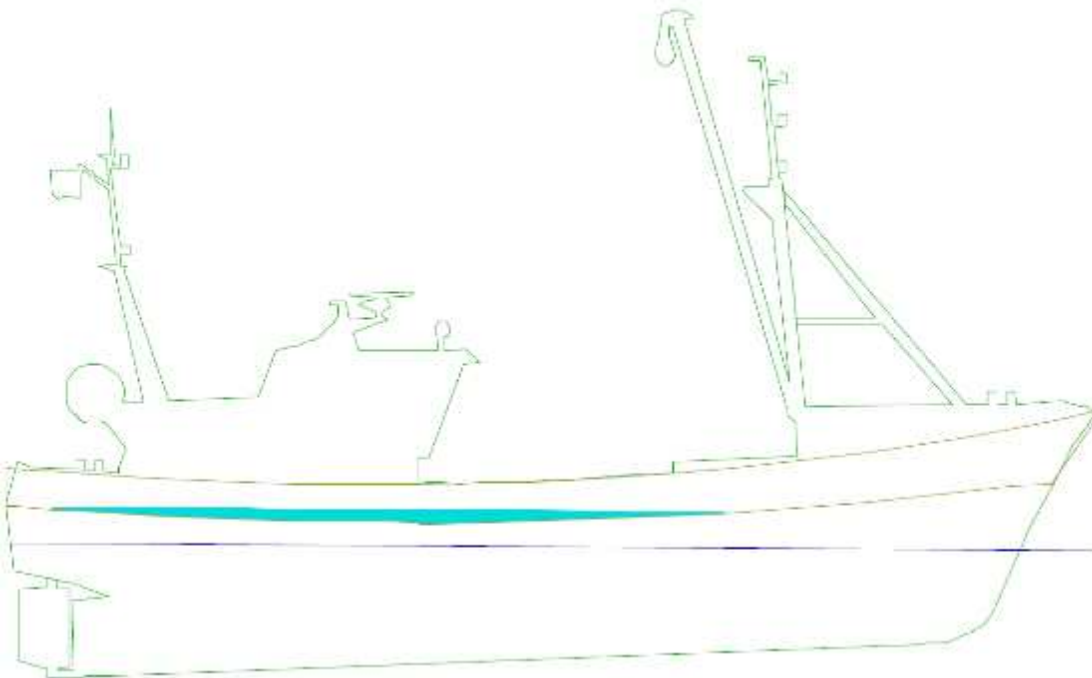
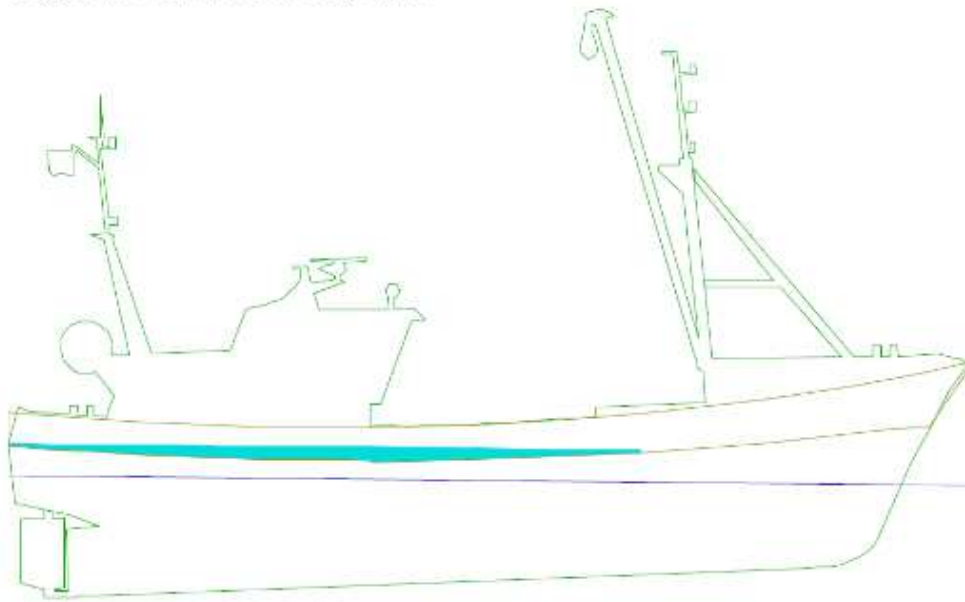
*Figure 16 - Water on deck*

Water on deck is a mass added to the vessel. It is a weight with a free liquid surface, thus it is easily moved by the motion of the vessel. Therefore, water on deck has a negative impact on the stability of the vessel and should be avoided as much as possible.

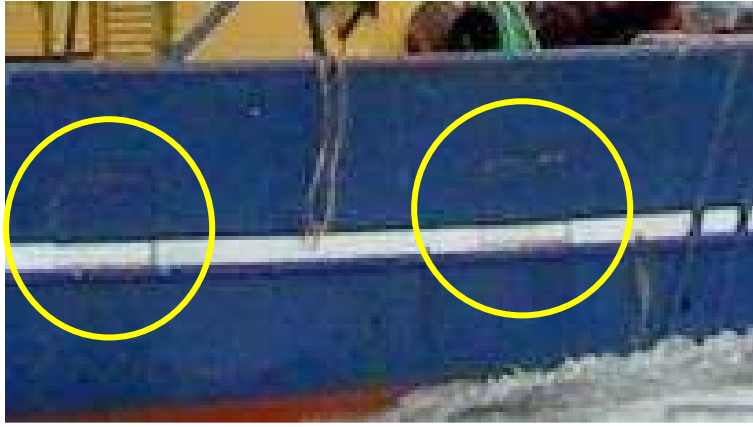
*Figure 17 - Freeing ports on board O.13 - MORGENSTER*

The inspection of freeing ports is part of the yearly flagstate inspection. The flagstate inspection report (dated March 2018) did not mention any shortcomings related to the freeing ports.

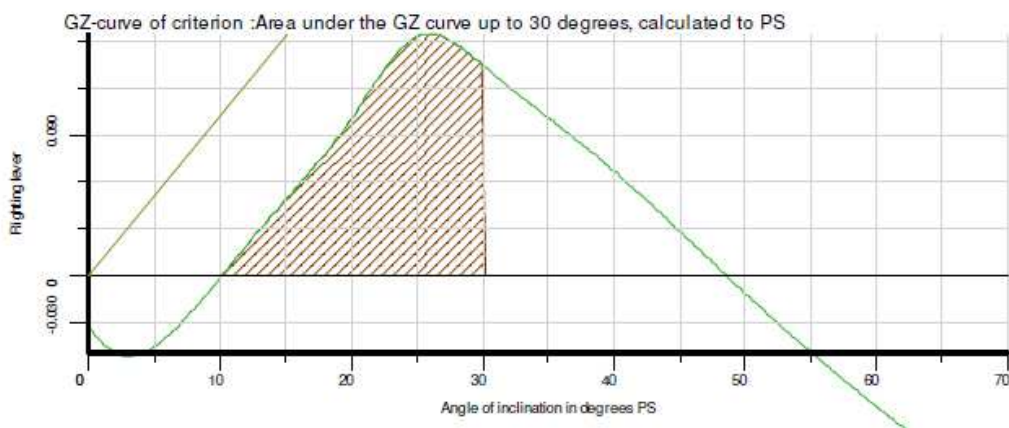
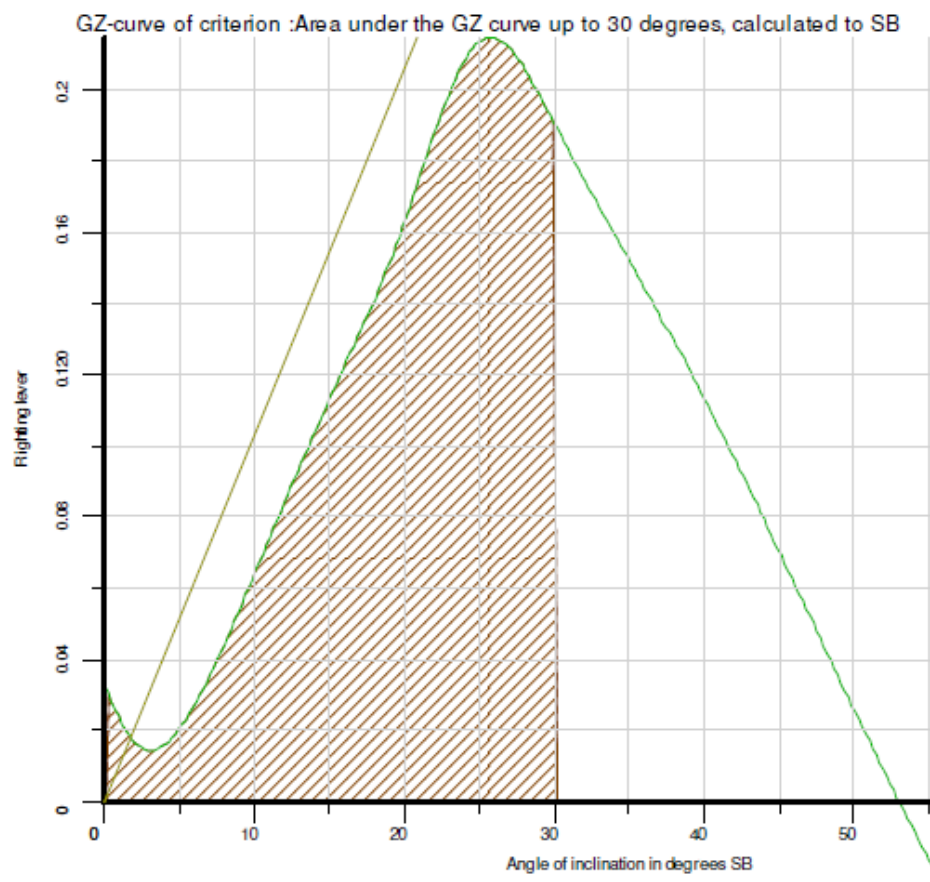
Figure 18 - Step 2, derrick 20°, 5m³ water

Stability values were almost 50% of the required values for different loading conditions in Service regulation 15. The static angle of inclination with 5m<sup>3</sup> water on deck was 9 degrees. There was a positive range of stability of almost 42 degrees. The vessel should not have capsized, but the stability decreased significantly.

**Loading condition DOES NOT comply with the stated criteria.**

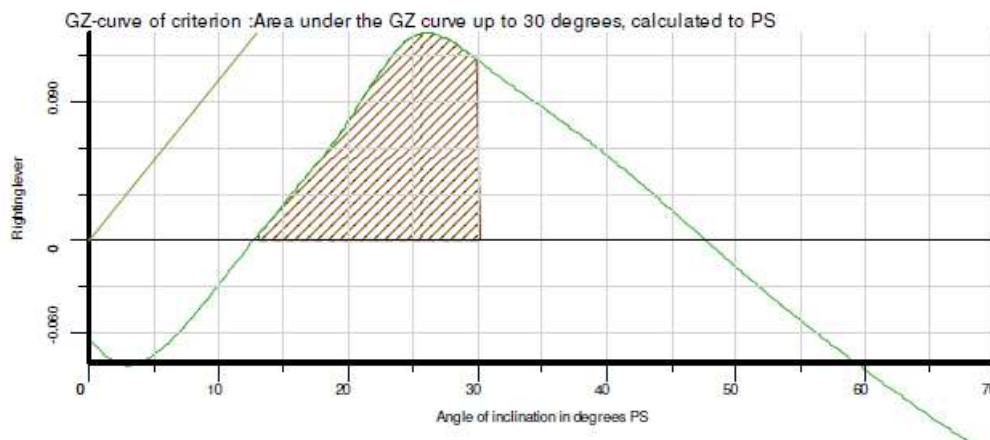
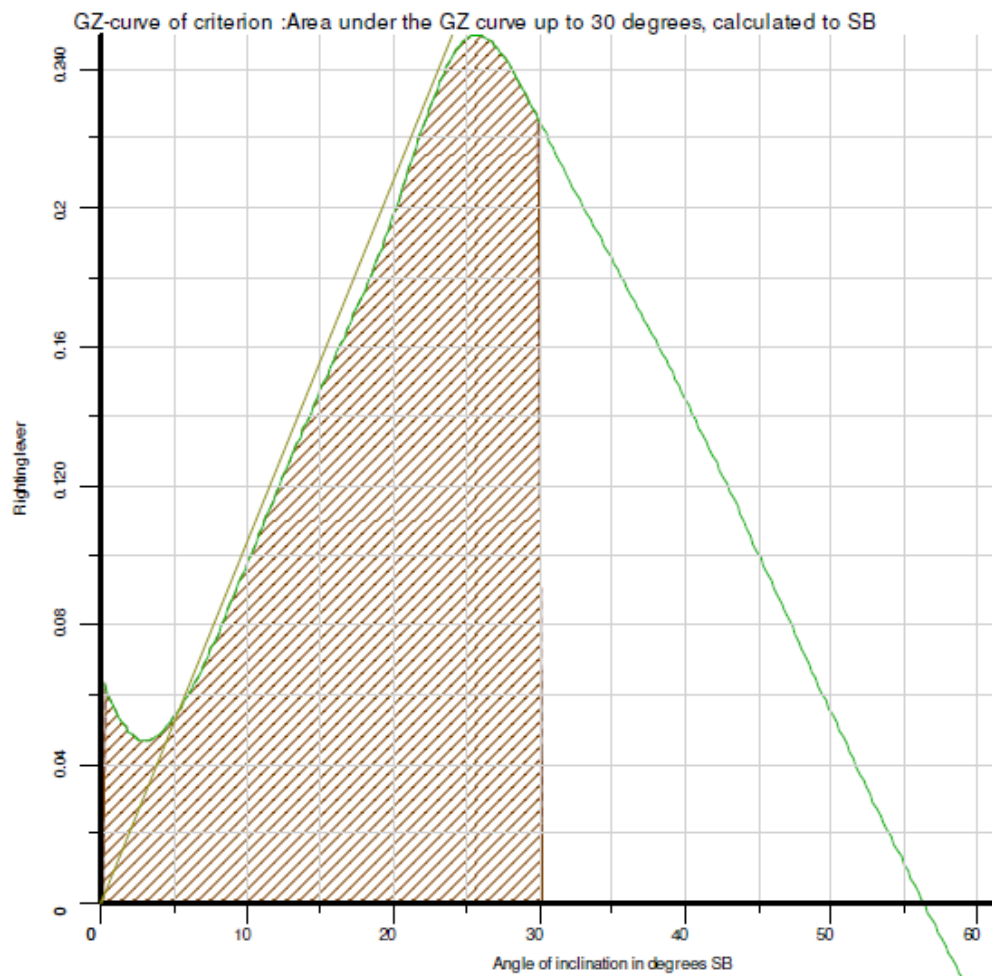
Figure 19 - Step 2 , derrick 35°, 5m<sup>3</sup> water

Stability values were less than 50% of the required values for different loading conditions in Service regulation 15. The static angle of inclination with 5m<sup>3</sup> water on deck was 11,4 degrees. There was a positive range of stability of 38.5 degrees. The vessel should not have capsized, but the stability decreased significantly.

**Loading condition DOES NOT comply with the stated criteria.**

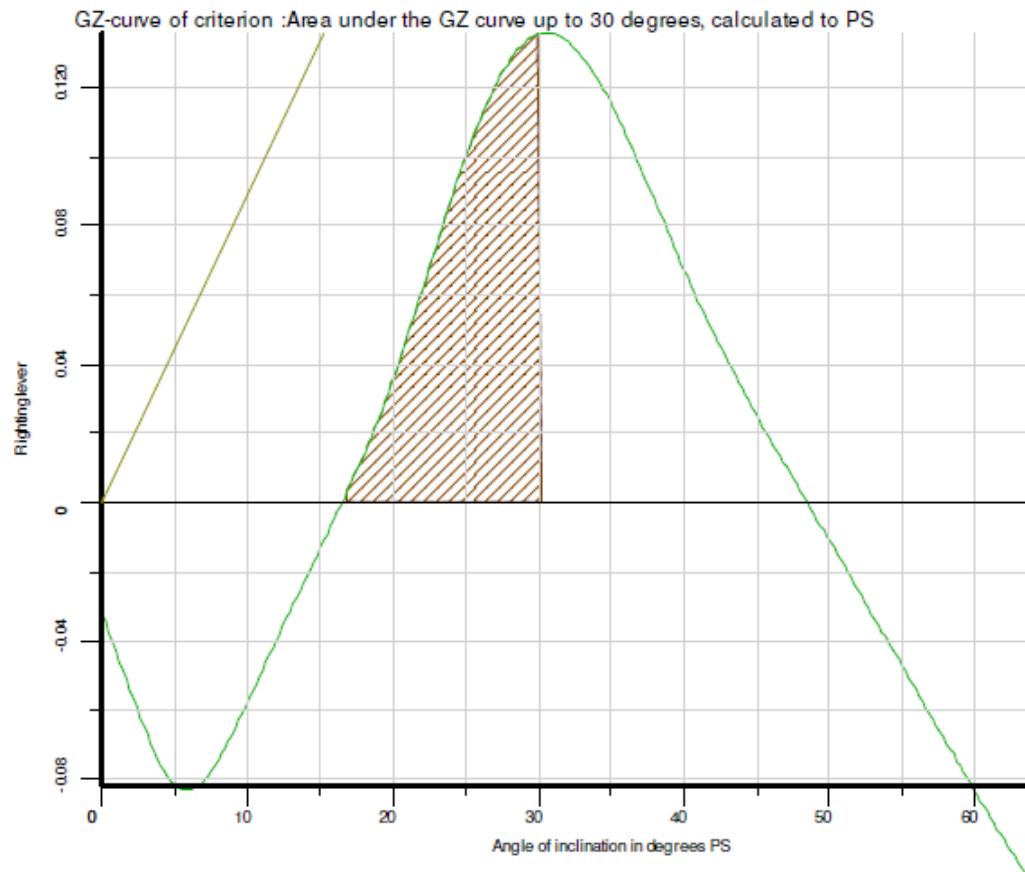
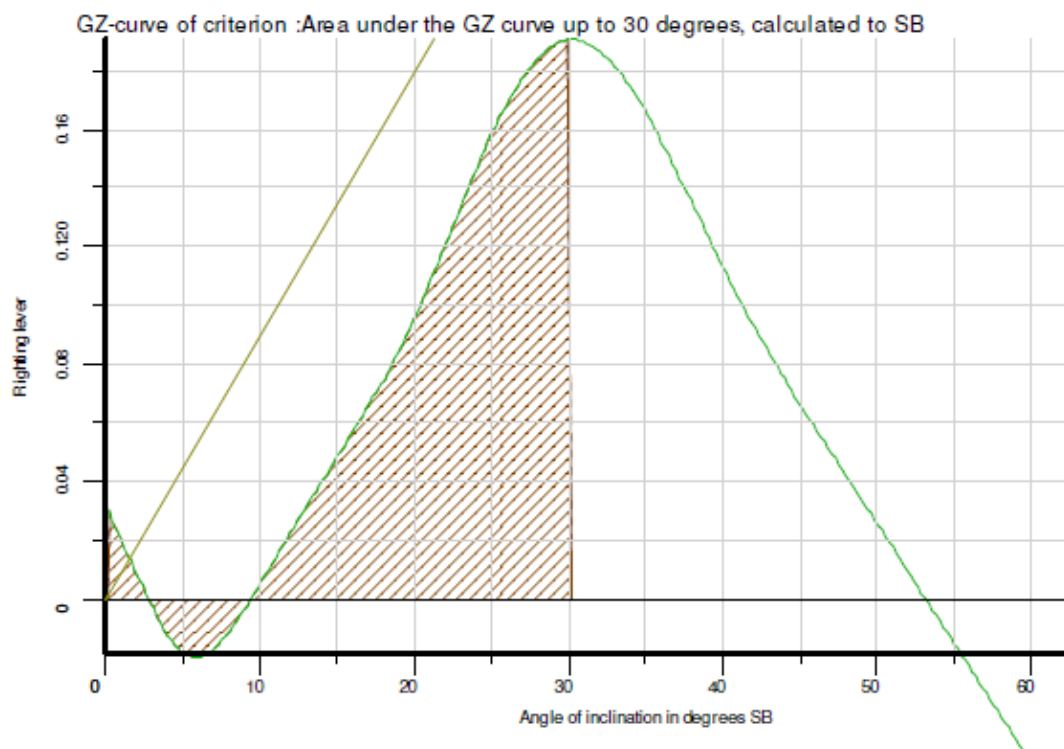
Figure 20 – Step 3, derrick 20°, 10m<sup>3</sup> water

Stability values were 1/3 to 1/2 of the required values for different loading conditions in Service regulation 15. The static angle of inclination with 10m<sup>3</sup> water on deck was 14,5 degrees. There was a positive range of stability of 36 degrees.

**Loading condition DOES NOT comply with the stated criteria.**

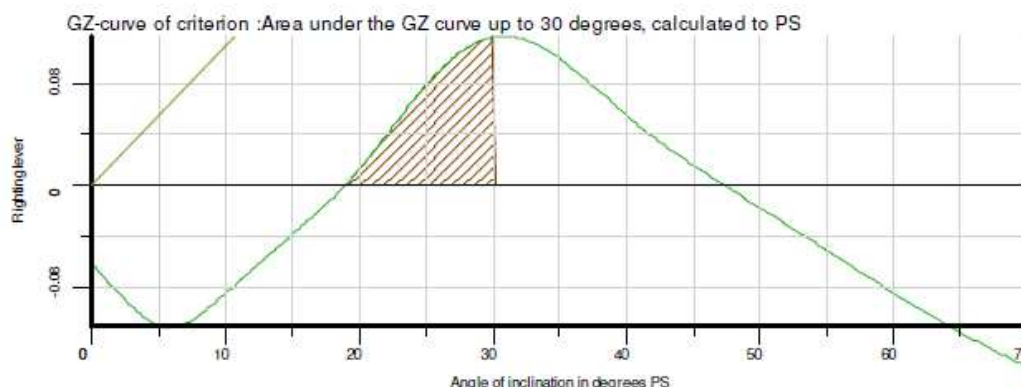
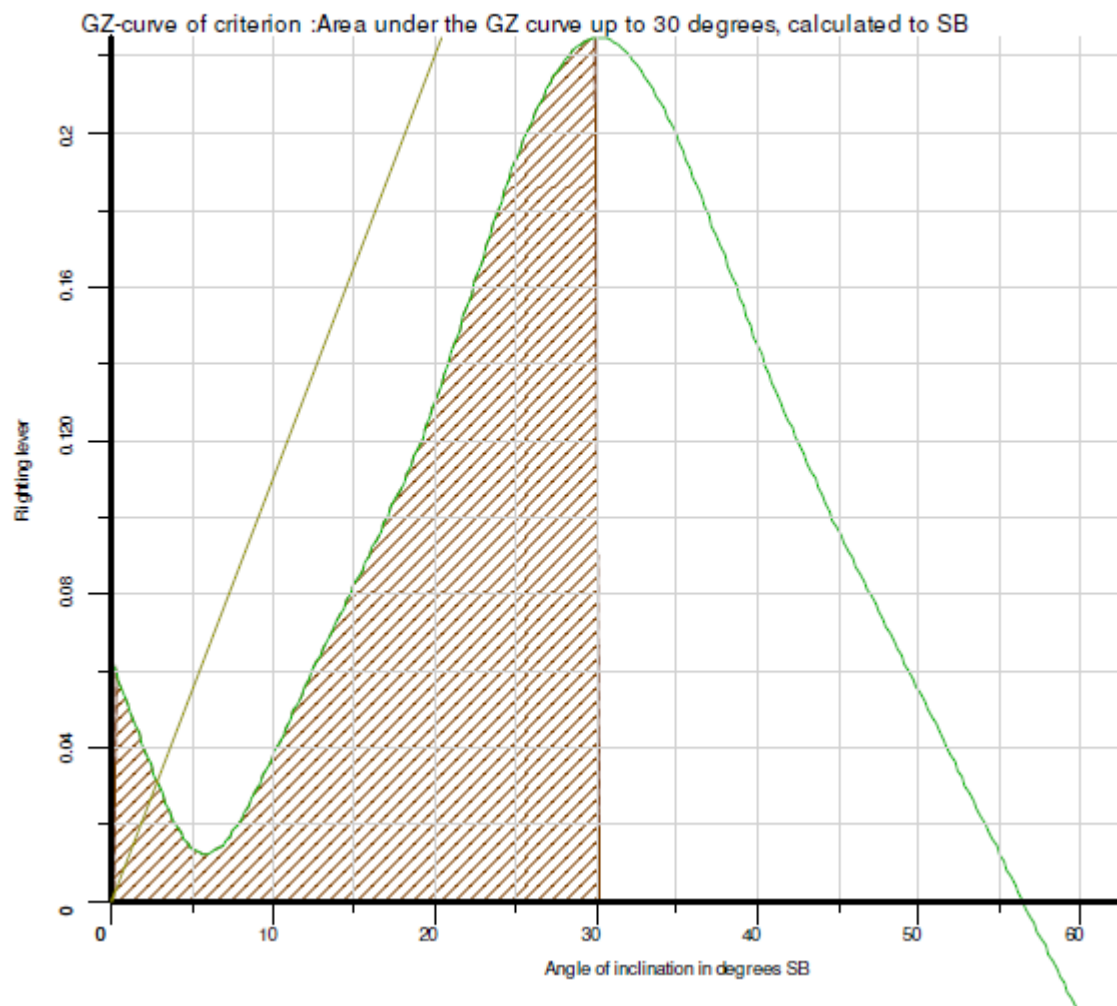
Figure 21 - Step 3, derrick 35°, 10m<sup>3</sup> water

Stability values were about 1/3 to 1/2 of the required values for different loading conditions in Service regulation 15. The static angle of inclination with 10m<sup>3</sup> water on deck was almost 17 degrees. There was a positive range of stability of almost 38.5 degrees.

**Loading condition DOES NOT comply with the stated criteria.**

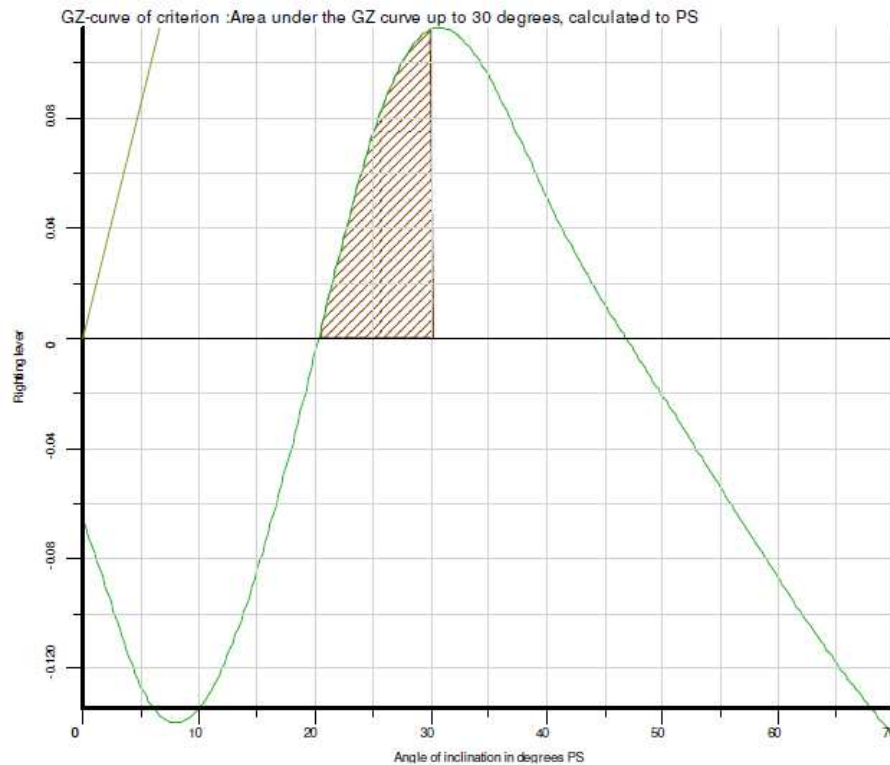
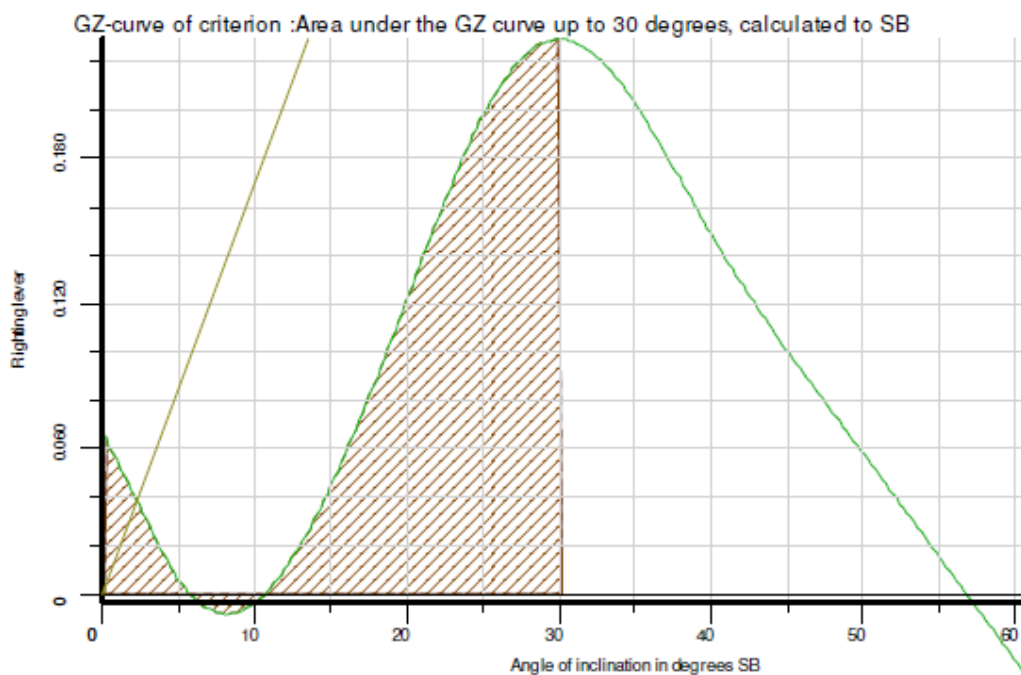
Figure 23 - Step 4, derrick 35°, 15m³ water

Stability values were about 1/3 of the required values for different loading conditions in Service regulation 15. The static angle of inclination was more than 19 degrees. There was a positive range of stability of only 30 degrees. Within this small positive range, the “amount” of stability was also much reduced, meaning that not a lot of energy remained to upright the vessel to its equilibrium at 19 degrees.

**Loading condition DOES NOT comply with the stated criteria.**

The (negative) area from 0 degrees to the static angle of equilibrium (20 degrees) is about the size of the positive (hatched) area from the static angle to the angle of vanishing stability. The area represents the “energy” of the vessel to get back to its equilibrium. This energy also causes the vessel to roll further than the static angle of equilibrium. Therefore the vessel does not calmly lay at its static angle of 20 degrees, but will roll further. Apparently until the wheelhouse gets flooded and the vessels capsizes.

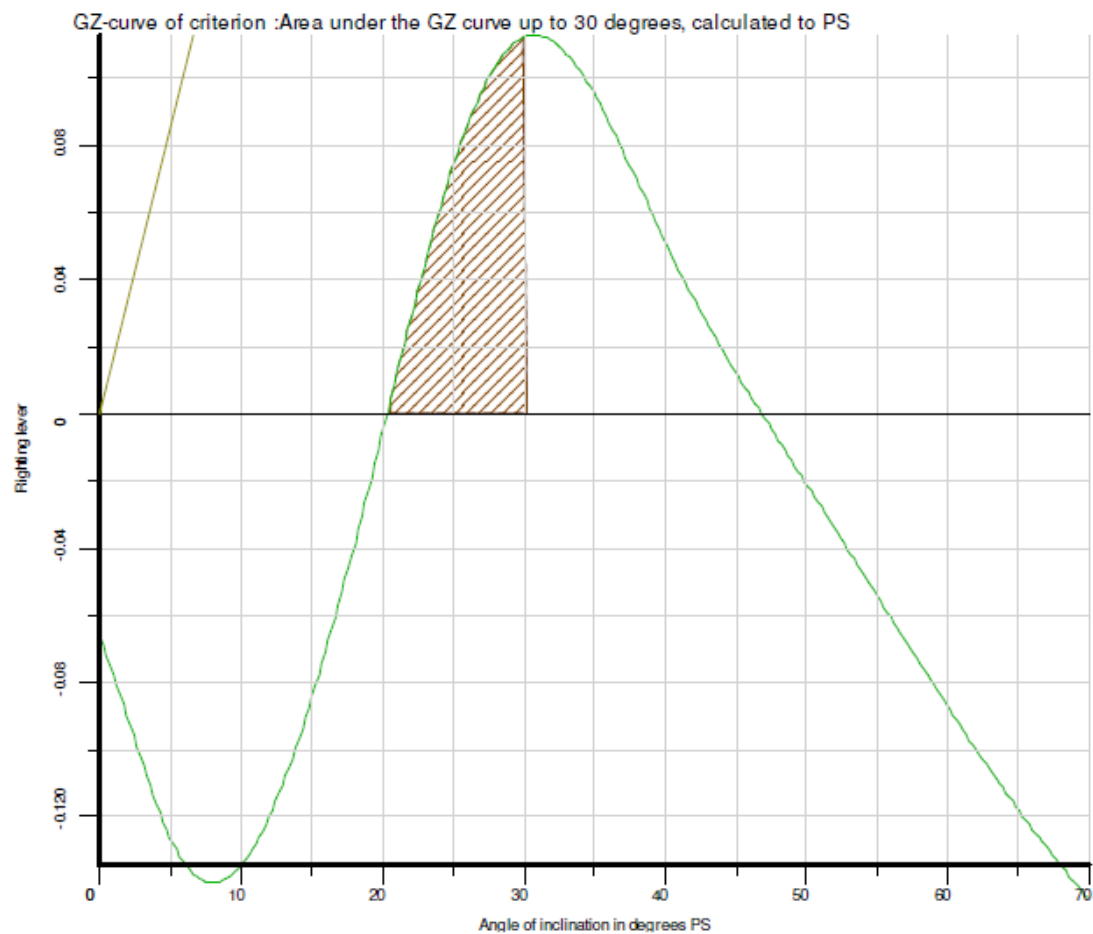
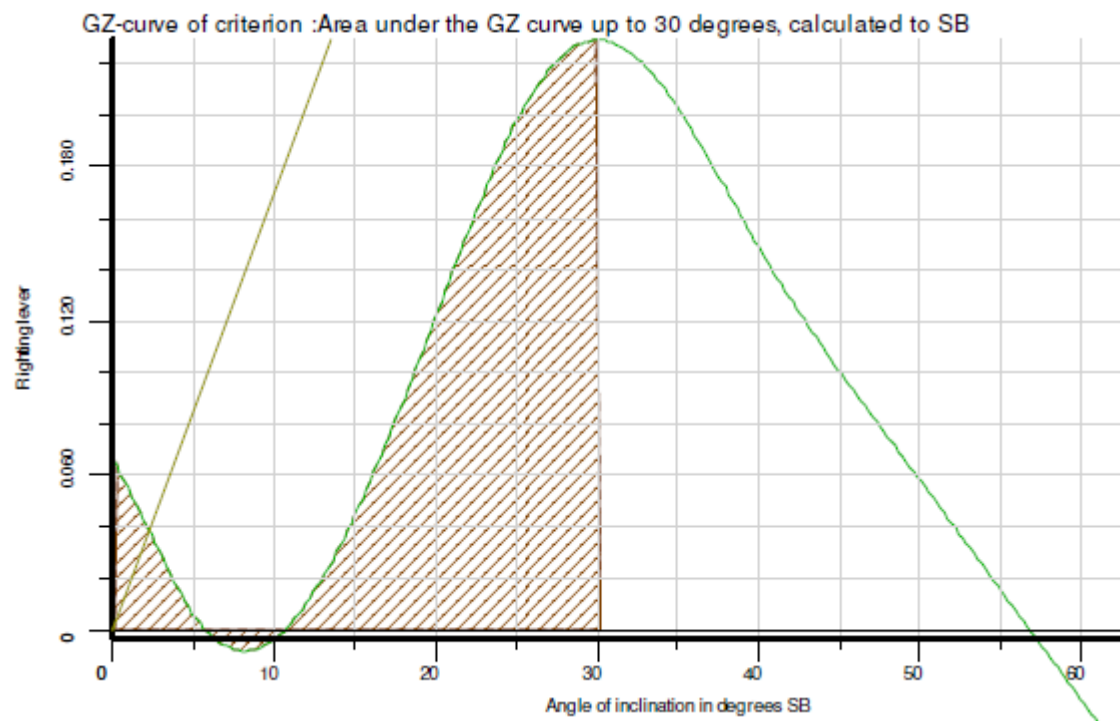
Figure 24 - Step 4, derrick 35°, with wind

Figure 24 represents the condition into step 4, derricks at 35° and 15m<sup>3</sup> of water on deck.

<u>Hydrostatics</u>		
Draft mld.	2.406	m
Trim	-0.541	m
Statcal angle of inclination	20.32	degrees PS
Statcal angle of inclination	10.68	degrees SB
Flooding angle PS	>70.00	degrees
Flooding angle SB	>70.00	degrees
<u>Calculated to PS</u>		
-----Without wind		
Minimum metacentric height G'M	0.500	0.977 meter
Maximum GZ at 30 degrees or more	0.240	0.113 meter
Top of the GZ curve at least at	25.000	30.700 degrees PS
Area under the GZ curve up to 30 degrees	0.066	0.012 mrad
Area under the GZ curve up to 40 degrees	0.108	0.027 mrad
Area under the GZ curve between 30 and 40 degrees	0.036	0.016 mrad
-----With wind [7Bft]		
Maximum GZ at 30 degrees or more	0.240	0.083 meter
Top of the GZ curve at least at	25.000	30.700 degrees PS
Area under the GZ curve up to 30 degrees	0.066	0.007 mrad
Area under the GZ curve up to 40 degrees	0.108	0.018 mrad
Area under the GZ curve between 30 and 40 degrees	0.036	0.011 mrad
----- Additional information

**Loading condition DOES NOT comply with the stated criteria.**

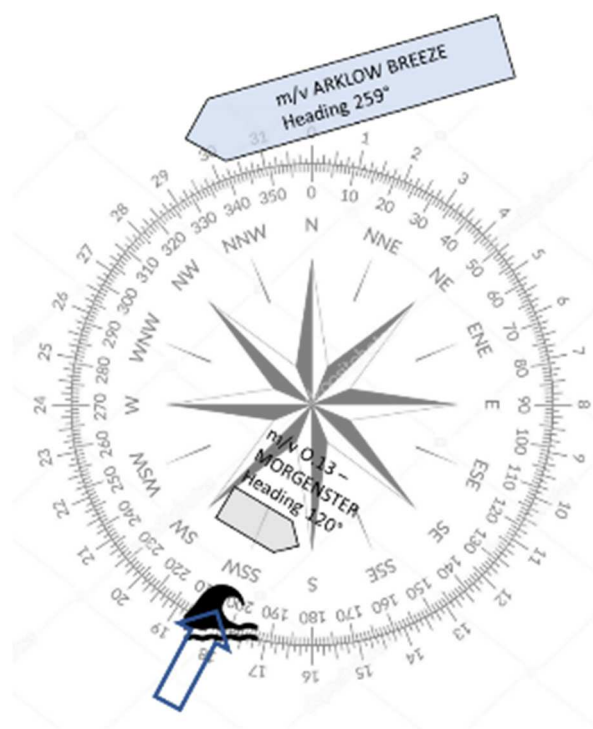
Figure 25 - Beam waves

The heading of fv O.13 - MORGENSTER was 120°. Beam waves were coming in on SB, as shown in Figure 25.

It was not possible to determine the effect of beam waves as there was no calculation model available for beam waves.

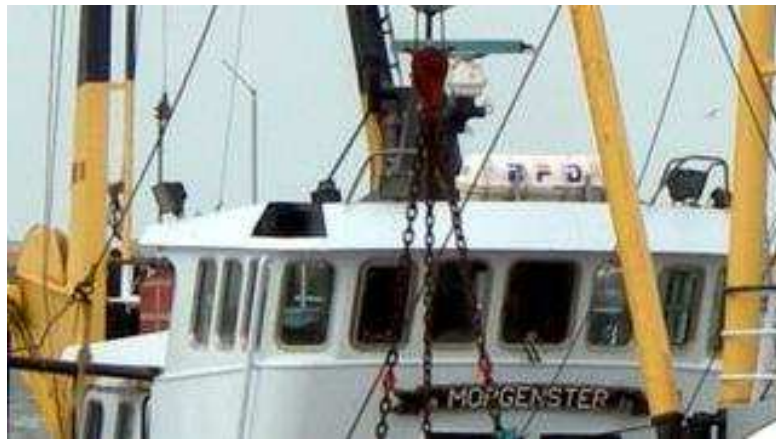
*Figure 28 - Position of the life raft on board*

Probably obstructed by SB net and/or stuck under the vessel, the life raft did not come afloat.

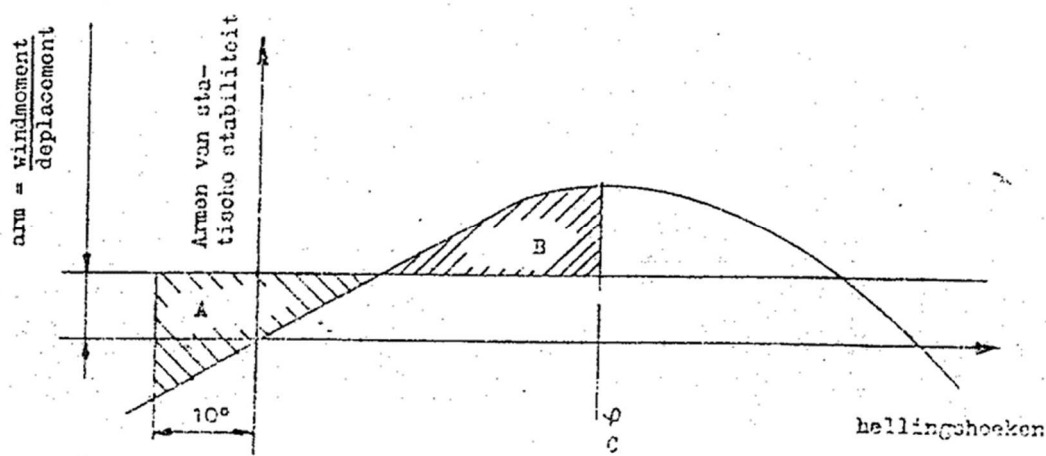
The calculation of the angle of heel ( $\varphi_c$ ) caused by the wind moment should be based on a windward angle of heel of 10°; see the corresponding figure. Surface B indicated in this figure must be equal to surface A indicated.

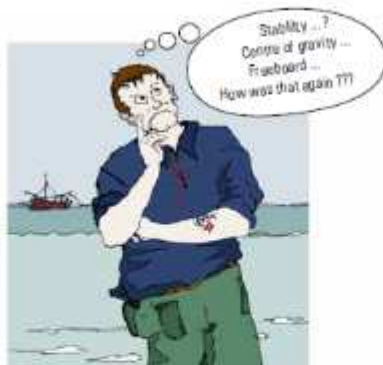
Different factors affect a vessel's stability.

Basically it is the ratio between the centre of gravity and the distribution of a vessel's buoyancy that determines the vessel's ability to get back on an even keel.

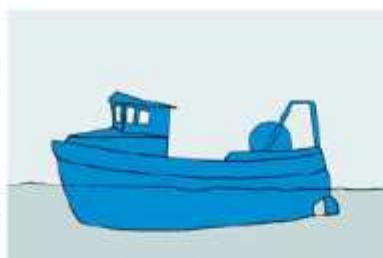
This is the weight of the unrigged vessel without gear, fuel oil, water, ice, boxes, crew, provisions, catch, etc.

Lightweight changes e.g. when the vessel is fitted with optional equipment, when switching engines, winches or other fixed components.

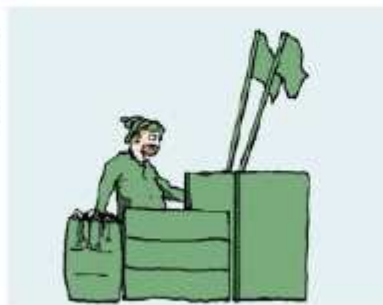
This is the term for all the weights the crew takes on board in order to fish or during fishing. Deadweight includes equipment, fuel oil, water, ice, boxes, crew, provisions, catch, etc.

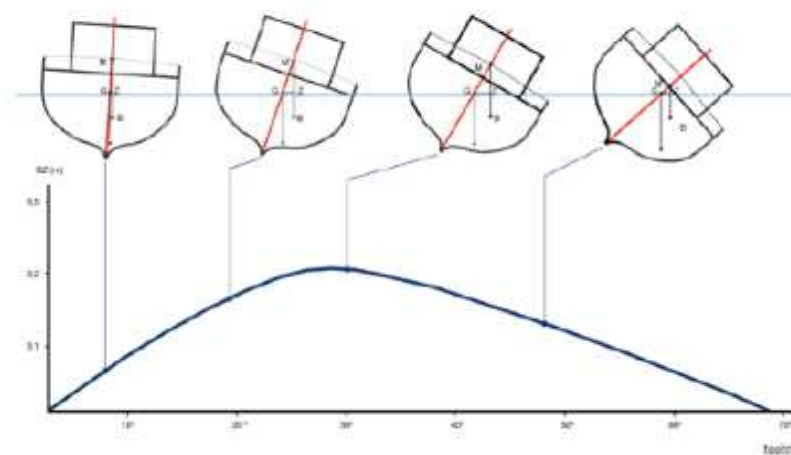
$GZ$  values at different degrees of heeling can be plotted to form a curve as shown below - called a  $GZ$  curve.

$GZ$  curves give a quick impression of the vessel and its stability. Different types of vessels have different  $GZ$  curves.

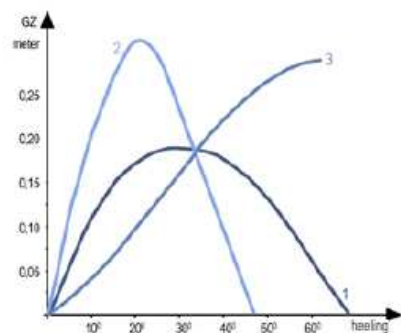
The illustration below shows 3 GZ curves for 3 different types of vessels.

**Curve 1** is for a traditional deck vessel. The curve peaks at approx. 25 degrees and extends to approx. 70 degrees.

**Curve 2** is a wide flat-bottomed vessel. The curve is initially steeper than curve 1. This means that the vessel is more rigid - it has a big GM and is difficult to get to heel, but the steep curve can also be an indication that the vessel rolls faster. The vessel already reaches the maximum righting arm at a slight heel. A characteristic of these vessels is that the righting arm drops fast
