# Getting lost during solo navigation

Issued by the Air Accident Investigation Unit of Belgium, section of the FPS Mobility and Transport

Issue 5 / November 2018 – Original version based on safety briefing from an ATO

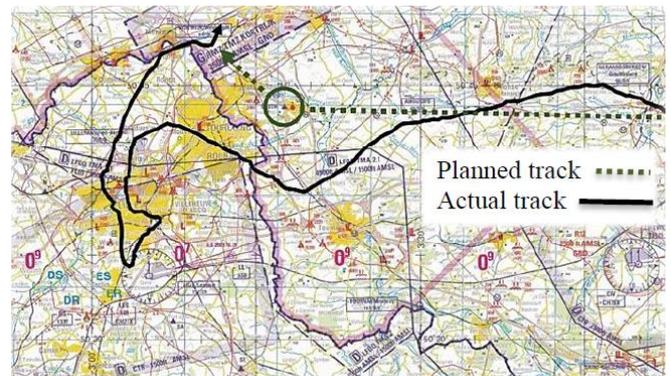
Figure 1

For what concerns the routing, I had to proceed via NW (exit North RWY25 EBKI), Braine-l'Alleud, Tubize, S1 (entry point of EBKT), S2, then integrate the circuit at EBKT. I was in contact with EBKI TWR on 121.3 to NW, and my transponder indicated 2000. Shortly after leaving this point, I left their frequency for Brussels Information on 126.9, and I set my transponder to 7000. Contact Brussels Information, and after giving my route and all required information, ATC asked me to set my transponder back to 2000, which I did. So I proceeded on Braine-l'Alleud and Tubize without the slightest problem, before turning on the long leg (about 30 NM) towards S1. About 5 minutes before my arrival on S1, I asked to leave the frequency to switch on Kortrijk Radio.

I was not sure I found this point S1 when I veered North to reach S2. There was a bit of drift, but I thought that what I was identifying on the ground was S1. Of course, the sequence of landmarks did not correspond with what I should have found on my map ... So I tried to identify other landmarks to find my position, which were also inaccurate thereafter. I did not go back to the Brussels Information frequency directly, as I thought I still had reliable landmarks. I disregarded my stopwatch, judging that it was giving me no more useful

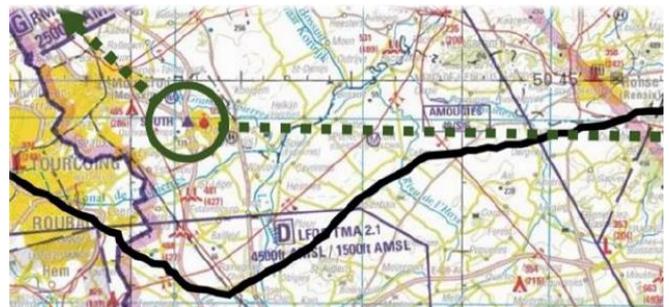
Figure 2

- **Navigational error:** South of Amougies, a deviation of 40°, noticeable on radar track, happened approximately 5 minutes prior reaching EBKT. Looking at S-PIC's report, that was the time when he left Brussels Info for Kortrijk Radio. Because that specific deviation led to the mis-happening, let's focus on that particular moment. Although flight instruments were working properly, we can imagine that S-PIC mis-prioritized the task in his cockpit, probably busy with his Nav Log / Map / Comm box instead of aviating - navigating and then communicate ...
