# **Safety Investigation Report**

Ref. AAIU-2019-05-29-01 Issue date: 9 September 2021 Status: Final

During a proficiency check for the renewal of a SEP (Single Engine Piston) rating, the aircraft experienced a tail strike.

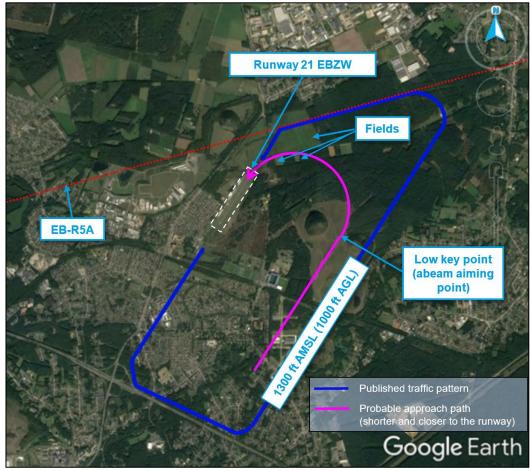
Figure 1: probable flight path (magenta) and traffic pattern (blue) as published by Jeppesen (formerly 'Bottlang')

A small navigation flight was done towards the airfield of Zwartberg-Genk (EBZW) to execute some manoeuvres. After 2 normal approaches (touch and go's) on runway 21, the Flight examiner (FE) initiated a simulated engine failure abeam the landing position at 1000 ft (low keypoint).

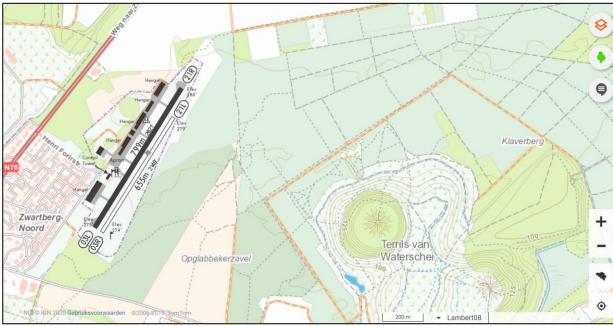
Figure 5: Topographical map (NGI) with Jeppesen aerodrome chart superimposed on it

Genk is a former coal mining region, and there is a coal mine spoil tip (identified as the "Terril van Waterschei" in Dutch on Figure 5 hereunder) remaining from these times, located east of the airfield at 1.15km from the runway, close to the pattern. The spoil tip culminates at 666 ft AGL. The elevation of the airfield is 278 ft.

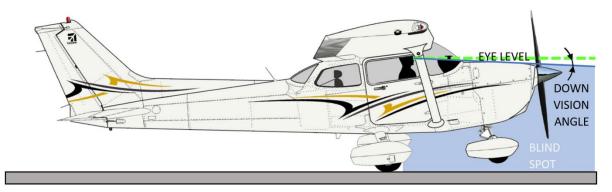
Figure 9: normal touchdown with still a 'down vision angle', still seeing the end of runway

Perhaps the flaps and ground effect were used to 'stretch' the glide. However, this required an increased pitch angle to generate sufficient lift. The damage to the tail shows that the pitch was at least 12,5 degrees.
