# Safety Investigation Report

Ref. AAIU-2012-08

**Classification:** Serious incident

**Aircraft:** CESSNA F150M

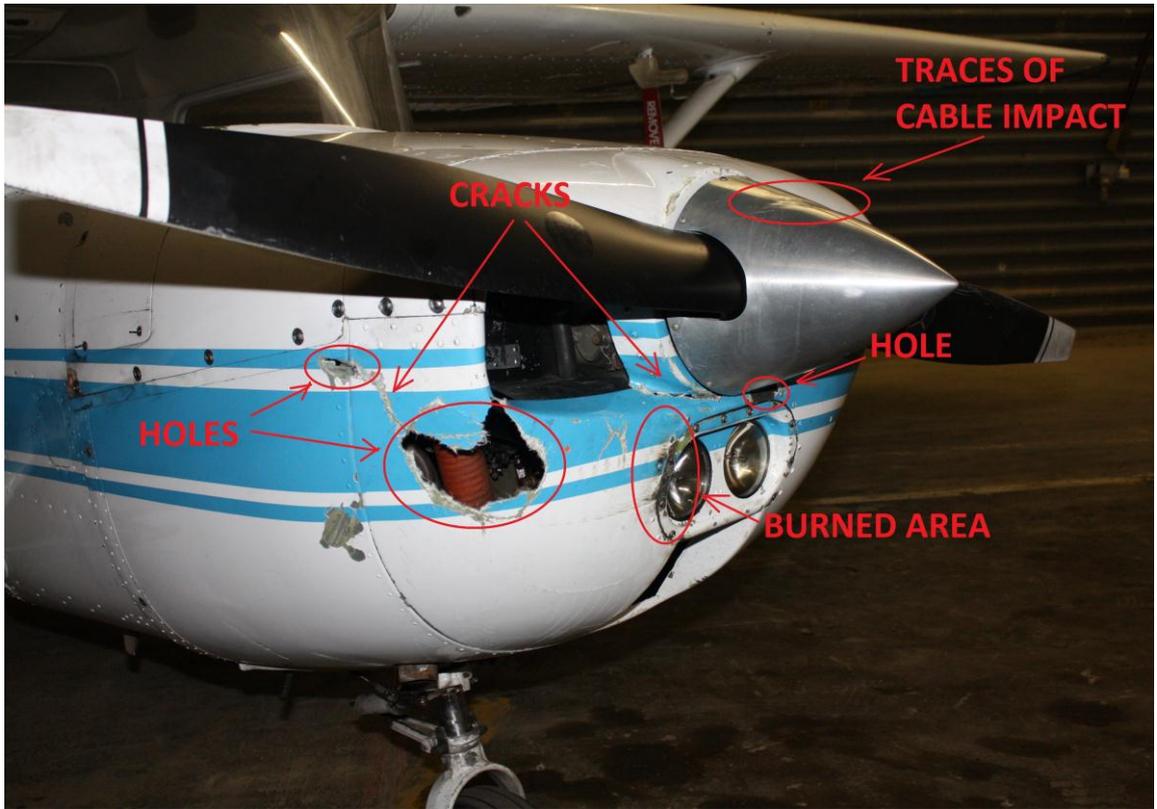
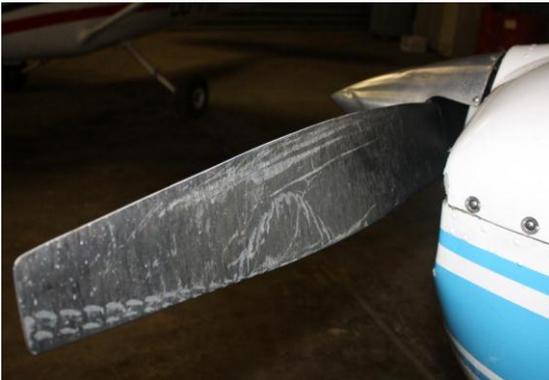
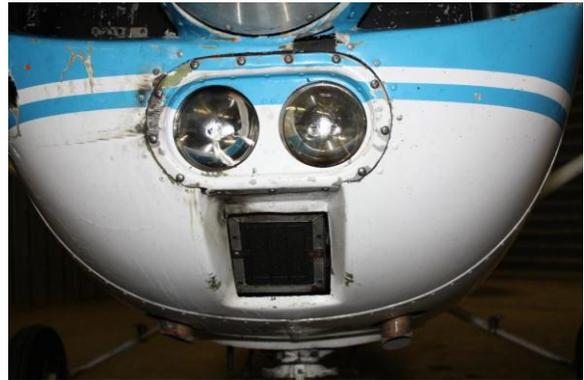
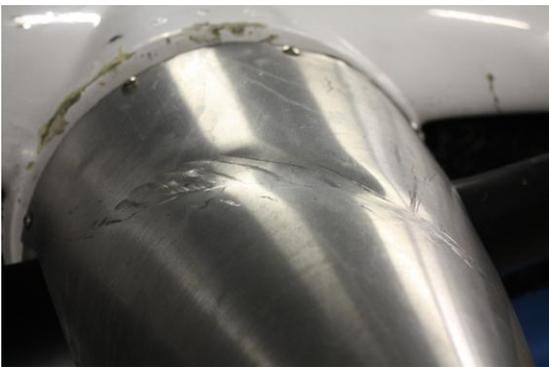
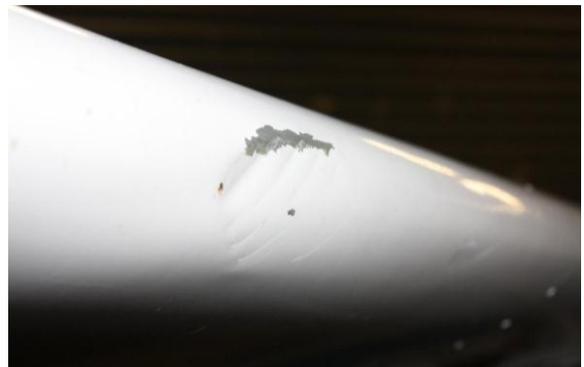
The damage was concentrated on the engine cowling and spinner. Minor cable impact damage was also visible on both the intrados and extrados of the propeller blades (scratches) and on the right hand wing leading edge (small recess).

The damage seemed consecutive to a collision with an electrical power line, owing to the cable strand indications on the propeller blades and spinner and the burning traces around the engine air intake.

As the crew did not notice the exact location of where the incident occurred and no complaint was filed by the owner of the power cable, the exact location of the cables could not be retrieved. Therefore the damage and the type of the cables could not be determined. However it is assumed that the cable(s) was (were) relatively small and were cut by the impact
