Inspection of control cables in general aviation

Issued by the Air Accident Investigation Unit of Belgium, section of the FPS Mobility and Transport

Issue 4 / July 2018 – based on Safety Information Note 2016-2

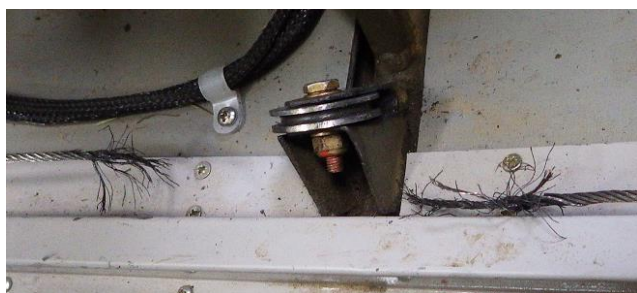
Figure 1: failed left rudder control cable

The left rudder control cable of the aeroplane failed completely at the point the cable ran over the first guide pulley (fig. 1).

The cable failed due to the cumulative effects of both fatigue cracking of the individual strand wires and chaffing wear. The cable suffered multiple wire failures on the inside bend of the cable, specifically where it contacts the pulley.

- In order to detect failed wires in control cables, prevent cable separation and possible loss of control, AAIU(Be) advises to inspect flight control cables in accordance to the applicable maintenance program using **FAA AC 43-13-1B, chapter 7, section 8, paragraph 7-149(d)** as a guidance, particularly in the areas of the cable at the specific points of contacts with the pulleys and guides. This includes amongst others:

- A **close inspection in the critical fatigue area** by first moving the controls towards its stops in order to clear the area to be inspected and thereafter **pass a cloth over the cable**. This will clean the cable for visual inspections and detect broken wires if the cloth snags on the cable.

- A **visual inspection of the cable**, eventually by removing and **slightly bending the cable** at the critical area, to detect otherwise hidden damage.

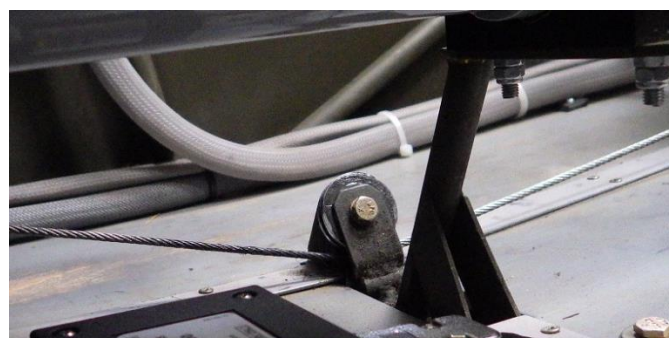
Figure 3: right rudder control cable

The right rudder control cable did not fail but showed also the same phenomenon of individual failed strand wires and chaffing.

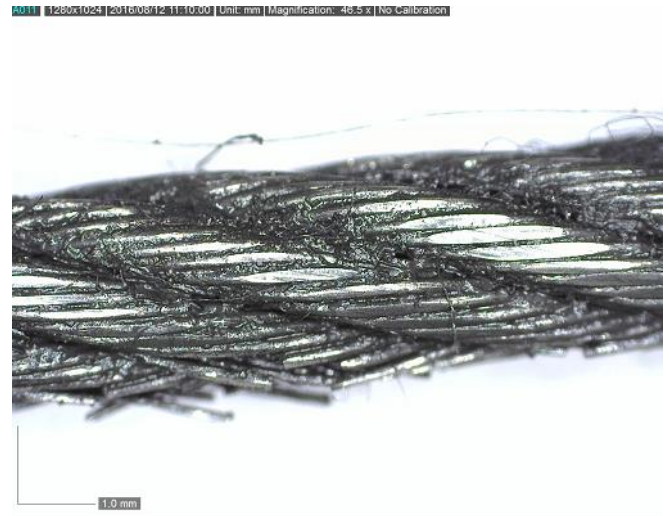
Figure 6: right rudder cable (with grease)

Both cables were greased at the point of contact with the pulley. Close examination of the cable showed accumulation of dirt at that position, as grease tends to attract dirt and the compound is believed to increase inter-wire friction, causing wear. The presence of extensive grease prevented also the visual detection of failed wires.

- The **use of grease** on control cables (unless required per maintenance manual) is **to be avoided**.

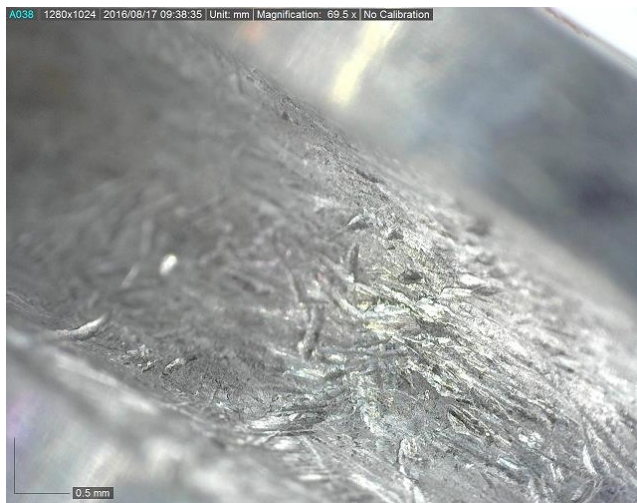
Figure 5: pulley groove damage

The inner surface of the left pulley groove showed damaged caused by chafing with the damaged cable.

Two small wire strand bits were found in the pulley groove.

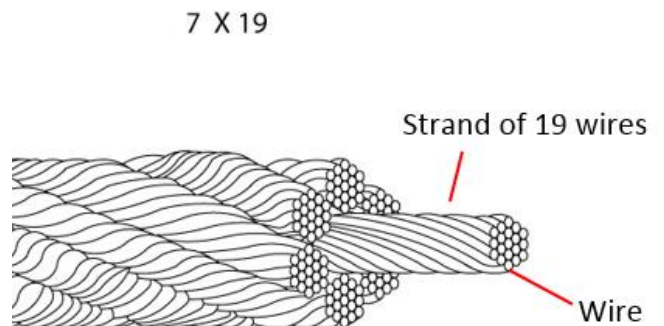
Figure 7: Construction of the control cable

The rudder cable was identified as a 1/8" diameter spiral-wound galvanized carbon steel cable, of 7 strands, each of 19 wire construction (7x19).

The cable had been installed when the aircraft was manufactured in January 2013 and had been in service for 500 hours since new.
