Safety matter

Following a serious incident, this note has been made to remind to not use the airstair when the stair's guiderails are removed and no two-way communication is established with the cabin crew.

Related incident

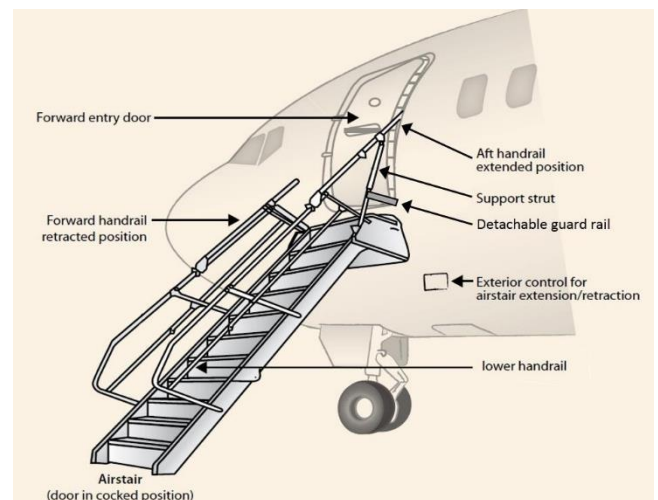
Figure 1: Parts of the Boeing 737 airstair

Some Boeing 737 series aircraft are fitted with a retractable airstair at the forward left entry door to allow the boarding and disembarkation of passengers without the need for additional ground support equipment. The airstair is stowed inside a compartment just below the forward entry door. It includes an integral double handrail on either side. These rise into position during deployment of the

stairs, but due to the geometric restrictions imposed by the retraction mechanism design, they do not extend to the fuselage side.

In order to bridge the gap between the top of the handrails and the fuselage, a manually extendable upper handrail is fitted to each of the integral rails. After deployment of the airstair, these are extended and secured to support brackets inside the entry door. Each extendable rail is supported by a strut extending from the side rail of the airstair. The airstair is electrically operated and may be controlled from either outside or inside the airplane via switches on the forward attendant panel in the cabin.

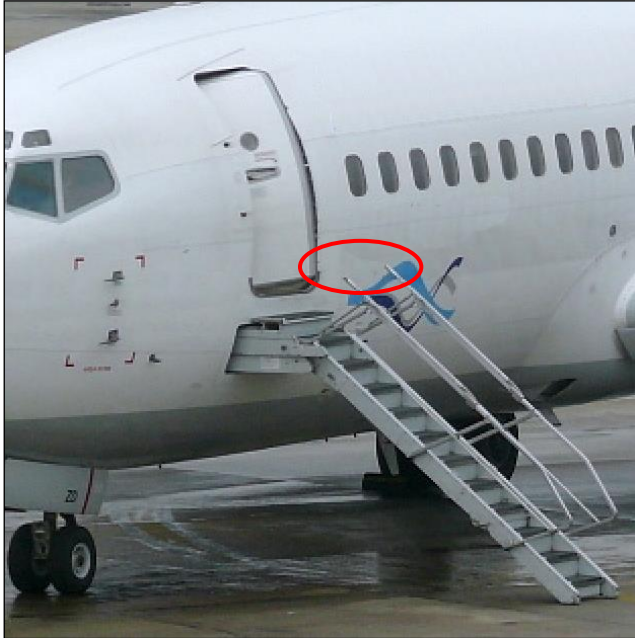
Figure 2: Door in ‘cocked’ position and retracted handrails (red encircled)

Then the door is pulled over and left in the ‘cocked’¹ position . This is because on one hand the airstair can’t be operated from the inside when the door is closed and on the other hand to provide maximum safety protection to the cabin crew when working close to the door frame.

- Any person intending to use the B737 forward airstair to enter the aircraft should verify the **presence of the upper handrails of an airstair**, the absence of it (see Figure 2) is a danger anyway.
- Moreover, the entry door in the **cocked position** is a sign that the airstair is highly probably about to be retracted. In this case, the person wanting to enter the airplane must
 - first **establish a two-way communication** with the cabin crew
 - **wait** until the door has been **fully opened** again by a cabin crew member.

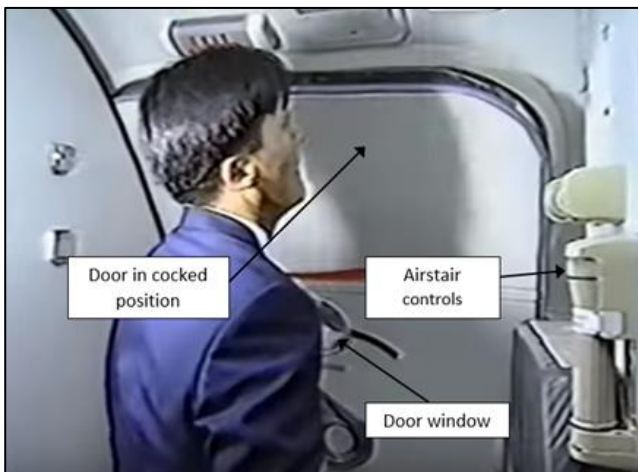
Figure 3: Screenshot from flight attendant training video (former Canadian Airlines)

The airstair is finally retracted by operating a switch on an attendant panel. As the small door window is not at eye level, it is impossible for the cabin crew member to continuously look outside while operating the airstair, see Figure 3.

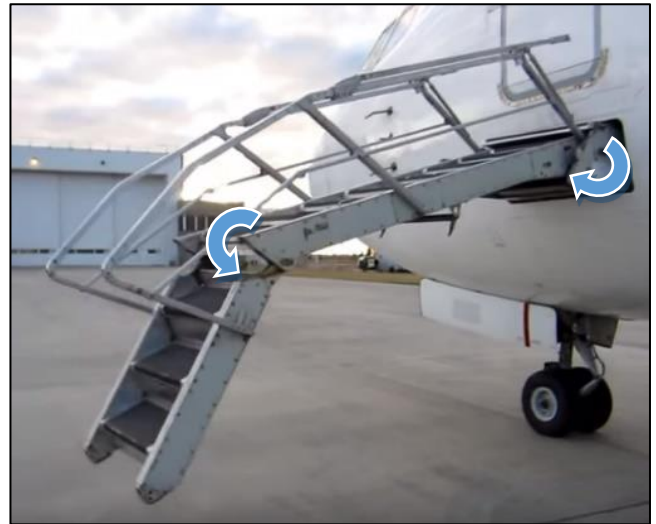
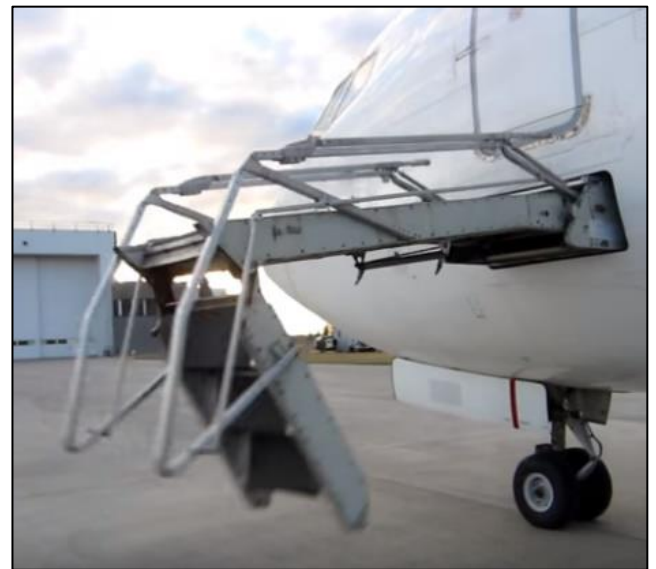
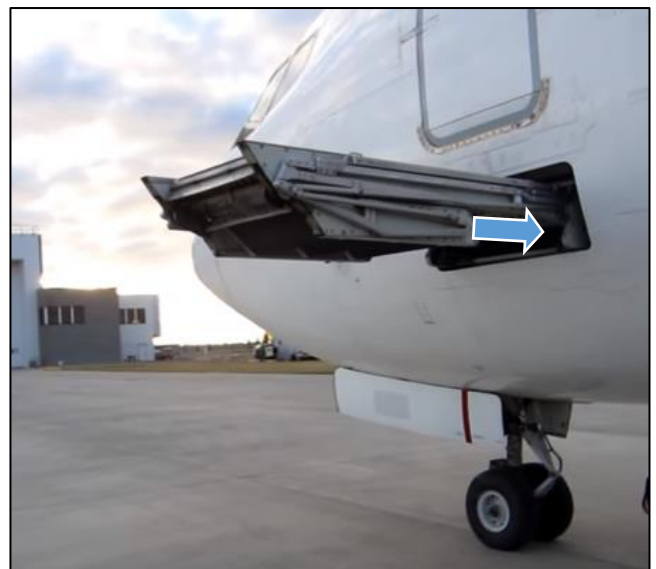
Figure 4: Sequence of airstair retraction (operated via exterior control on these pictures)
