Report on the joint investigation of the collision
between the LNG Carrier

mts **AL ORAIQ** and the mv **FLINTERSTAR** off
the coast of Belgium on 6 October 2015 with the
total loss of the mv **FLINTERSTAR**

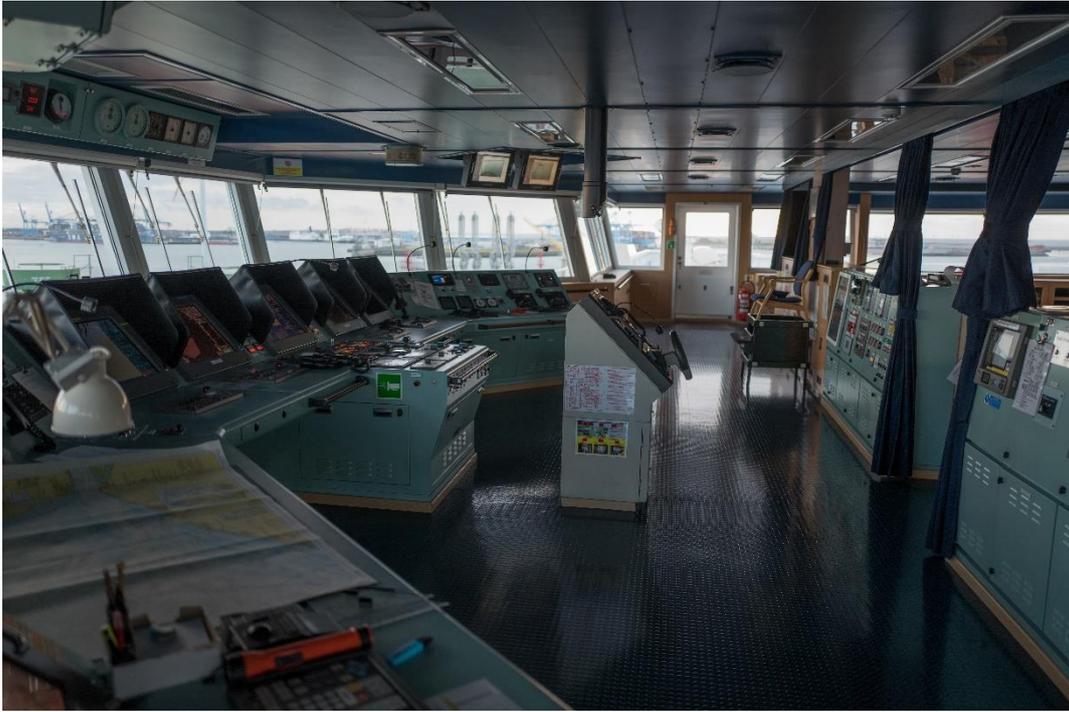
Figure 9 – Mts AL ORAIQ's wheelhouse

The mts AL ORAIQ's primary aids to navigation was ECDIS. Two independent units were fitted. The ship was fitted with an X band radar, an S band radar and ARPA. The displays are located on a console in the forward part of the wheelhouse. There were two VHF radios, both of which are located on the navigation console.

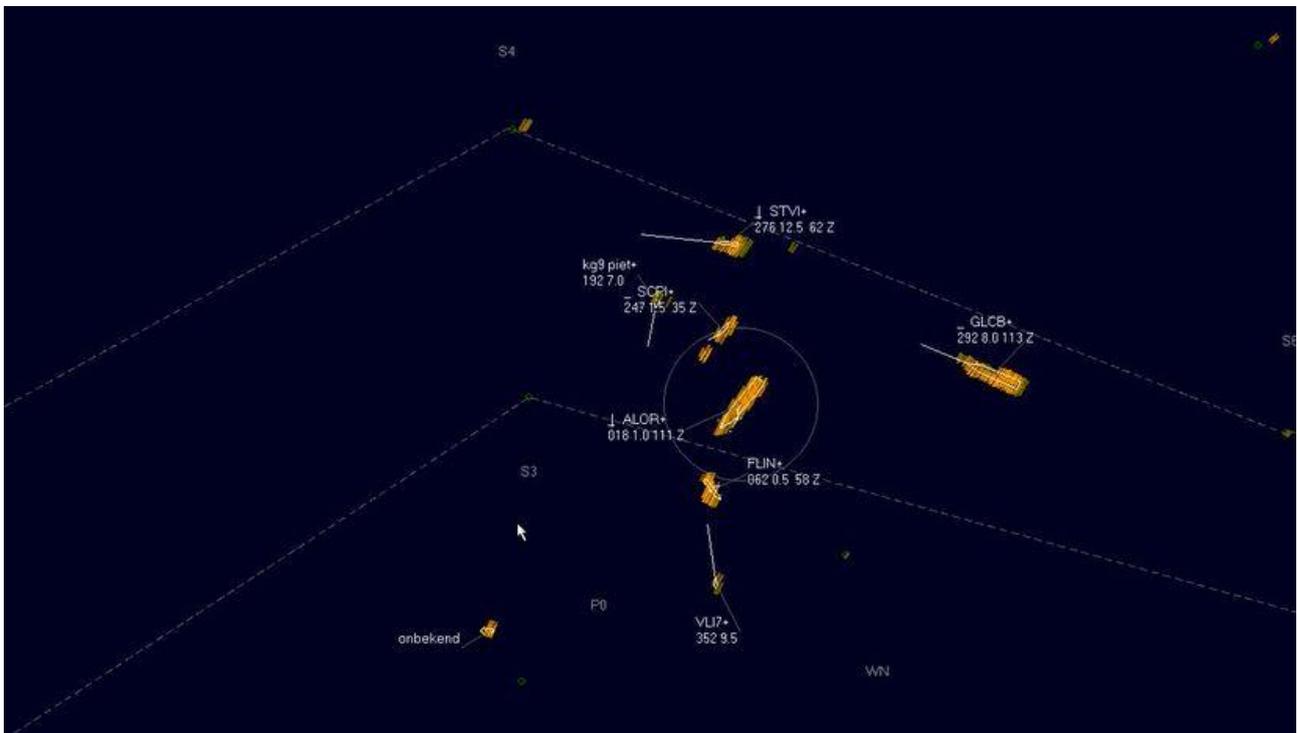
Figure 6 - mv SCOTT PIONEER & fv VLISSINGEN 7 on scene near mv FLINTERSTAR and mts AL ORAIQ as seen on the VTS radar

Immediately thereafter the Backup Coastal Pilot on board the mts AL ORAIQ inquired with Traffic Centre Zeebrugge via radiotelephone Channel 69 whether a fishing vessel in the vicinity of the collision could be identified and summoned for immediate assistance. The Coastal Pilot informed Traffic Centre Zeebrugge that the rescue boat from the mts AL ORAIQ had been launched and that several people were now in the water. Traffic Centre Zeebrugge replied that the fishing vessel could be identified as fv VLISSINGEN 7 and that the vessel had been instructed in the meantime.

The Backup Coastal Pilot on board the mts AL ORAIQ informed approaching fishing vessels, that were coming to lent assistance, that the wreck of the mv FLINTERSTAR was not fully submerged, but unlit.

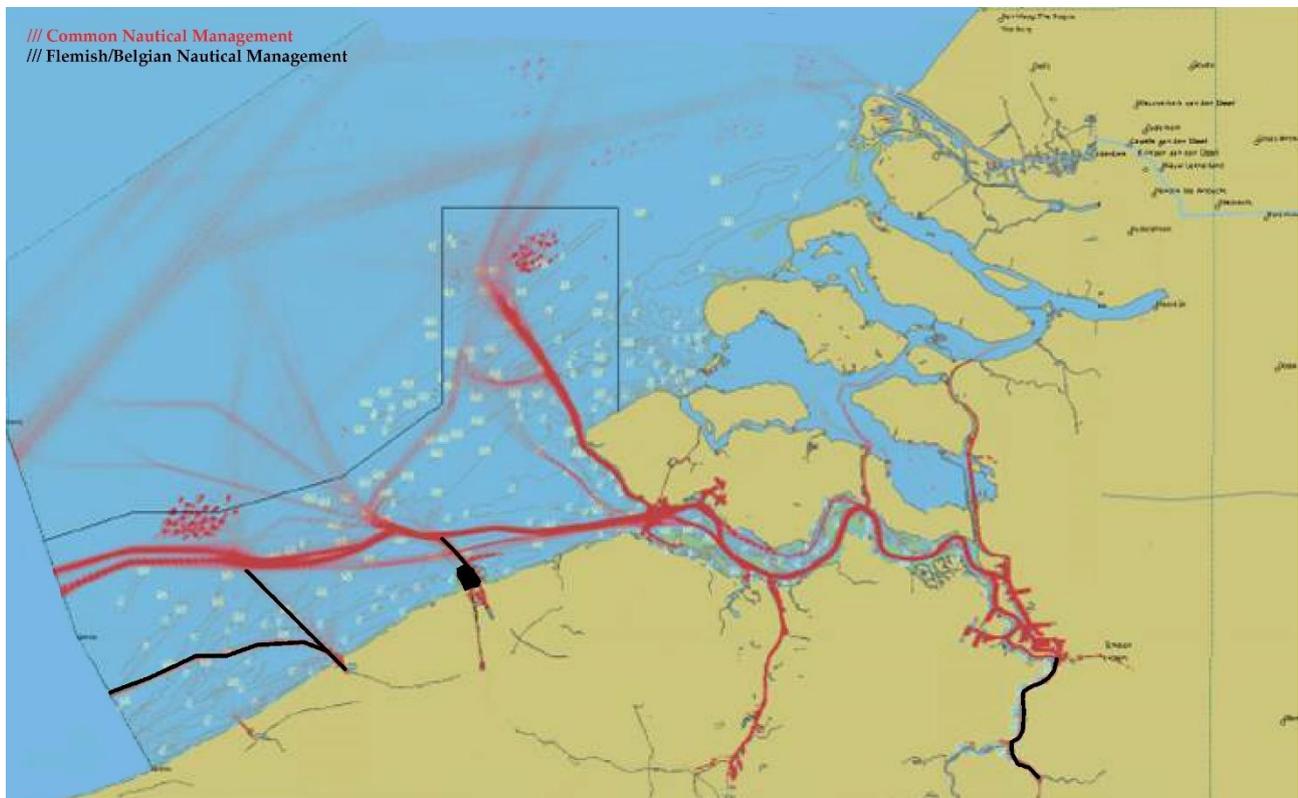
Figure 10 - Areas in black not governed by the Common Nautical Management

The common nautical management of the Scheldt Region has as purpose primarily to ensure a safe navigation in the fairways from and to ports in the Scheldt Region, including the approaches, in direct contact with the aforementioned waterways, with the exception of fairways to the Ports of Nieuwpoort, Oostende and Zeebrugge branching from the main fairways in the Scheldt Region. These branching fairways are not governed by the Common Nautical Management but are governed by the local government which governance over said branching fairways shall be in line with the Common Nautical Management. On following Figure 10 the area off the Belgian Coast, as part of the

approaches to the river Scheldt, where the Common Nautical Management is not in place at the time is delimited in yellow.

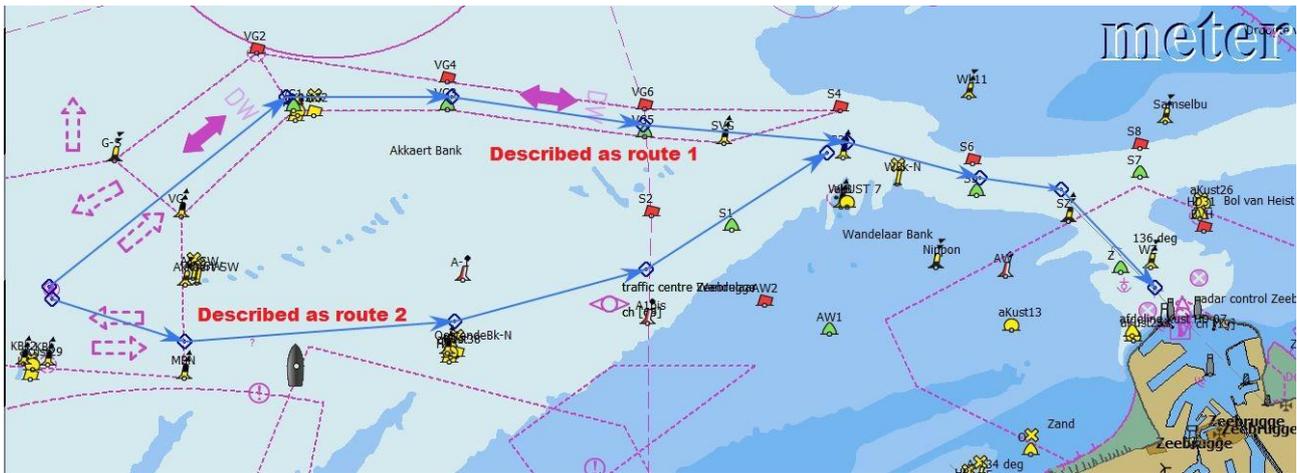
Figure 12 - Mandatory (route 1) and alternative (route 2) inbound routes for LNG Carriers

The LNG shipping procedures, published with the Notices to Mariners n°1 of 2015, clearly state that Inbound LNG carriers shall follow the route: precautionary area Wandelaar - Vaargeul 1 - S3/S4 - Ribzand - Pas van het Zand described as route 1 on Figure 12. Depending on traffic agreements made earlier and on fairway obstructions, LNG carriers

can deviate from this and follow the route Akkaert-SW - A1 - Scheur West - Ribzand and Pas van het Zand describes a route 2 on Figure 12.

At the time of the collision between the mts AL ORAIQ and the mv FLINTERSTAR on 6 October 2015, the mts AL ORAIQ was sailing inbound following the alternative route, described as route 2 on Figure 12.
