Report on the investigation into the capsizing of the
fishing vessel

Z 582 ASSANAT

off the British coast near Margate with the loss of two lives
on 27 December 2016

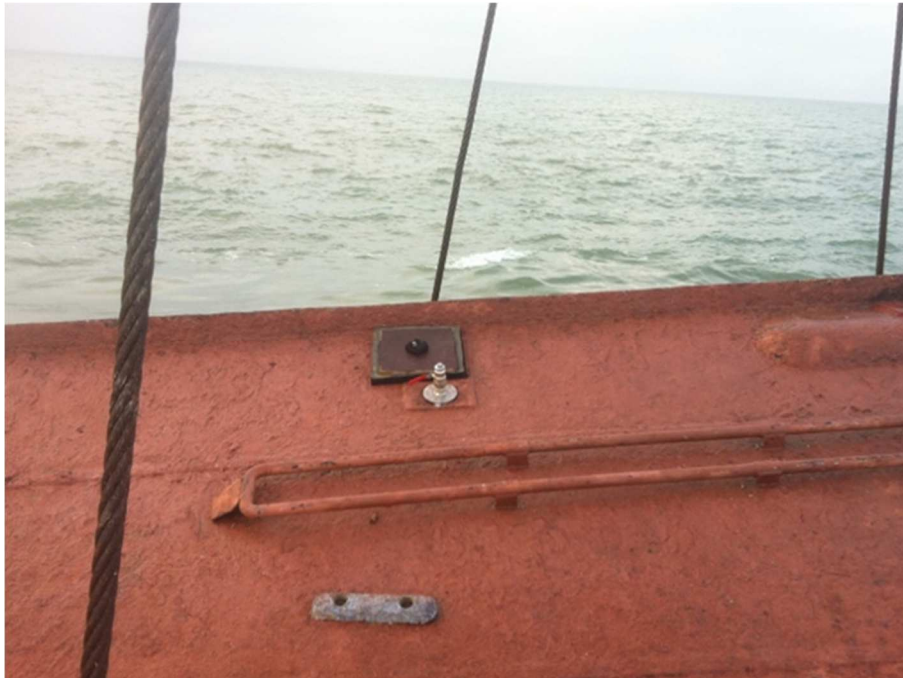
Figure 5 - Hot taps placed onto hull of Z582 ASSANAT

A salvage company sent a rescue vessel on scene and after having arrived a rescue worker placed hot taps onto the overturned hull of the fv Z582 ASSANAT to prevent the derelict from sinking.

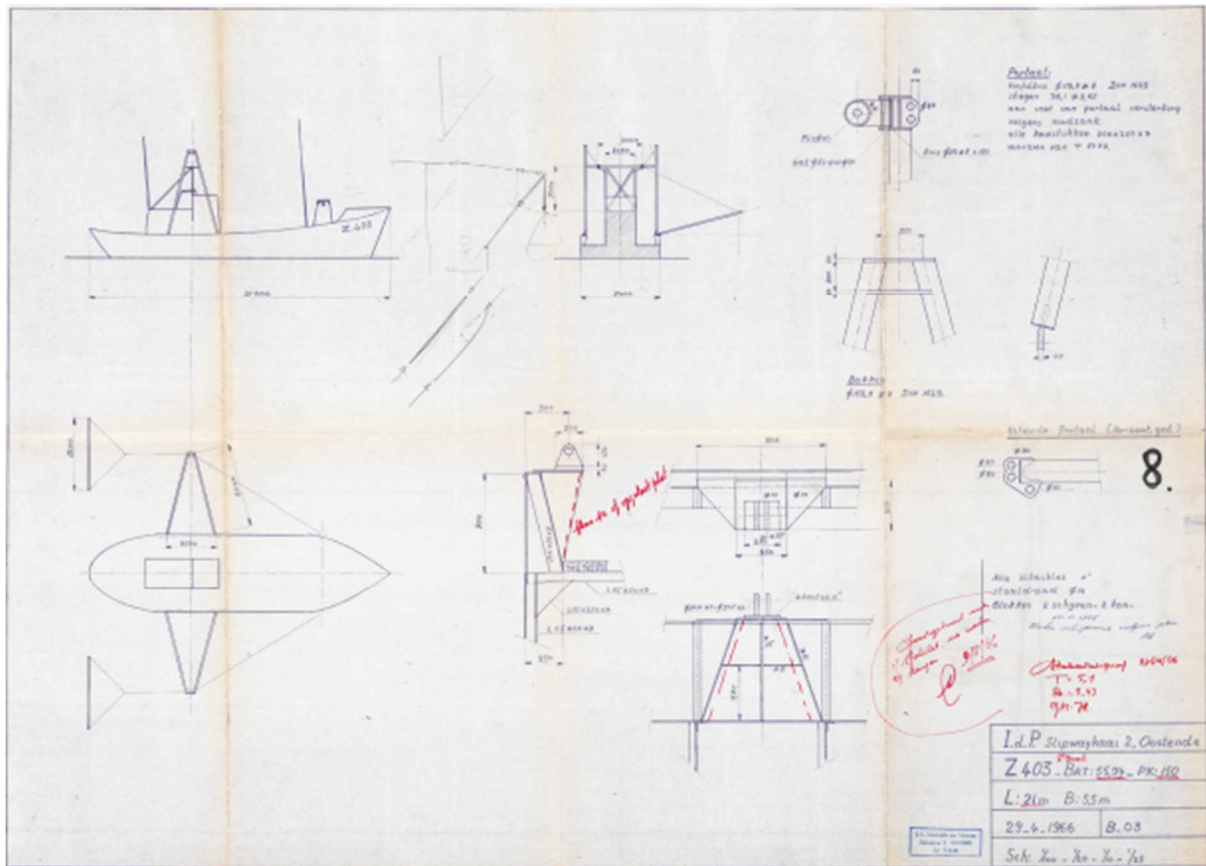
Figure 11- Original building plan with A - Frames

The fv Z582 ASSANAT was originally built in 1963 as Z403 STERN, with A frames instead of booms as seen in Figure 11 on page 1919.

On Figure 11 on page 19 a handwritten note from 1966 was found indicating that the initial GM was 72 after an inclining test. No unit was indicated, however, it was assumed to be in centimetres. The origin of said values could not be determined.

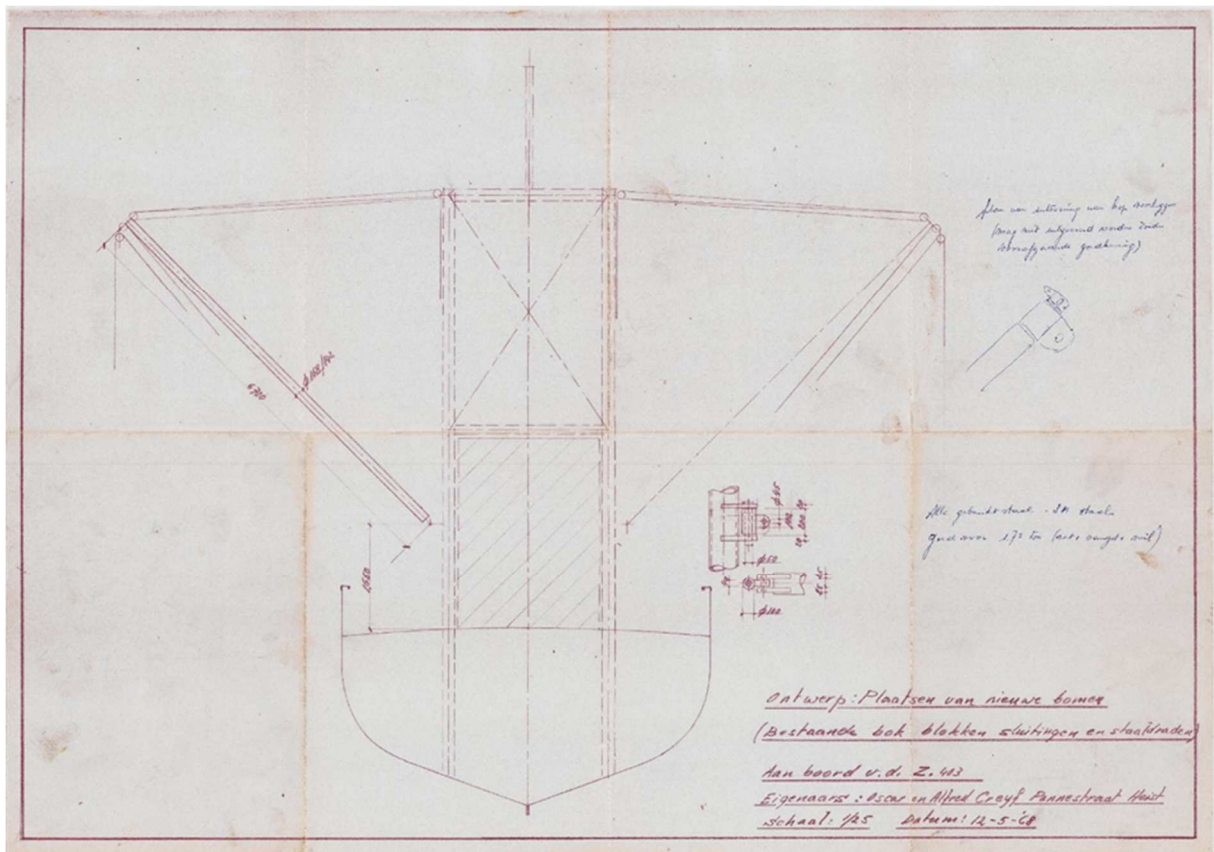
Figure 12 - Plans of booms to replace the existing A - Frames

The A frames were hinged to allow for in up and down movement. Later , in 1968, the A frames were replaced with typical booms, with a length of 6,70 m, as seen in Figure 12 on page 20.

Later the booms were again replaced with different ones with a length of 9,00 m.

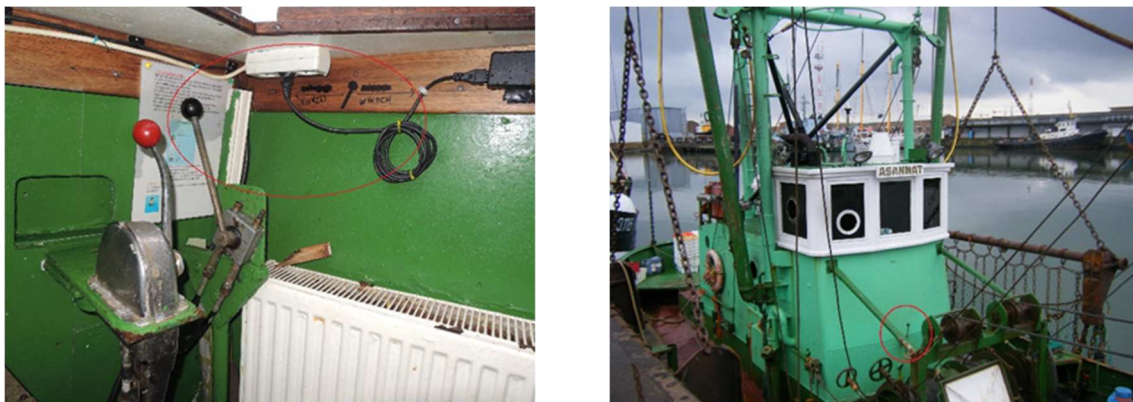
*Figure 17 - winch control valves inside the wheel house and on facing of superstructure
of fv Z582 ASSANAT (archive pictures)*

Inside the wheel house, by means of permanent marker, it was indicated how to operate the lever of the hydraulic valve to increase or decrease the speed and how to heave or slack.

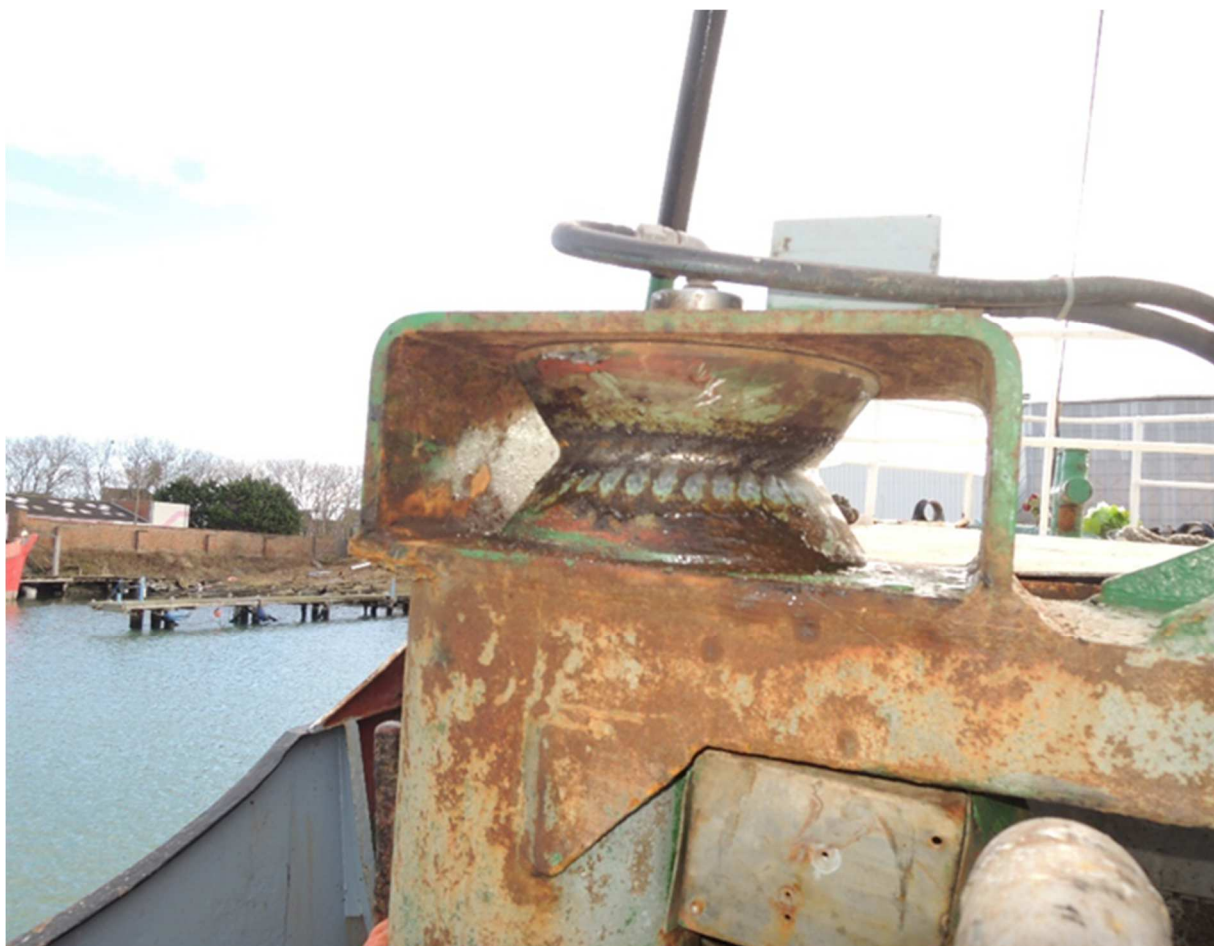
Fairleads on deck, through which the warps of the fishing nets were rigged were equipped with a patented length of line and force meter as an indicator for when the nets would be entangled with objects on the seabed as seen in Figure 18 on page 26.

The system did not foresee in letting go of the nets or automatically reducing the revolutions of the main engine in case of entanglement of the fishing nets.

*Figure 18 - fairlead through which the net warp was rigged
equipped with hydraulics to measure line length of the warp and forces on the warp*

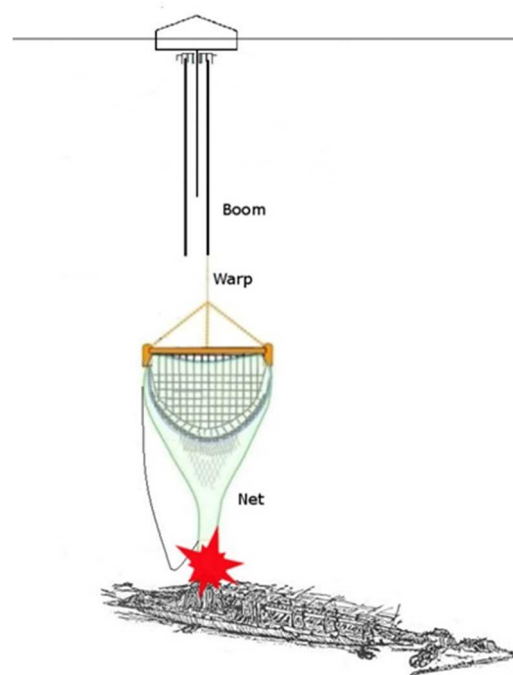
The skipper of the rescue craft, that had towed the overturned derelict of the fv Z582 ASSANAT to a rendezvous point with the crane barge CORMORANT, had declared that during the tow, the speed had been reduced a few times by external factors. Considering the length of the fishing net and the boom, and the water depth and the presence of several wrecks on the bottom of the sea, there was a possibility that the net had been damaged during the tow from the place

where the derelict of the Z582 ASSANAT had been fastened to the rescue craft to rendezvous point with the crane barge CORMORANT as seen in Figure 32 on page 46.

*Figure 32 - Pictorial representation of net being entangled during tow
(not to scale)*

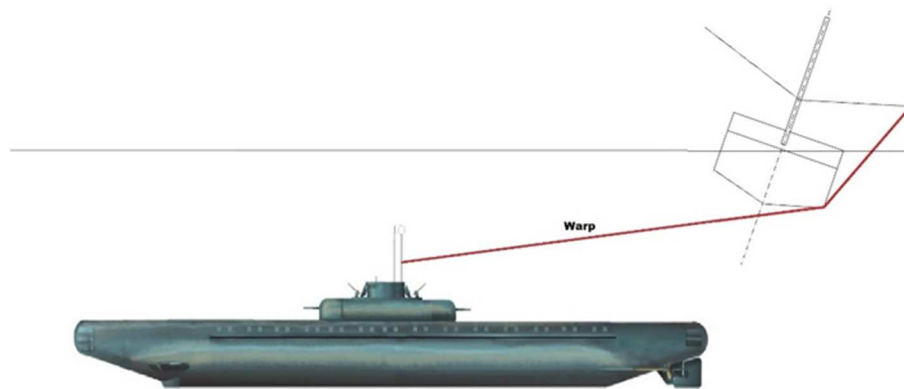
The submersible snagging the starboard net would have created a situation as in Figure 33.

*Figure 33 - Pictorial representation of submersible snagging fishing net
(not to scale)*

The hypothesis whereby a submersible snagged the starboard net of the Z582 ASSANAT, and created enough torque to turn the Z582 ASSANAT upside down in the water would have been as in paragraph 7.1.3 Forces acting on booms during beam trawling when fishing vessels run off course on page 32 whereby the component V increased to such extent that the initial stability of the fv Z582 ASSANAT is lost. The underwater velocity of the submersible would also have had an increasing effect on the torque necessary to turn the fv Z582 ASSANAT upside down.

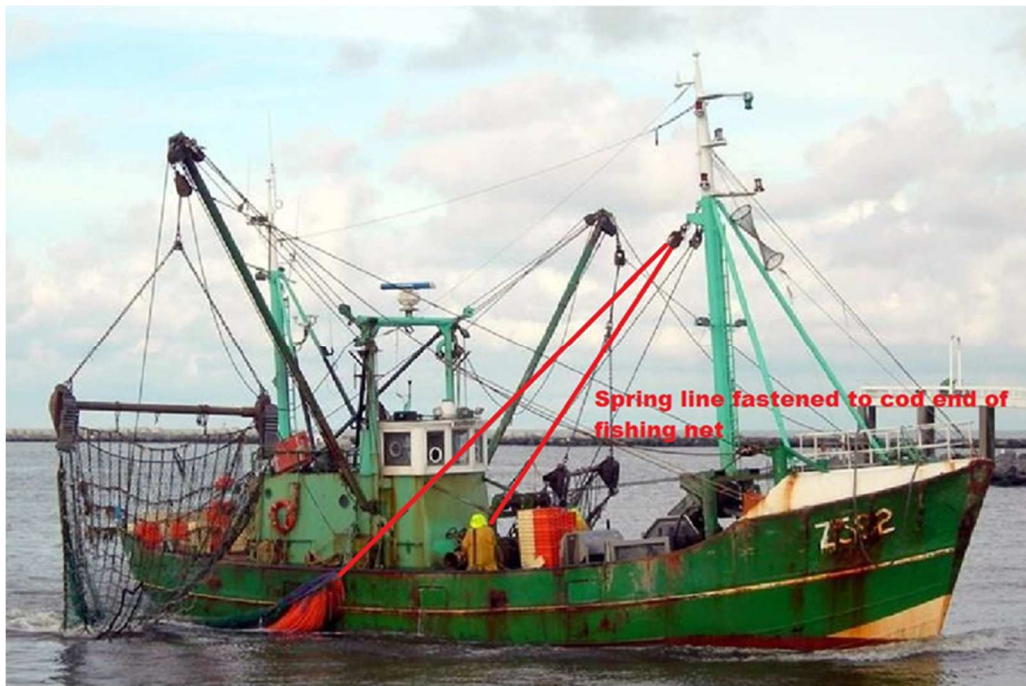
After the nets are symmetrically hoisted to water level, crewmembers fastened a spring line, a natural fibre rope, to the lazy tackle of the starboard net allowing them to hoist the cod end over the bulwark, by running the spring line on the turning warping head of the winch.

The spring line was rigged through a pulley that was attached to the mast of the fv Z582 ASSANAT at approximately 10 metres above the base of the vessel as seen in Figure 35 on page 50.

*Figure 35 – spring line (coloured red) fastened to starboard fishing net
on board the Z582 ASSANAT archive picture)*

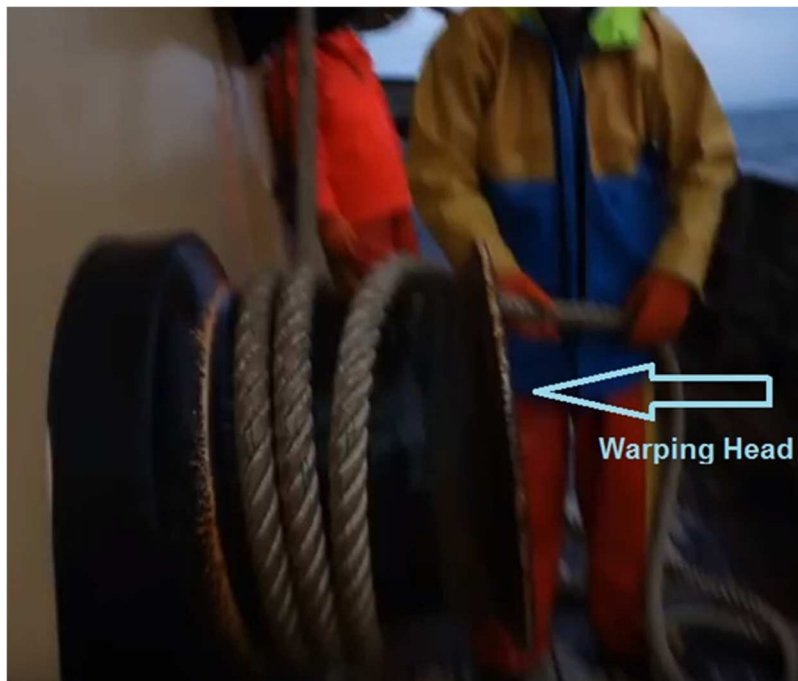
Figure 36 - Running a spring line over a turning warping head of a winch

When the hoist reached the desired height, the crewmember running the spring line over the warping head of the winch slacked the spring line over the turning warping head, whilst another crewmember manipulated the cod end on deck.

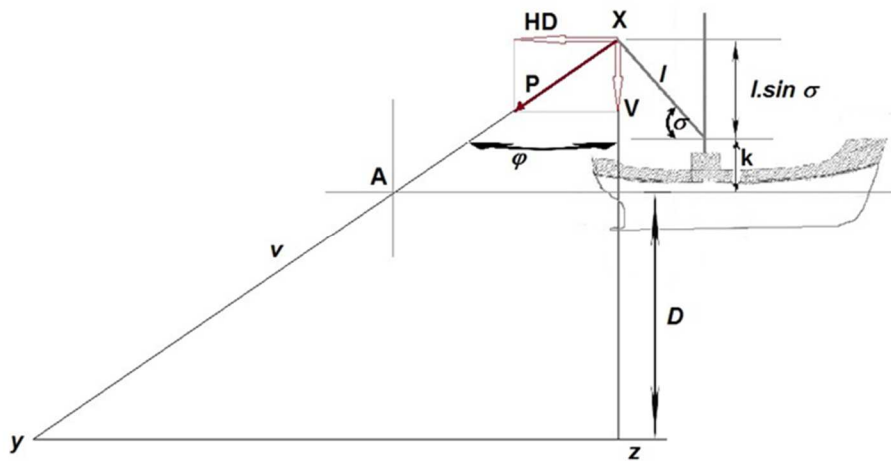
Figure 39 - forces acting upon booms when trawling

From Figure 39 we learn that:

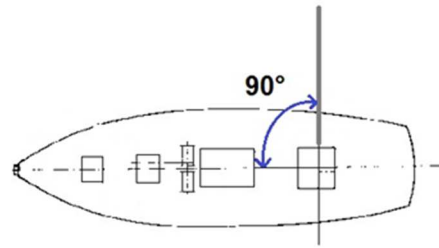
Figure 41 - Angle between boom and keel

The arm of the torque equals $l * \cos\sigma$. It is assumed in this equation that the angle in the horizontal plane between the boom and the keel is 90° as in Figure 41 on page 75.
