Report 2017-02 on the investigation into the capsizing and subsequent  
rescue mission of the sailing vessel

# CAPELLA

Off the Belgian coast with the loss of three lives on July 1<sup>st</sup> 2017

***Federal Bureau for the Investigation of Maritime Accidents (FEBIMA)***

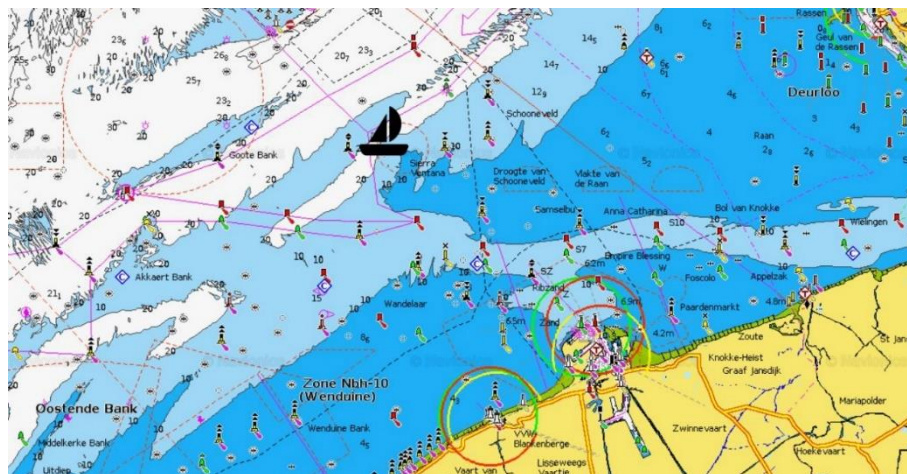
*Figure 1 - Approximate position of the capsizing of the sy CAPELLA  
off the Belgian Coast at 08:14 lt on July 1st 2017*

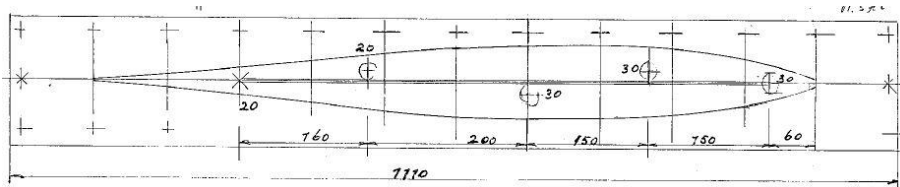
Four threaded rods had a diameter of 30 mm, the aftermost threaded rod had a diameter of 20 mm. The threaded rods or keel bolts were all located near or on the centre line of the keel. The additional two bolts were not included in the drawing.

*Figure 10 - Drawing of keel plate seen from top with configuration of threaded rods*

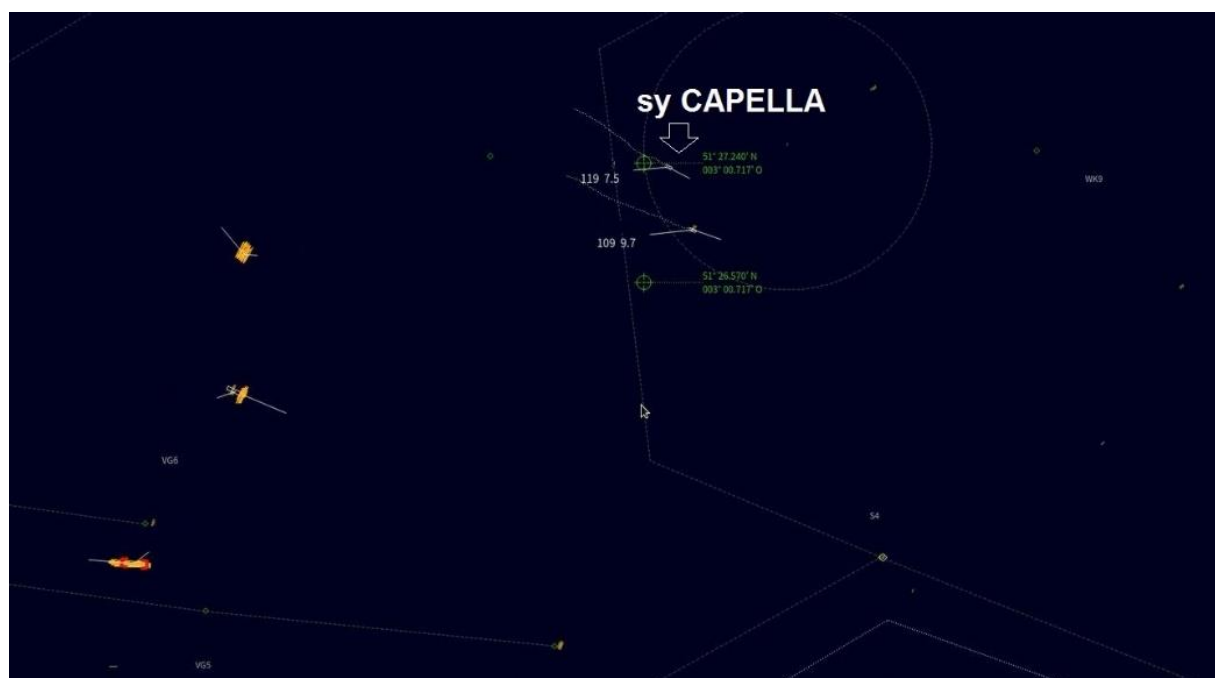
Analyses from recorded radar images indicated that the sy CAPELLA capsized at 08:14 in the morning on July 1<sup>st</sup> 2017. At that time the sy CAPELLA disappeared from the radar in position 51°27'24 N and 003°00'88 E, when sailing with wind on the port quarter, as seen on recorded radar images from VTS

*Figure 12 - Radar images of sy CAPELLA at time of capsizing  
with another contender in very close vicinity*

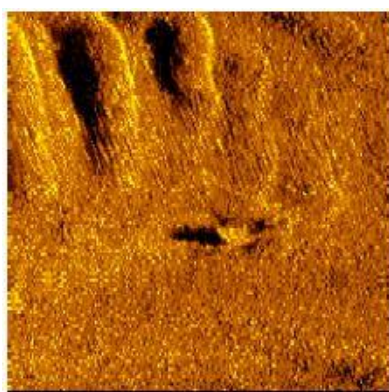
Months later, at the end of the month of September 2017, a Belgian navy vessel BNS CASTOR located the sy CAPELLA's keel, by means of active sonar<sup>5</sup>, in position 51° 27'045 N and 003°1'105 E, or very close to the last position of the sy CAPELLA before capsizing as determined by radar, indicating that the keel of the sy CAPELLA was lost at the time of capsizing, and that the loss of the keel played a part in the capsizing.

*Figure 13 - SONAR location of the keel of the sy CAPELLA*

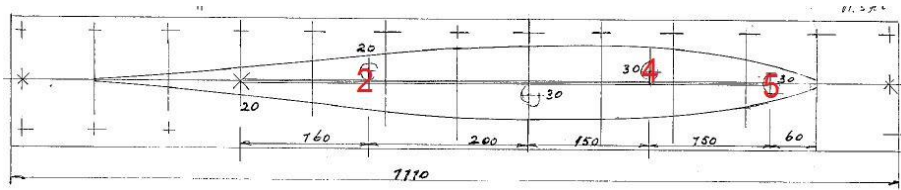
Figure 16 - Numbering of the keel bolts

It was noted that the threaded rods or keel bolts, provided to keep the keel in place, were sheared off below the welds, where the threaded rods or keel bolts had been welded to the keel plate. It was also noted that all keel bolts had been positioned near the centre line of the keel.

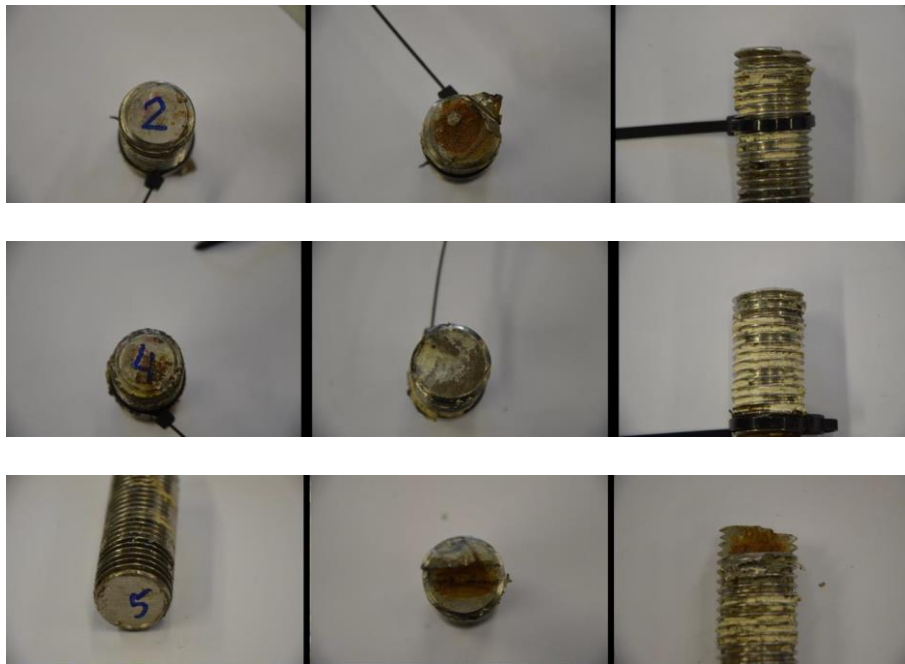
Bolts numbers 2, 4 and 5 had been submitted for fracture surface analysis.

Figure 17 - Keel bolts 2, 4 and 5 as submitted to the laboratory

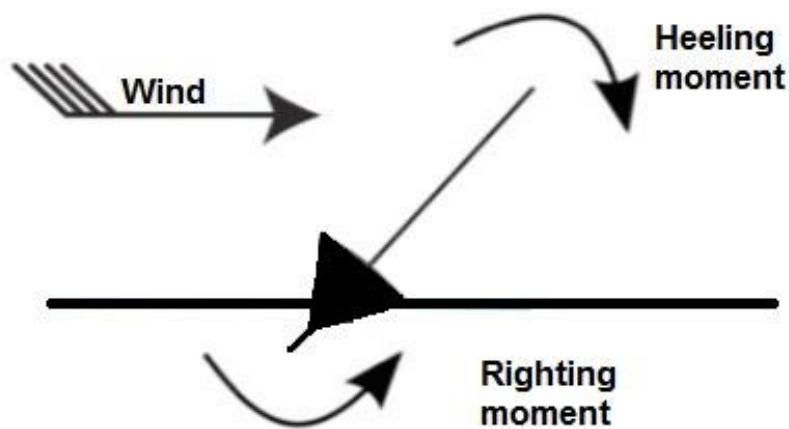
*Figure 28 - Moments acting upon sailing vessels when sailing*

The sudden loss of the keel disrupts the equilibrium between the heeling and the righting moment in such way that there would not be any time for the crew to adjust the sails in such way, or to reposition themselves on board, so that a new equilibrium is created between the newly developed righting moment without keel and heeling moment as a result of the force of the wind acting upon the sails.
