Report on the investigation of the capsizing of Z.19 -Sonja off the UK coast on 25 August 2018

August 25th 2018, 1530 LT (UK Daylight Saving Time, UTC+1), the Belgian Fishing vessel Z.19-Sonja capsized and sank in a position 25 nm ENE of Great Yarmouth.

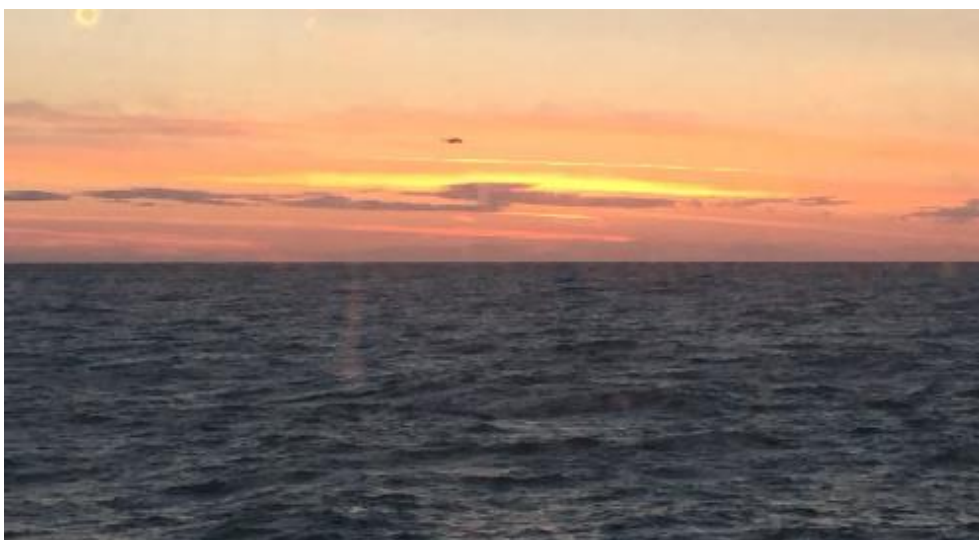
Figure 9- Arrival SAR

Picture taken by A. Rosen on board Pacific Princess when SAR helicopter arrives on the scene , after the cruise vessel picked up the surviving crewmembers.
