Report on the fatal accident on board mv SIMON STEVIN on 28 January 2019

The subsea rock installation vessel mv SIMON STEVIN was moored alongside at the Port of Zeebrugge for overhauling purposes. Most of the crew, except a few watchmen, were working in dayshifts, from 06.00 to 18.00.

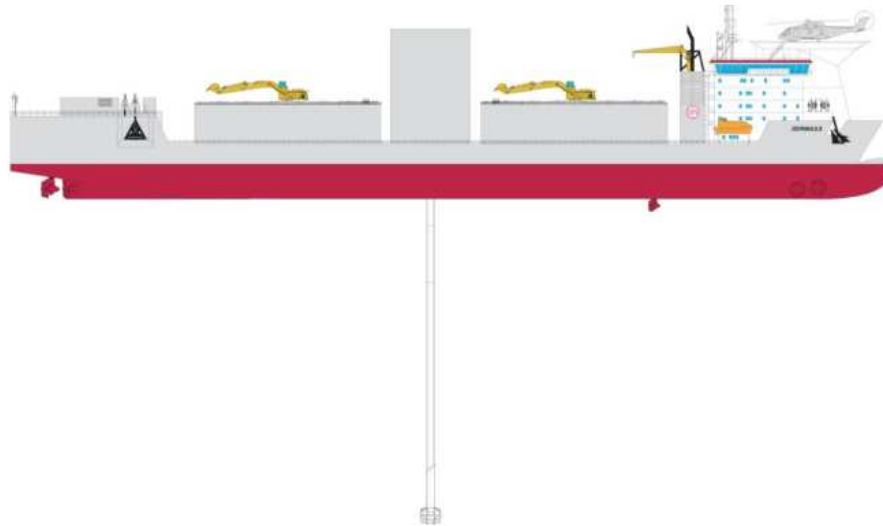
Figure 2 – Pictorial representation of a fall pipe vessel

A fall pipe vessel (FPV) is a self-propelled vessel that is equipped with pipe sections that can be connected on board to obtain a long fall pipe beneath the vessel as represented in Figure 2 on page 11.
