Report on the investigation into the  
cause of a serious injury  
on board MT COASTALWATER  
on 27 October 2019

On October 27<sup>th</sup>, 0010 (UTC+2), a crewmember on board the Dutch flagged chemical tanker MT COASTALWATER seriously injured his right hand during mooring operations in the Boudewijn lock at the Port of Antwerp (Belgium). After surgery, four of his fingers needed amputation.

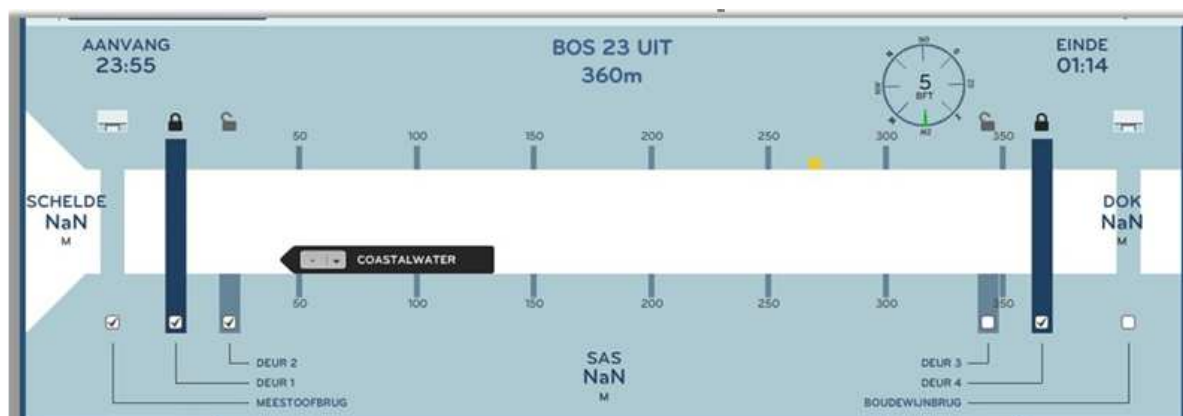
Figure 1 - MT COASTALWATER in the lock

The mooring configuration consisted out of one stern line, one fore line and one fore spring. The forward mooring station was manned by two crewmembers. The mooring station aft was manned by one crewmember. Communication on board between crewmembers on deck and bridge happened by means of two way VHF radios on the same working channel.
