Report on the investigation into the grounding of
mv LA BELLE DES OCEANS

near the Phi-Phi Islands, Thailand with hull rupture below the
waterline on 25 November 2019.

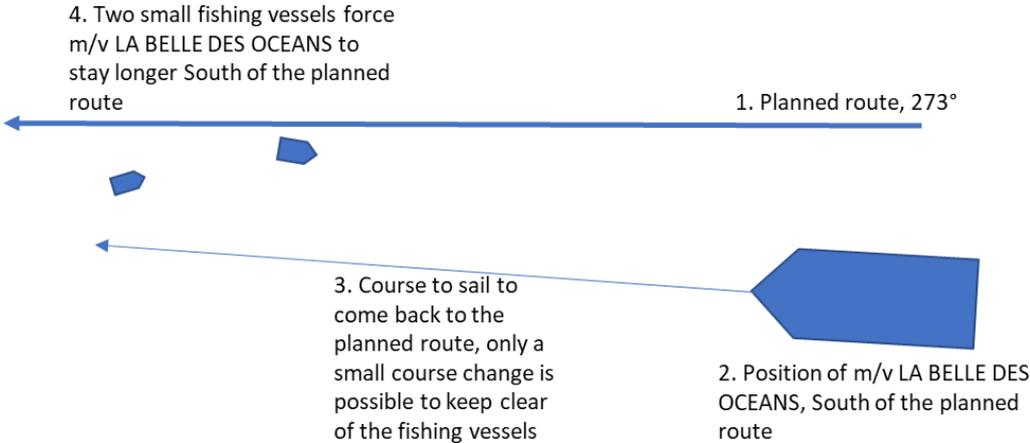
Figure 4 - Drawing of traffic situation

After the fishing boat was passed, another two small fishing boats became visible. Additionally some smaller white lights were visible in the water, indicating the presence of fishing nets. Reportedly, it was decided to make a small alteration in course to SB of a few degrees to return to the initial course and thus stay South of the planned route, as explained in Figure 4.

This drawing only gives an indication of the maneuver and is not based on real positions.

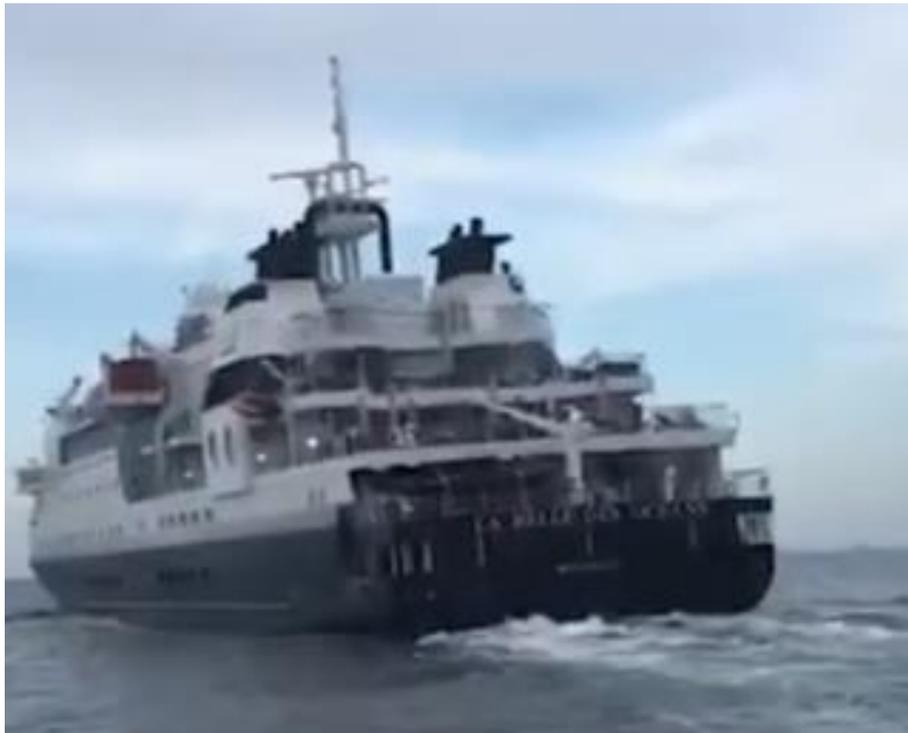
Figure 12 - Mv LA BELLE DES OCEANS underway to Phuket after grounding
